UNIVERSITÀ DEGLI STUDI DI PADOVA

MASTER'S THESIS IN WATER AND GEOLOGICAL RISK ENGINEERING

**“INCORPORATING GEOMORPHOLOGICAL ANALYSES TO
IDENTIFY POTENTIAL CRITICALITIES FOR FLOOD
SUSCEPTIBILITY IN ROMAGNA PLAIN”**

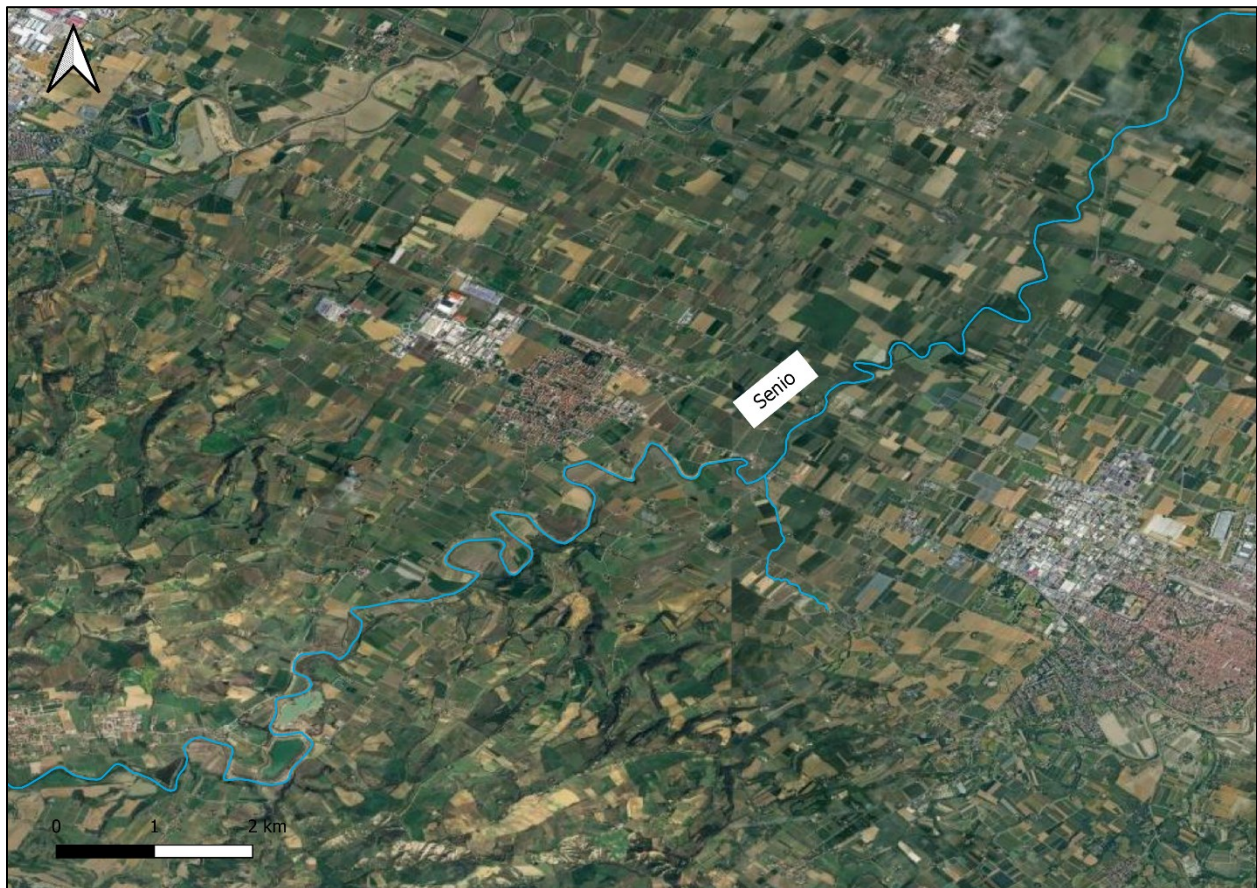
Figure 2.2: Highly sinuous section of Senio River

High sinuosity has been linked to increased flood susceptibility, as rivers with intricate meanders tend to have longer pathways and more frequent interactions with floodplains. Studies indicate that these rivers are more prone to overbank flooding during high flow events [17]. Floodplain connectivity is particularly critical in regions with high sinuosity, as the meandering river often spills over its banks, inundating adjacent lands. This highlights the importance of accounting for river sinuosity in flood risk assessments and the design of flood defenses.

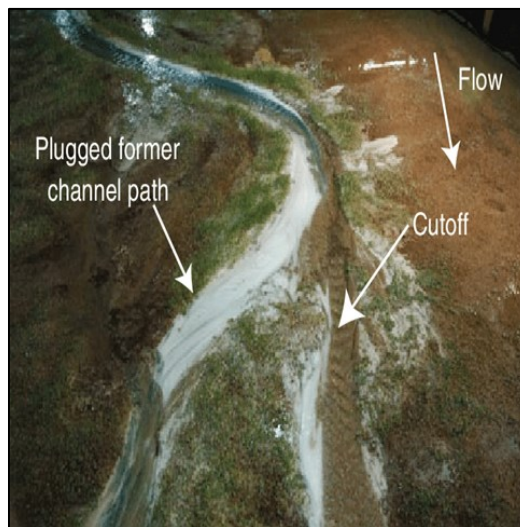
Figure 2.4: Meander cutoff example [17]

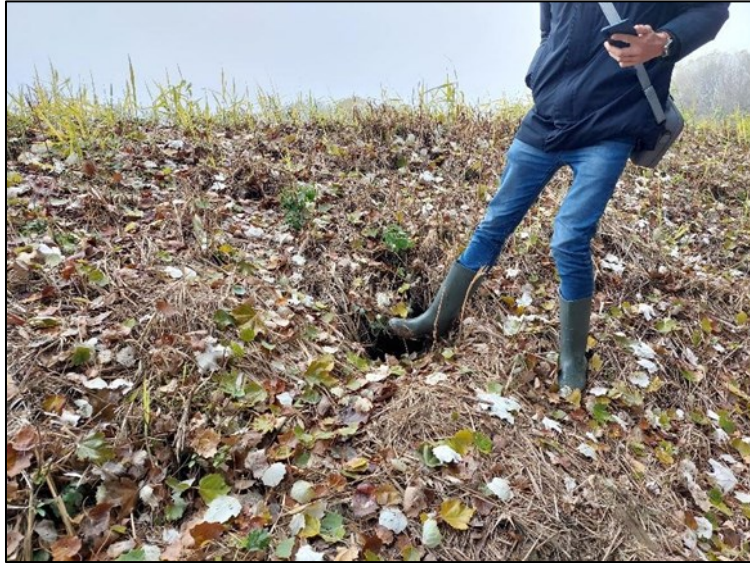
During the first flood, a breach emerged in a privately owned embankment near Via Chiesa in Sesto Imolese. A site inspection on December 1, 2023 revealed a significant presence of burrowing animals along the banks in the vicinity of the breach (fig. 4.2). This suggests that animal burrows, and activity may have been a primary factor in the embankment's failure.

Figure 4.2: Animal burrows observed, Via Chiesa site investigation

Following the event, the earthen embankment was likely rebuilt to protect the area, with prioritization of rapid reconstruction using readily available materials from the surrounding area to limit further flooding. Materials might include soil (clay or sand) from nearby stockpiles or borrow pits, and possibly even recycled debris from the flood. The damaged embankment is rebuilt, and though these repairs are often temporary, they provide immediate protection. Solutions that are more permanent will likely require replacing the temporary materials with engineered and tested alternatives and may necessitate a geotechnical analysis for long-term levee stability.

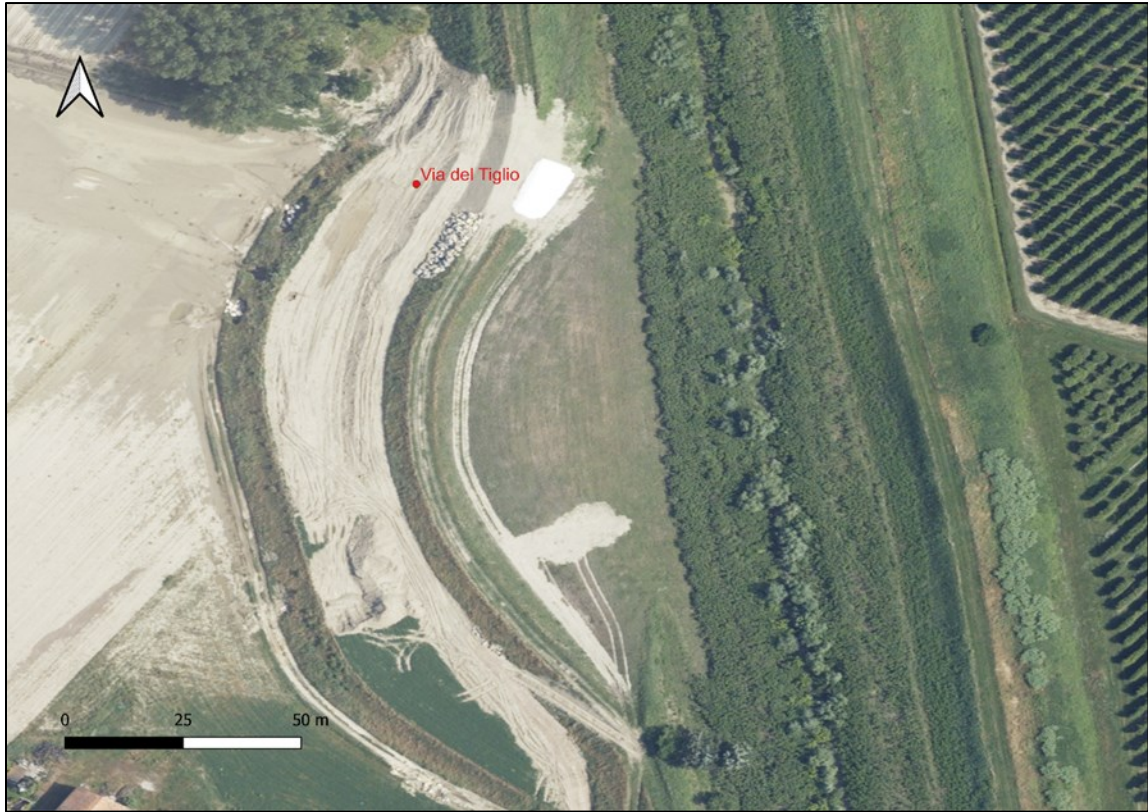
Another breach occurred at Via del Tiglio. This point likely marks the location of an old breach, where the levee likely failed in the past (fig. 4.3). Observations through field visit suggests that the breach was hastily repaired with a ring of boulders and then covered with soil – potentially without the crucial addition of a filter layer to prevent internal erosion. Despite the repair, the embankment remains significantly higher than the surrounding floodplain. Interestingly, it features distinct berms on the landward side, possibly indicating multiple attempts at reinforcement over time.

Figure 4.3: Post event orthophoto of Via del Tiglio breach

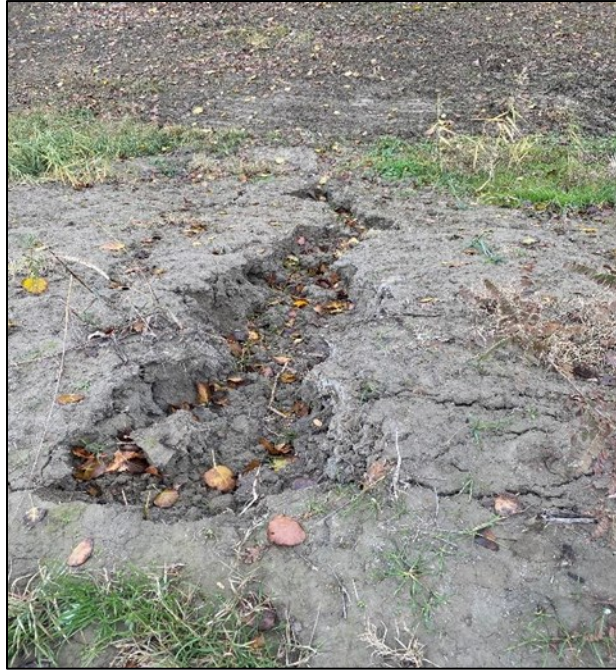
During the initial flood event, the breach occurred possibly at the junction where the previously repaired section met the original embankment. Field inspections revealed signs of water seepage through the embankment, gradually eroding the landward base (fig. 4.4) and exposing the boulders used in the prior repair. This exposure triggered minor collapse on the landward slope, indicating significant instability issues. The observations strongly suggest that the highly permeable materials used in the old repair's core allowed water to accumulate significant pressure within the embankment, thereby destabilizing the original levee structure. The junction where the boulder ring intersected the old embankment was particularly susceptible; the repair material's high permeability created substantial pressure, while the original embankment's resistance was likely compromised. Additionally, contact erosion might have contributed to the instability. This phenomenon occurs when two materials with vastly different grain sizes meet, causing water flow to transport small particles from the finer material into the coarser one, thereby increasing permeability, intensifying water flow, and further weakening the structure's integrity.

Figure 4.4 Erosion signs on levee body, Via del Tiglio site inspection

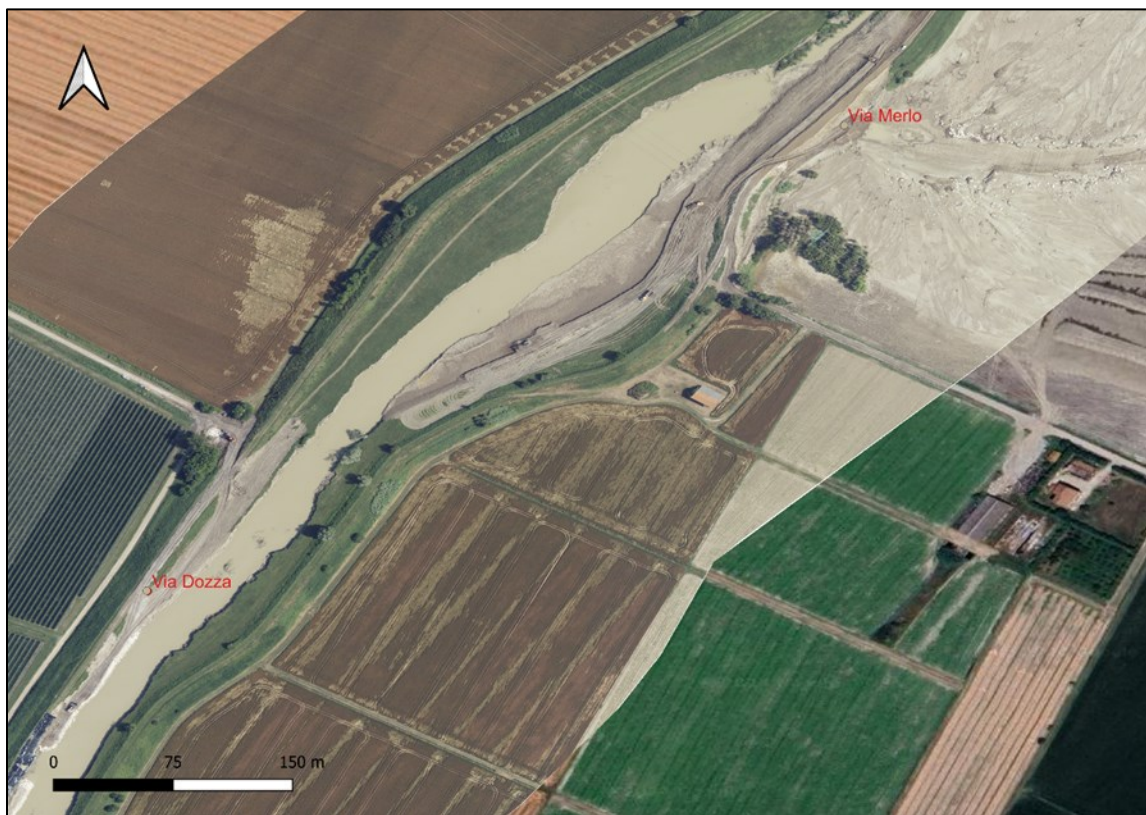
Amid the first event, a breach occurred in the levee at Via Merlo, Spazzate Sassatelli (fig. 4.5). Despite rapid repair efforts, the second event overwhelmed the reconstructed embankment, reopening the breach. Analysis of available videos does not suggest overtopping as the primary cause; rather, a localized defect within the embankment, such as an animal burrow, likely initiated concentrated erosion. The specific location of the embankment is notably high, which may have exacerbated the failure's severity. The breach extended approximately 50 meters, resulting in widespread flooding that affected the Spazzate Sassatelli district of Imola and Conselice (Ra).

In this particular reach, the watercourse runs elevated from the surrounding land. During the site visit, it is observed that the breach is hastily repaired using boulders, covered with soil likely sourced from nearby floodplains. Notably, the repair did not incorporate geosynthetics to separate these different materials. Reinforcement at the riverside base of the embankment includes 10-meter sheet piles, with boulders armoring the riverward slope to prevent erosion. To restore the embankments, 6,000 tons of rock were strategically positioned and an additional 23,500 cubic meters of earth were used to reinforce the structures. Current efforts focus on further strengthening the embankments, including the installation of sheet piling along a 100-meter stretch to increase impermeability and enhance overall stability, which is anticipated to significantly enhance the stability of this section.

Figure 4.5: Post event orthophoto of Via Merlo and Via Dozza breach

The floodplain has been altered, incorporating protective stonework to prevent further erosion. In regions where the embankment partially collapsed, large stones have been placed to reinforce its base, and the embankment has been meticulously rebuilt.

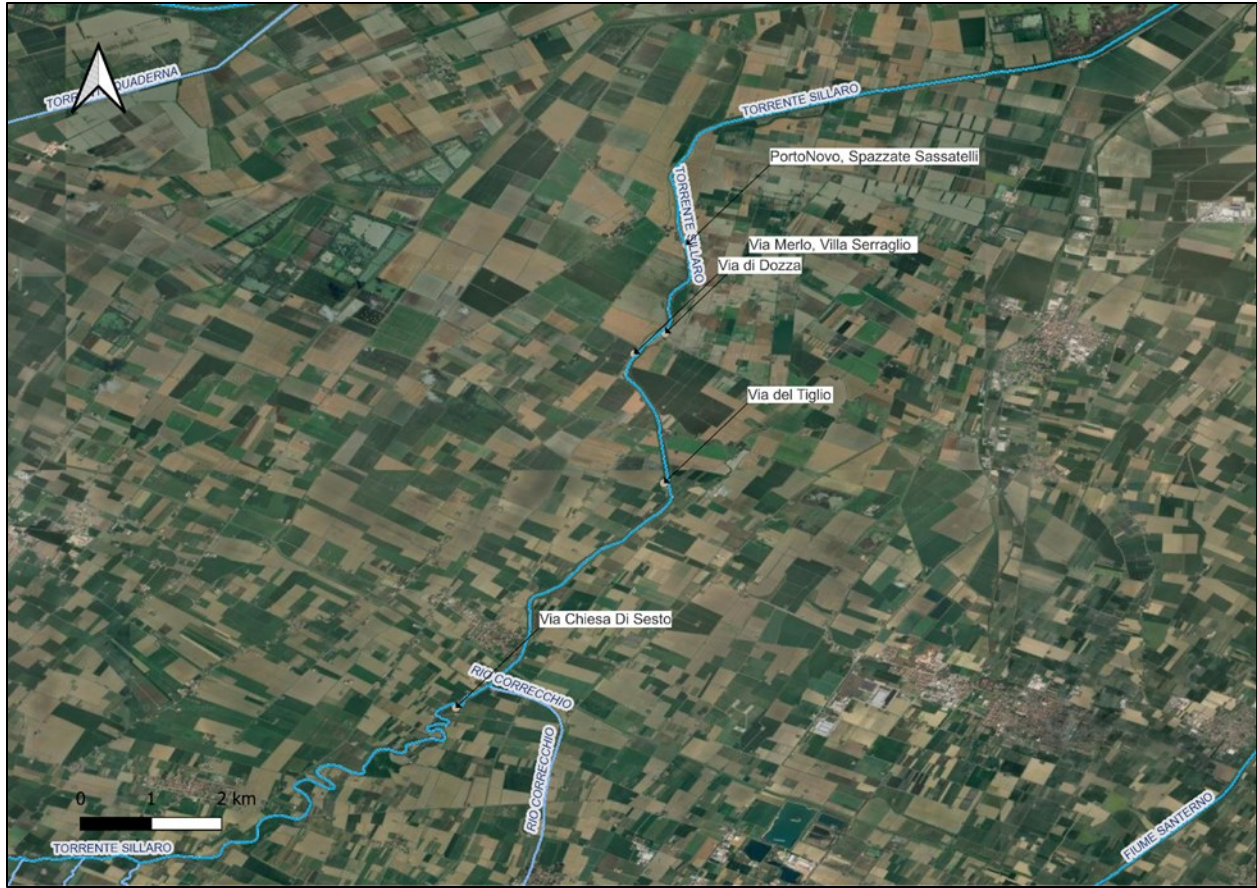
Figure 4.6: Breaches along the Sillaro watercourse

4	Via di Dozza	<ul style="list-style-type: none"> • Breach at Via Merlo triggered a chain reaction. • Erosion progressed backwards, compromising sections of the embankment at Via Dozza. • Rapid flow and powerful erosive force were primary drivers of destruction. 	<ul style="list-style-type: none"> • Altered floodplain with protective stonework to prevent further erosion. • Large stones placed to reinforce the base in partially collapsed regions
5	PortoNovo	<ul style="list-style-type: none"> • Overflow during second event. • Surge redirected against landward embankment causing substantial erosion. • Persistent erosion risks total levee segment failure and structural compromise of the bridge 	<ul style="list-style-type: none"> • Reprofilng scheme is proposed for the breached levee section.

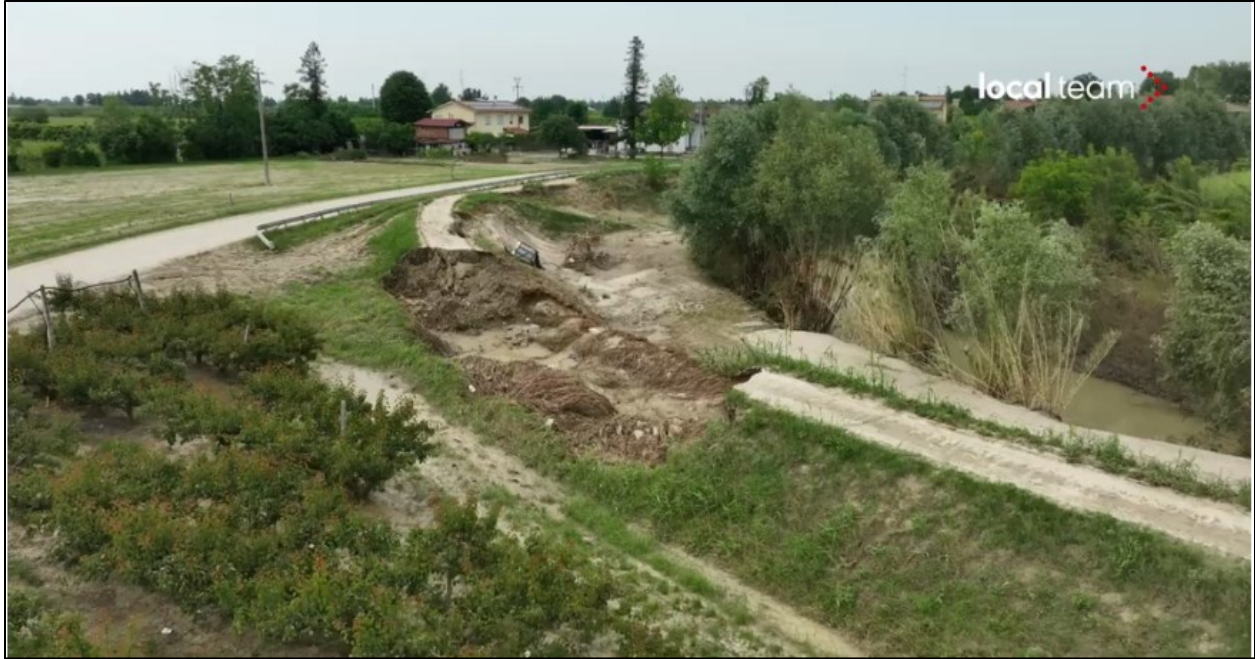
Figure 4.7: Snap from a post event aerial survey near the reaches at Castel Bolognese [22]

Following the event, the interventions proceeded in two directions: restoration of the hydraulic efficiency of the streambed and the restoration of the banks. Specifically, the structure of the watercourse between Riolo and Ponte del Castello is being strengthened and optimized to enhance lamination phenomena, while maintenance and arrangement of the full-bank section of the active riverbed aim to maximize flow capacity. Additionally, bank stabilization works are being implemented where lateral erosion threatens buildings and infrastructures, and a defensive system is being defined on the left bank to protect the town of Castel Bolognese.

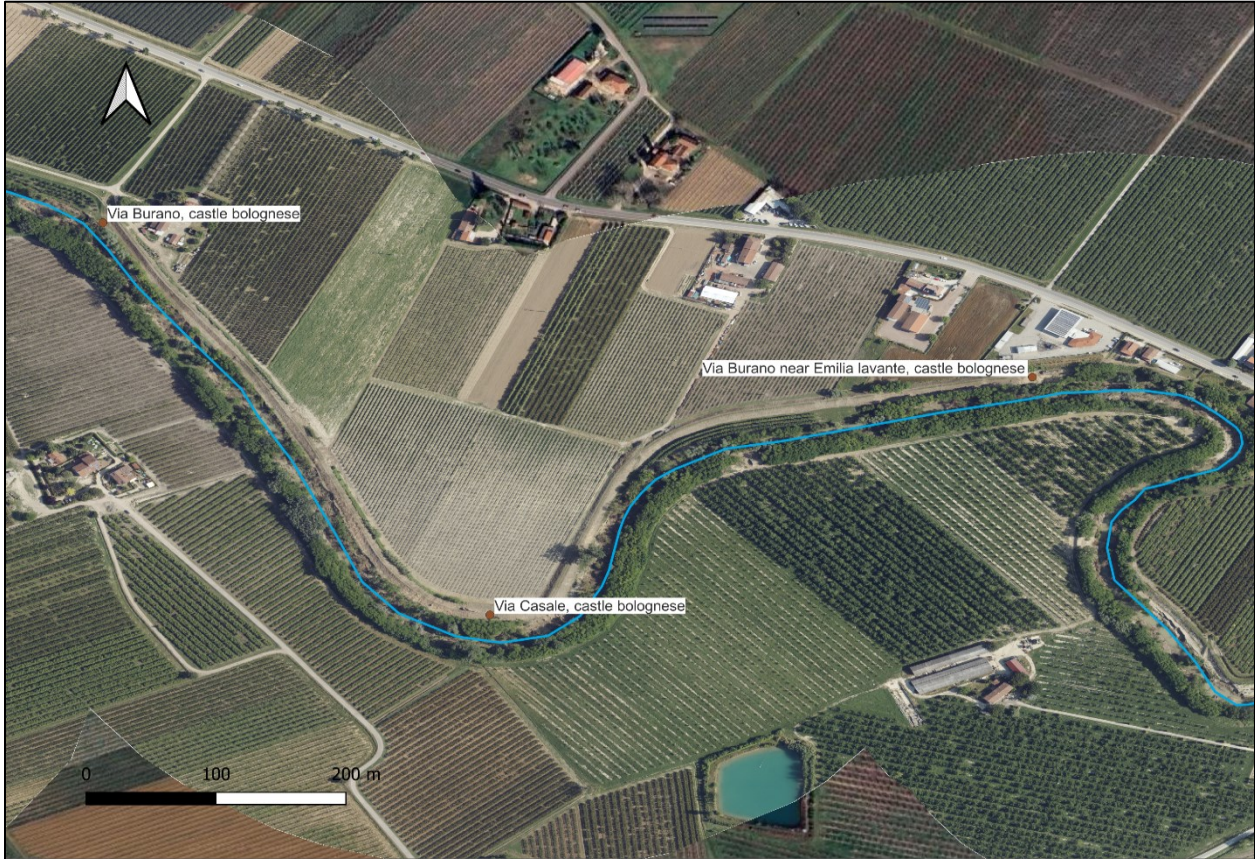
Figure 4.8: Post event orthophotos of main breaches near Castel Bolognese

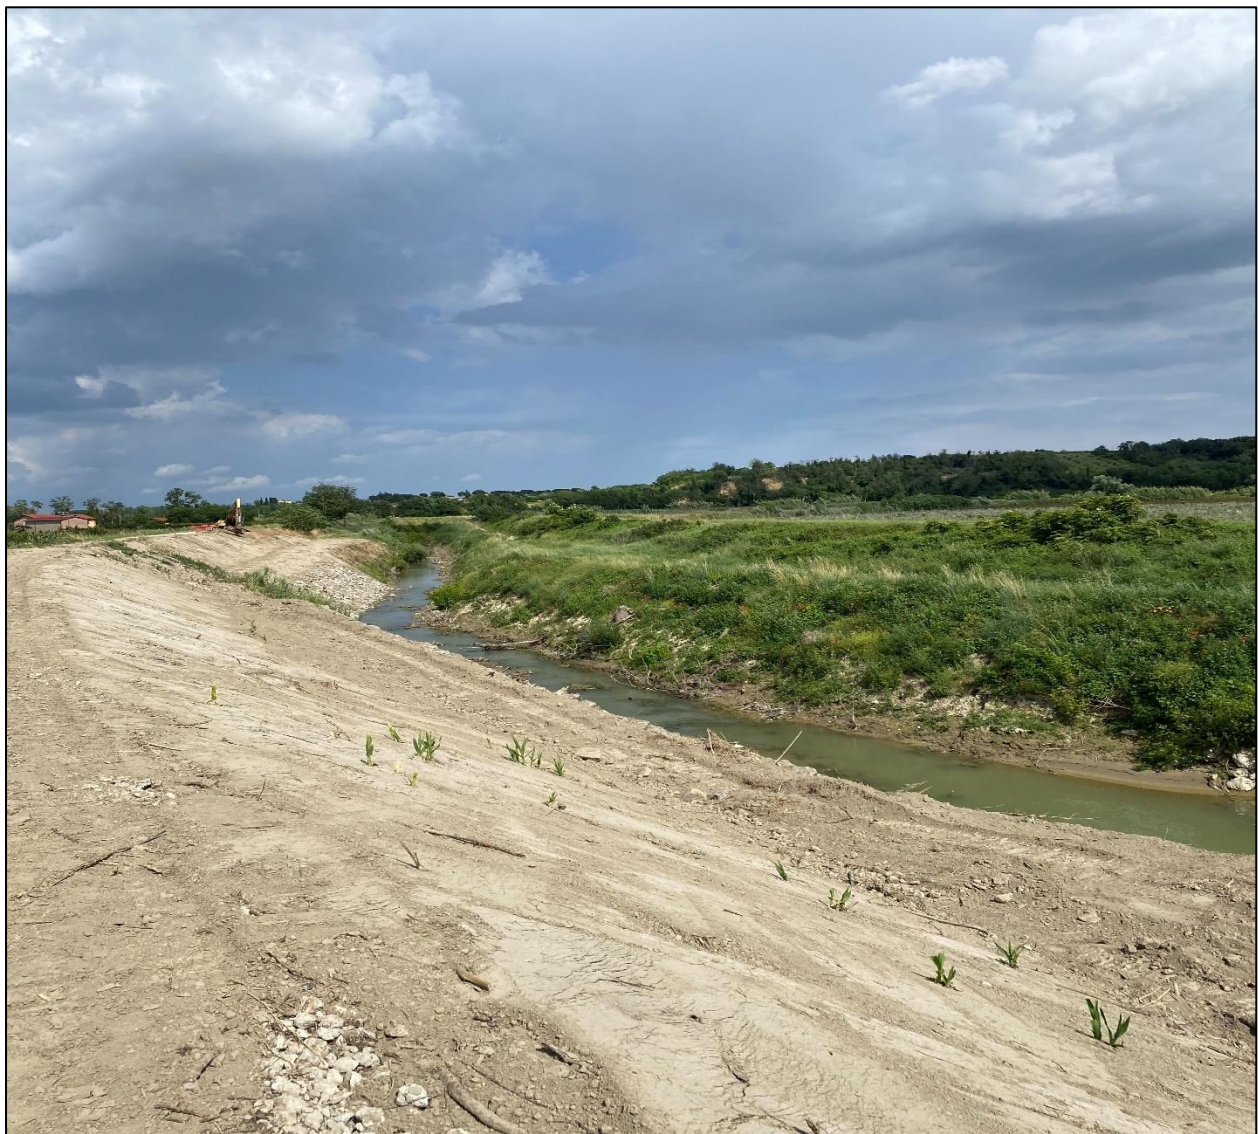
The intervention measures following the event includes the restoration of the riverbed's functionality and reconstruction of the hydraulic left embankment and removal of fallen vegetation (fig. 4.10). Table 4.3 constitutes the summary and key attributes of the main criticalities formed in Senio River during the May 2023 event while figure 4.11 depicts the location of the criticalities along the watercourse.

Figure 4.10: Intervention works at Via Canale breach, June 03, 2024 site inspection

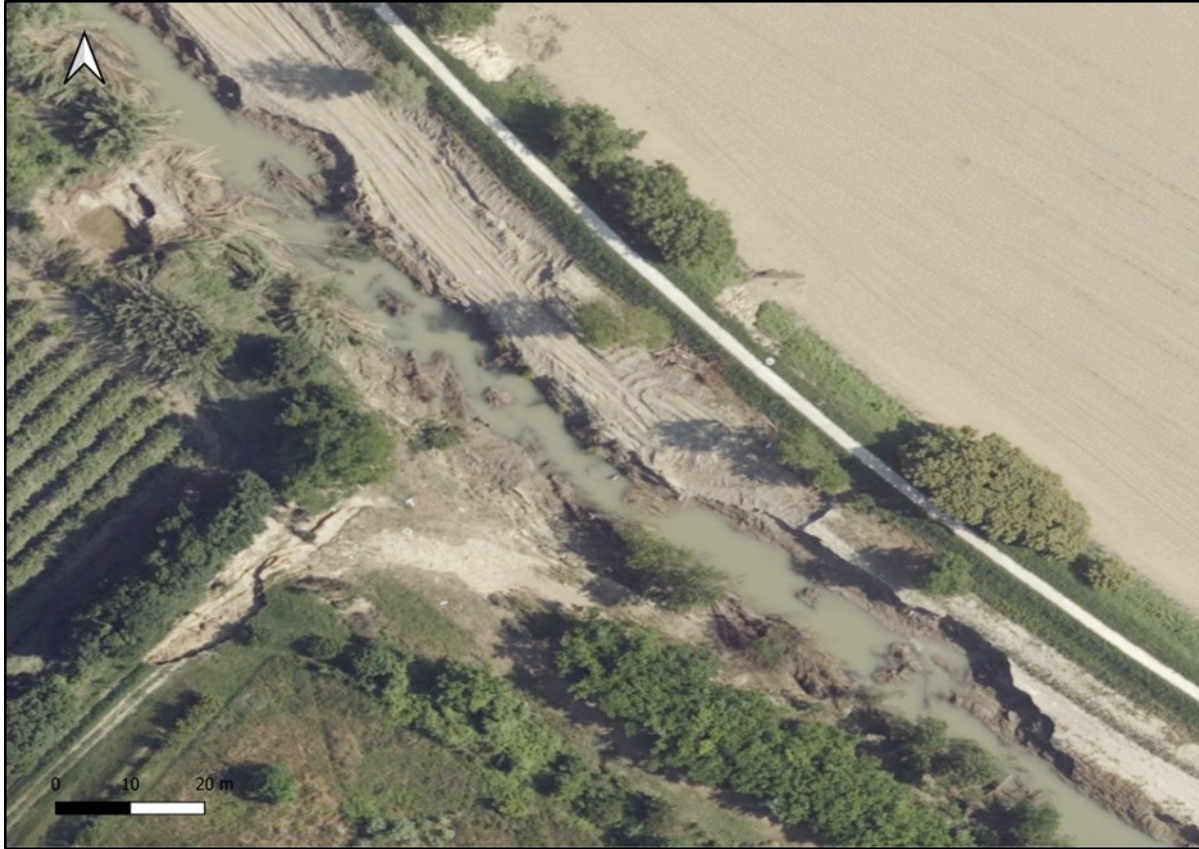
Bank erosion, as captured in the post-event orthophotos, is a primary indicator of flood impact on the fluvial morphology. The orthophotos reveal several sections where the riverbanks exhibit significant erosion, characterized by the removal of vegetation and soil layers, leading to the destabilization of the riverbanks. These eroded sections, marked by irregular, scalloped edges along the river course, suggest high-energy water flow during the flood event. The extent of erosion, in conjunction with the geomorphological context of the surrounding area, provides insights into the intensity and direction of floodwaters, as well as the vulnerability of specific riverbank segments to future flood events. Figure 6.1 discerns extensive bank erosion observed at highly sinuous section of Senio River

Figure 6.1: Observed bank erosion at meander section of Senio River

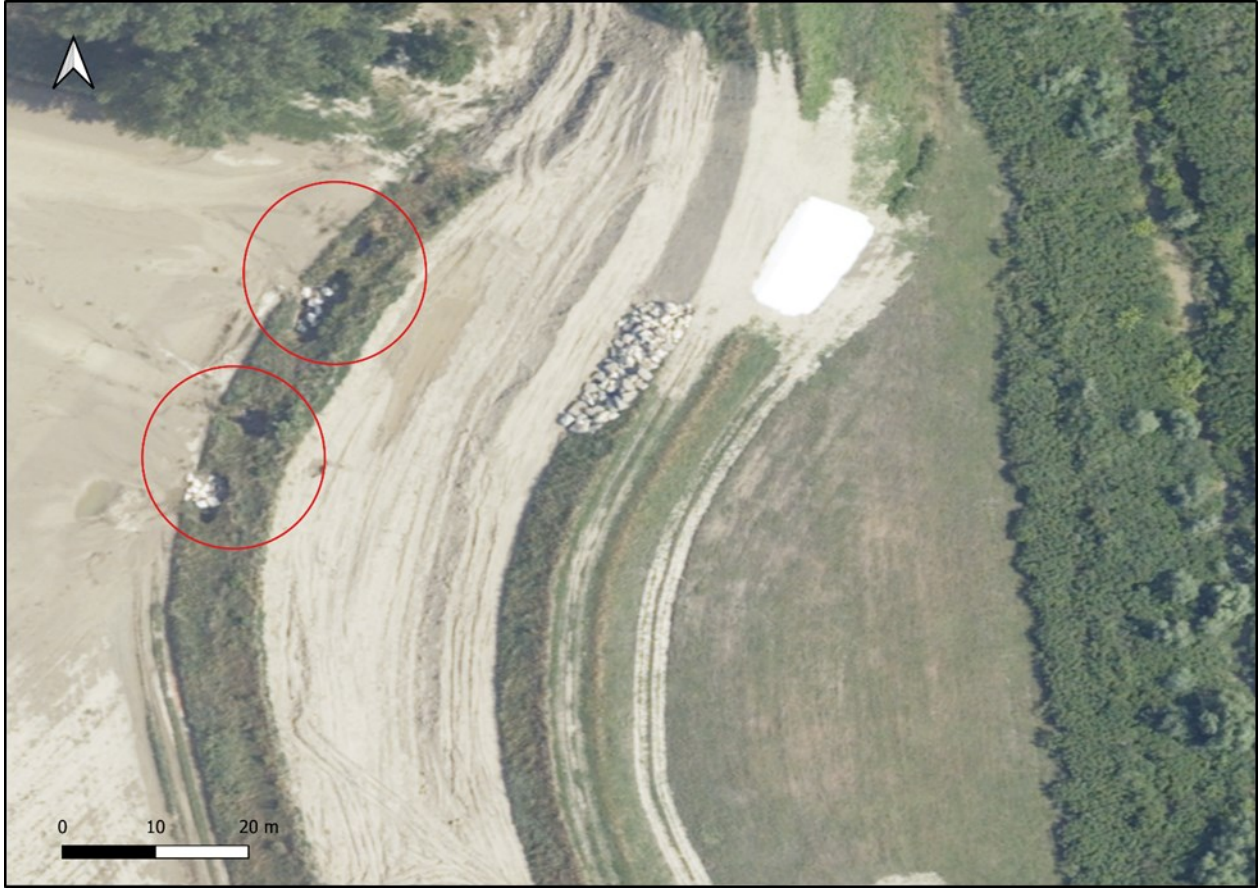
Piping, or the subsurface erosion caused by water flow through permeable soil layers, is another criticality identified through orthophoto analysis. The presence of piping is inferred from the appearance of sinkholes, depressions, and irregular surface patterns on the orthophotos, particularly in areas adjacent to embankments. These features suggest the internal weakening of embankments or levees, which, if left unaddressed, could precipitate larger breaches in future flood events. The identification of these piping signs is essential for the formulation of targeted remediation strategies aimed at strengthening embankment integrity. Figure 6.2 displays piping signs near Via del Tiglio breach at Sillaro River.

Figure 6.2: Observed possible piping sign at Sillaro River

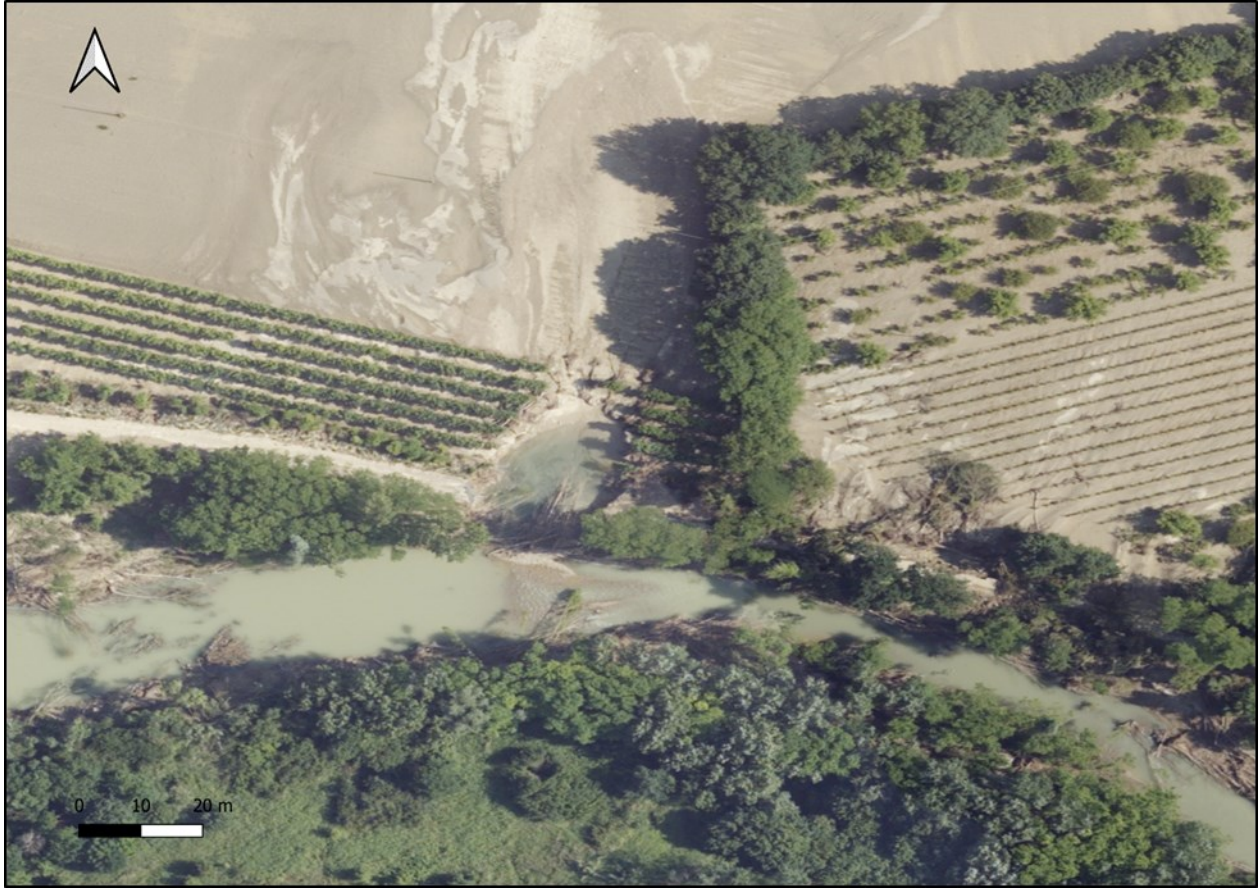
The orthophoto analysis also highlights few overflowing locations, where floodwaters exceeded the height of natural or artificial embankments, leading to the inundation of adjacent low-lying areas. The deposition of sediments and the flattening of vegetation typically mark these overflowing events, which are clearly visible in the orthophotos. By mapping these overtopping locations, this study identifies the most vulnerable sections of the flood defense infrastructure, thereby informing the prioritization of structural reinforcements and flood management interventions. Figure 6.3 exhibits one of the overflowing location identified through post-event orthophoto in Senio River

Figure 6.3: Observed overflowing location at meander part of Senio River

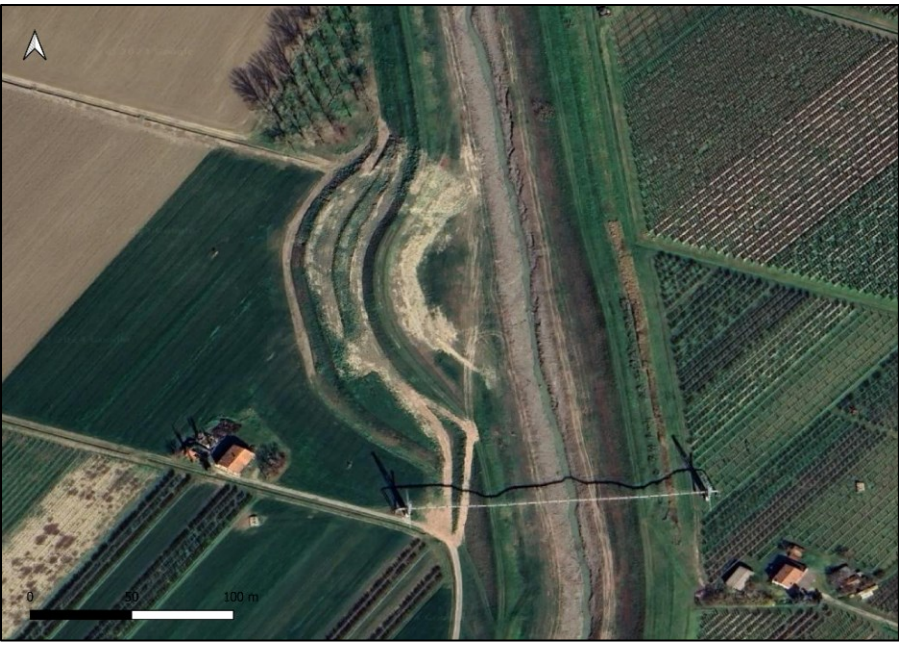
The identification of coronellas, which indicate historical breach locations, plays a significant role in understanding flood susceptibility. These features, often appearing as linear depressions or subtle curvilinear patterns in the landscape, are not merely remnants of past embankment failures or intentional breaches. Their presence signifies areas with a persistent vulnerability to breach events, which is beneficial for contemporary flood susceptibility assessments. Coronellas are potentially critical because they reveal locations where the landscape has repeatedly failed to contain floodwaters, suggesting an inherent weakness or susceptibility in these areas. Mapping these historical breach sites is essential, as they can aid in assessment of potential future vulnerable locations. By mapping coronellas alongside other critical indicators, this analysis provides a more comprehensive understanding of flood dynamics and vulnerability in the region. Figure 6.6 exhibits the identification of a coronella along the Sillaro watercourse.

Figure 6.6: Presence of Coronella along the Sillaro watercourse

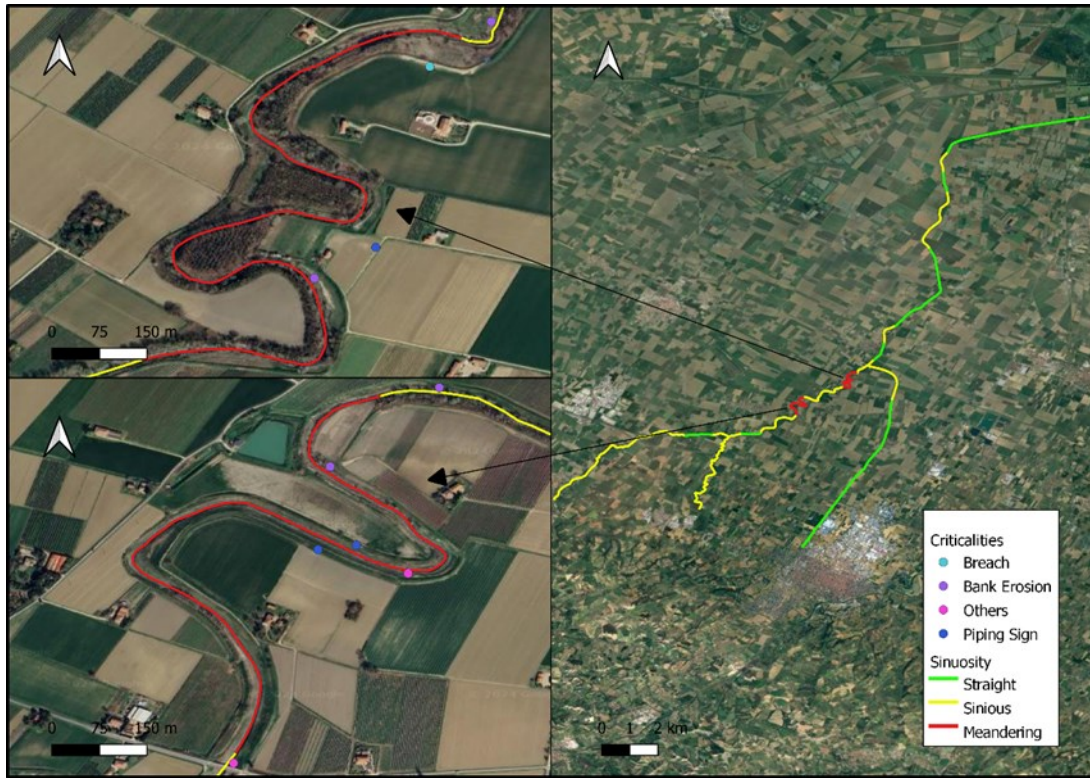
Figures 6.9 and 6.10 illustrate the regions where potential meander cutoffs may occur in the Sillaro and Senio Rivers, respectively. The sinuosity analysis reveals a high sinuosity index, in these sections, predominantly > 2.5 , while the riverbank digitization analysis shows that the banks within these meanders are progressively migrating toward the embankments. Furthermore, post-event orthophotos reveal evidence of erosion, piping and overflow in the highlighted river sections. Collectively, these indicators suggest areas of potential critical concern.

Figure 6.9: Regions vulnerable to cutoffs, Sillaro River

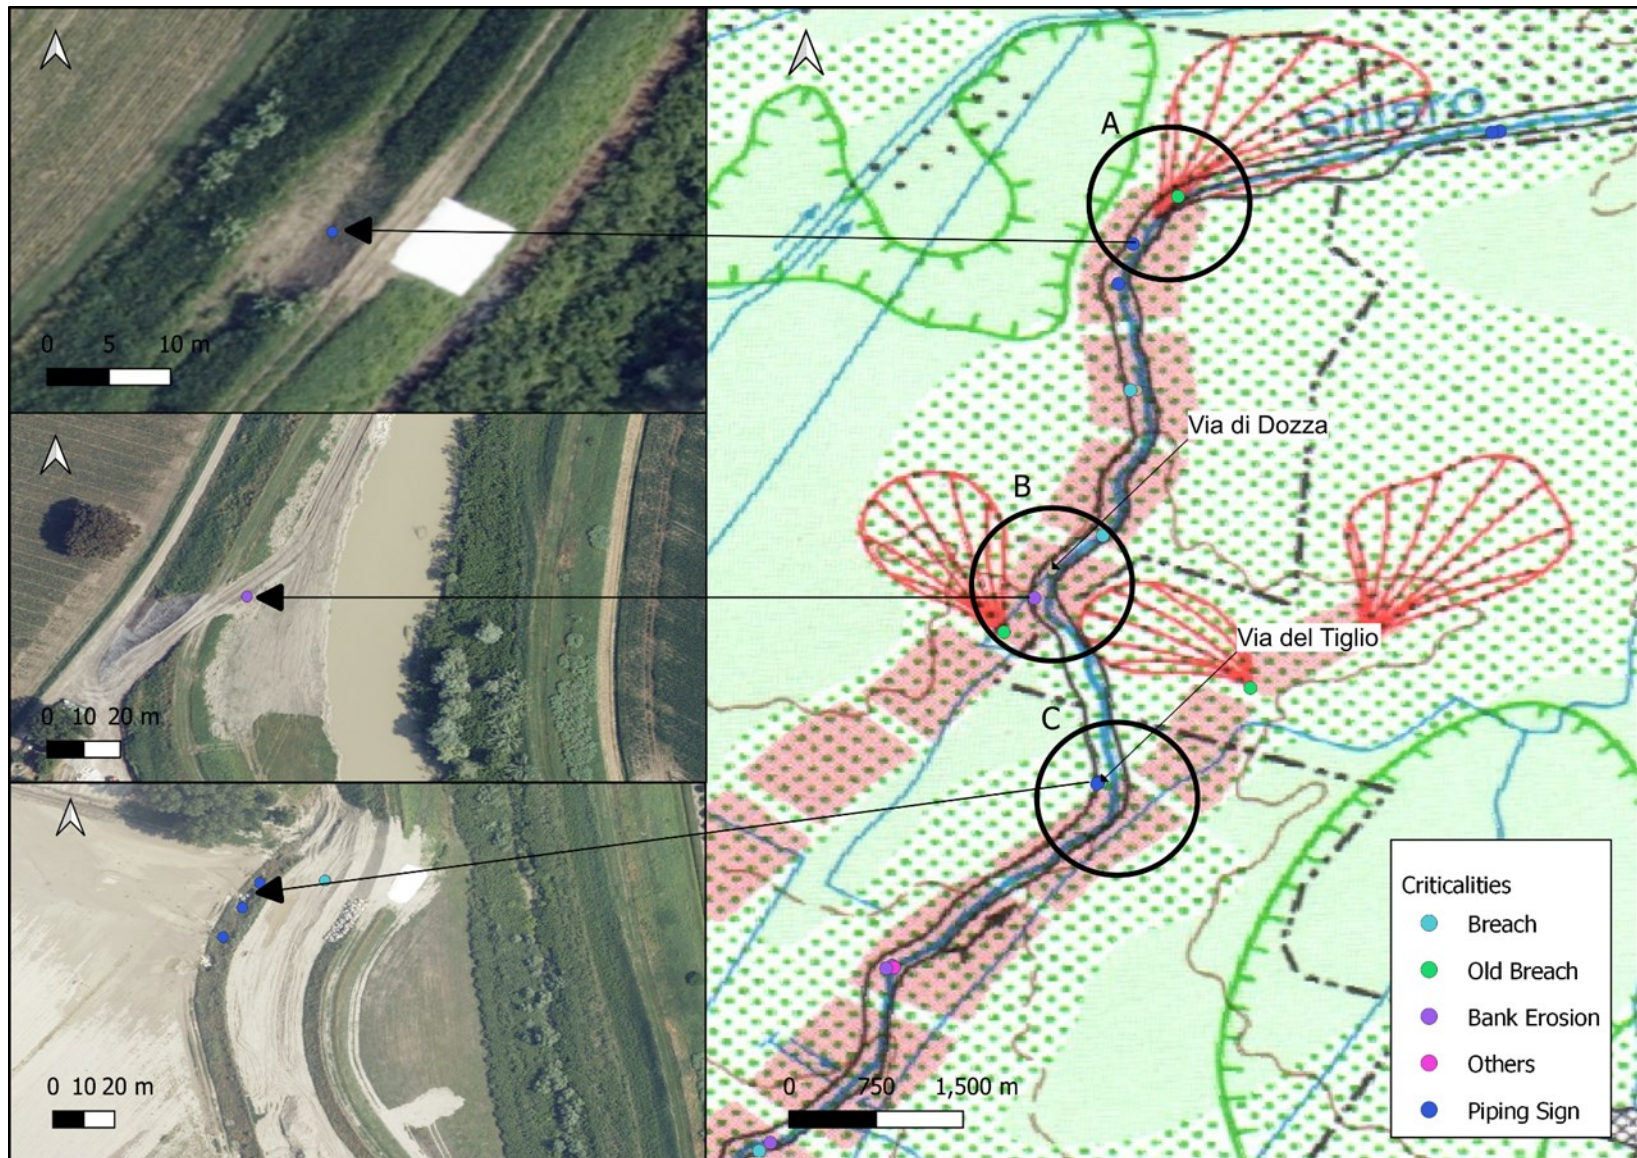
Figure 6.13: Geomorphological Map overlaid with criticalities observed from post May 2023 event orthophoto (Sillaro River)

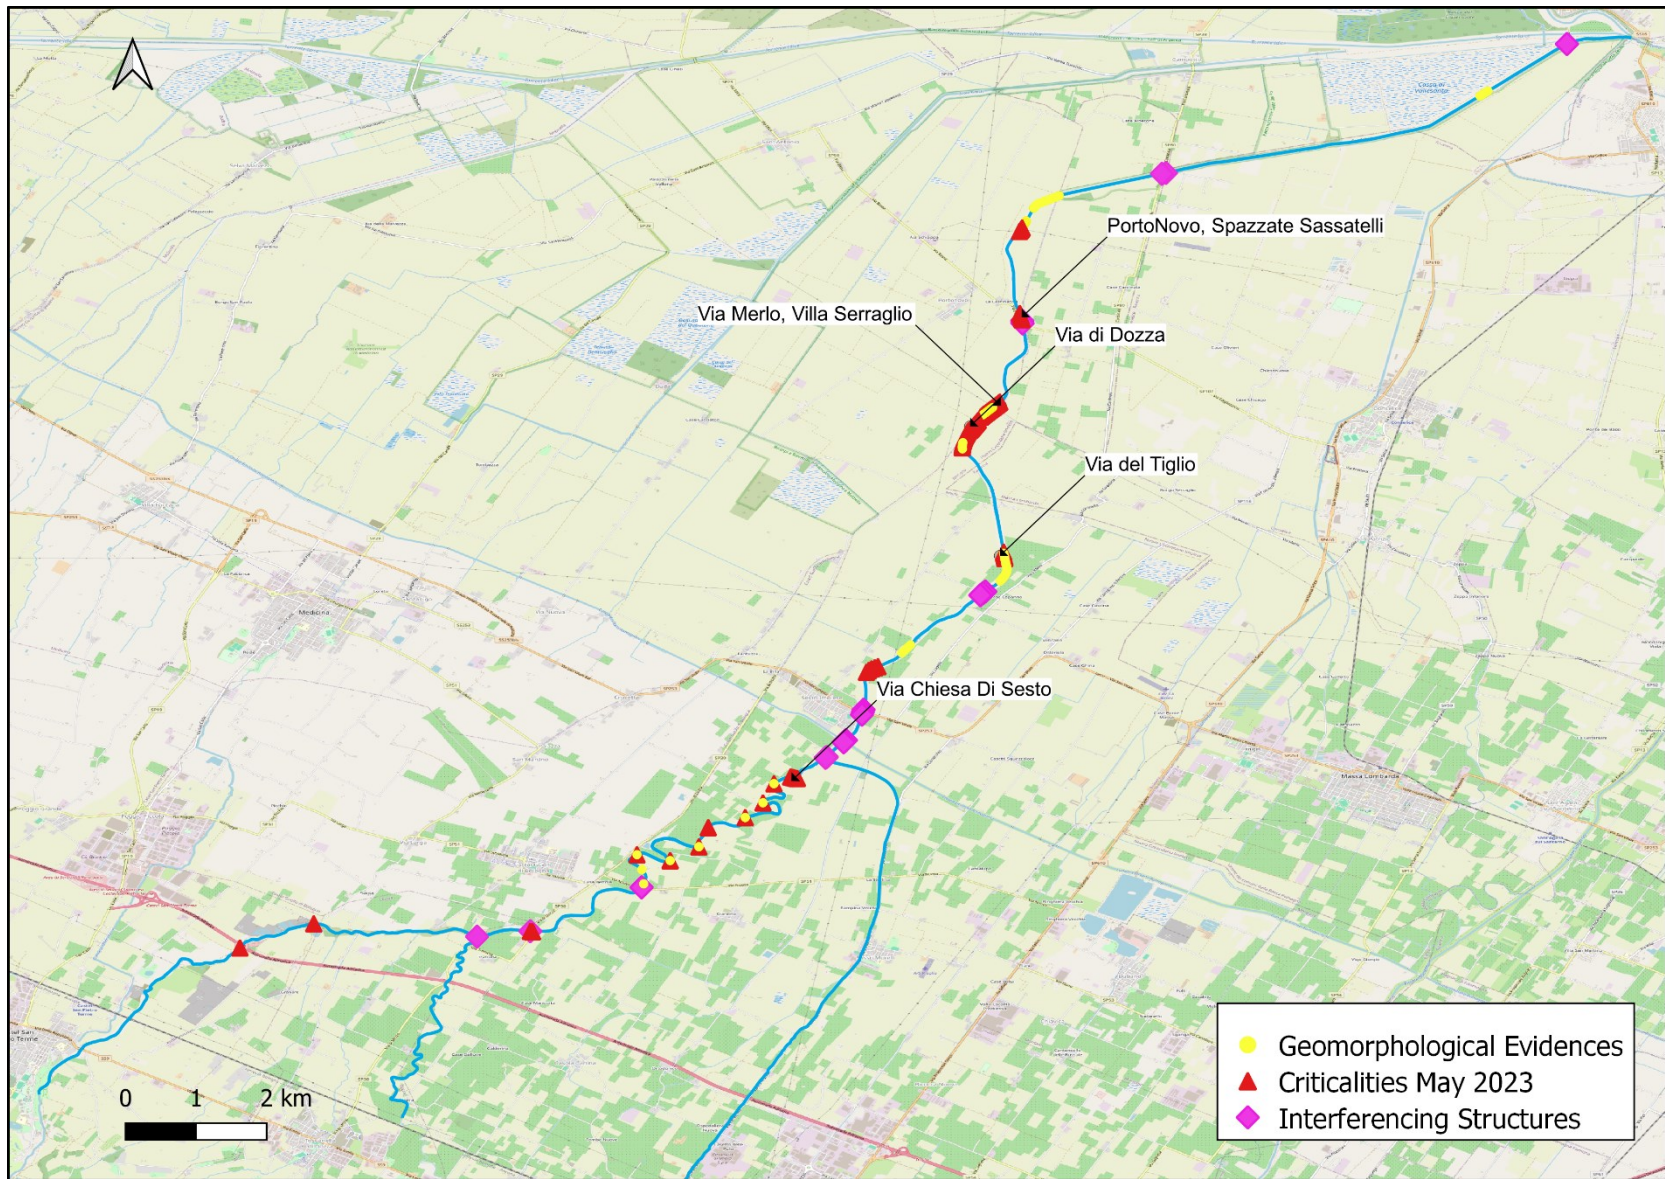
Figure 6.17: Synthetic flood susceptibility map of Sillaro River
