**DEVELOPING A FORENSIC ENGINEERING STRUCTURAL FRAMEWORK
FOR FAILURE EVIDENCES DURING THE STRUCTURAL REMODELLING
OF REINFORCED CONCRETE STRUCTURES: CASE STUDY AN R+1 RC
INDUSTRIAL BUILDING IN NSIMALEN, YAOUNDE.**

*A thesis submitted in partial fulfilment of the requirements for the degree of
Master of Engineering (MEng) in Civil Engineering*

Developing a forensic engineering framework for failure evidences during the structural remodelling of reinforced concrete structures: case study an R+1 building in Nsimalen, Yaoundé.

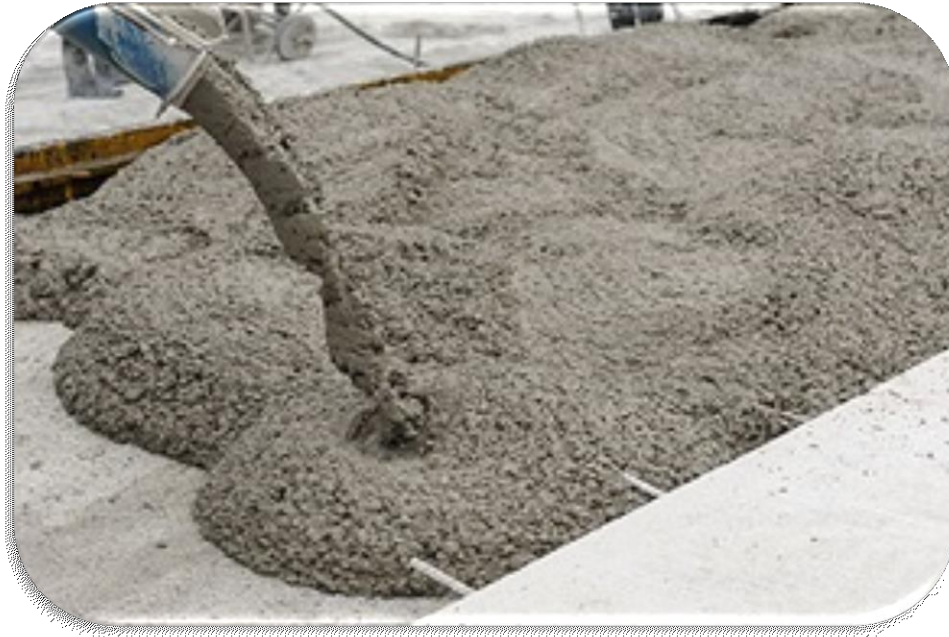
Concrete is the most commonly used man-made material on earth. It is an important construction material used extensively in buildings, bridges, roads and dams. Its uses range from structural applications, to pavious, kerbs, pipes and drains. Concrete is a composite material, consisting mainly of Portland cement, water and aggregate (gravel, sand or rock). When these materials are mixed together, they form a workable paste which then gradually hardens over time. The characteristics of concrete are determined by the aggregate or cement used, or by the method that is used to produce it. The water-to-cement ratio is the determining factor in ordinary structural concrete with a lower water content resulting in a stronger concrete. The benefits of concrete are numerous: It is a relatively cheap material, and has a relatively long life span with few maintenance requirements. It is strong in compression. Before it hardens it is a very pliable substance that can easily be shaped. It is non-combustible. (David Moore P.E, 2004).The limitations of concrete include: relatively low tensile strength when compared to other building materials, low ductility, and low strength-to-weight ratio. It is susceptible to cracking. Figure 1.1 illustrates concrete used for buildings.

Figure 1.1. Concrete construction material
(Source: m.wikipedia.org/concrete)

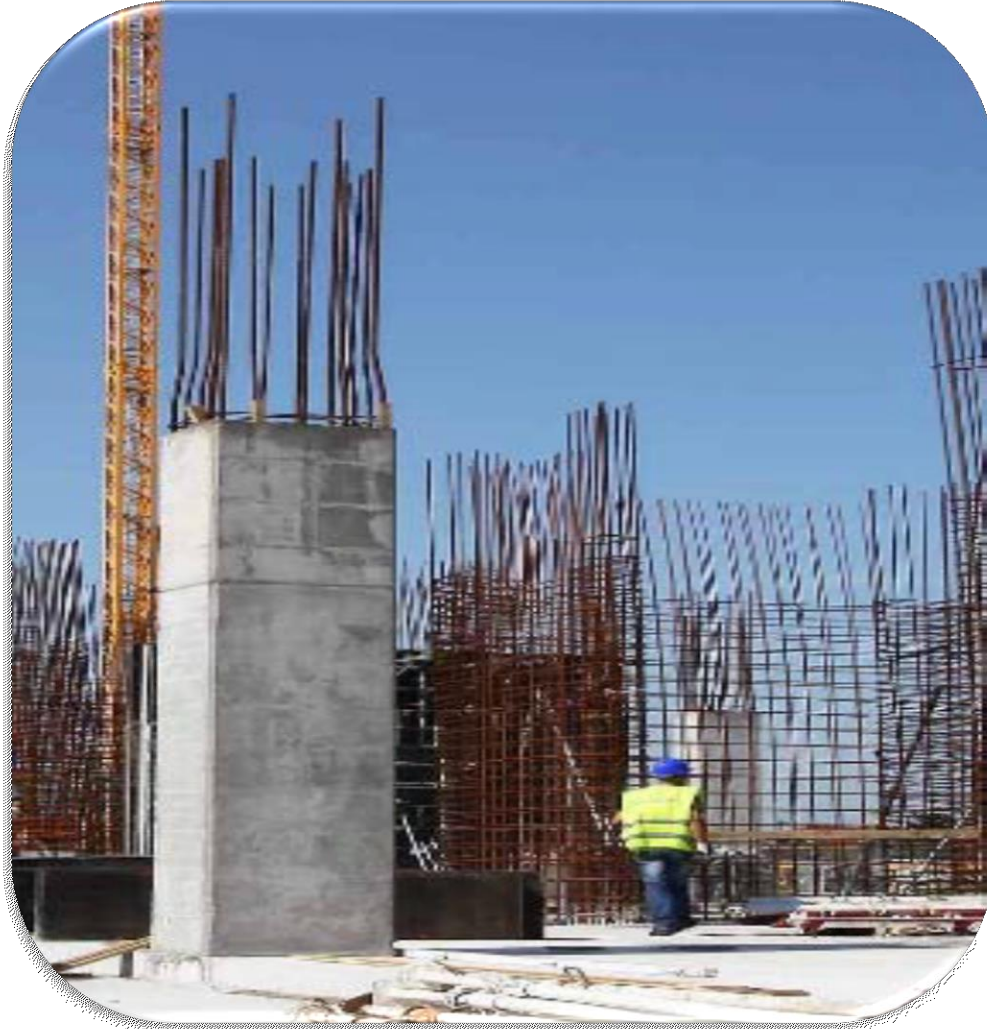
Figure 1.2. Reinforced concrete construction material
(Source: m.wikipedia.org/reinforcedconcrete)

example. (Ariana. Z, 2016). The most used type of reinforcement is steel in the form of reinforcement bars. Figure 1.2 indicates reinforced concrete with reinforcement bars.

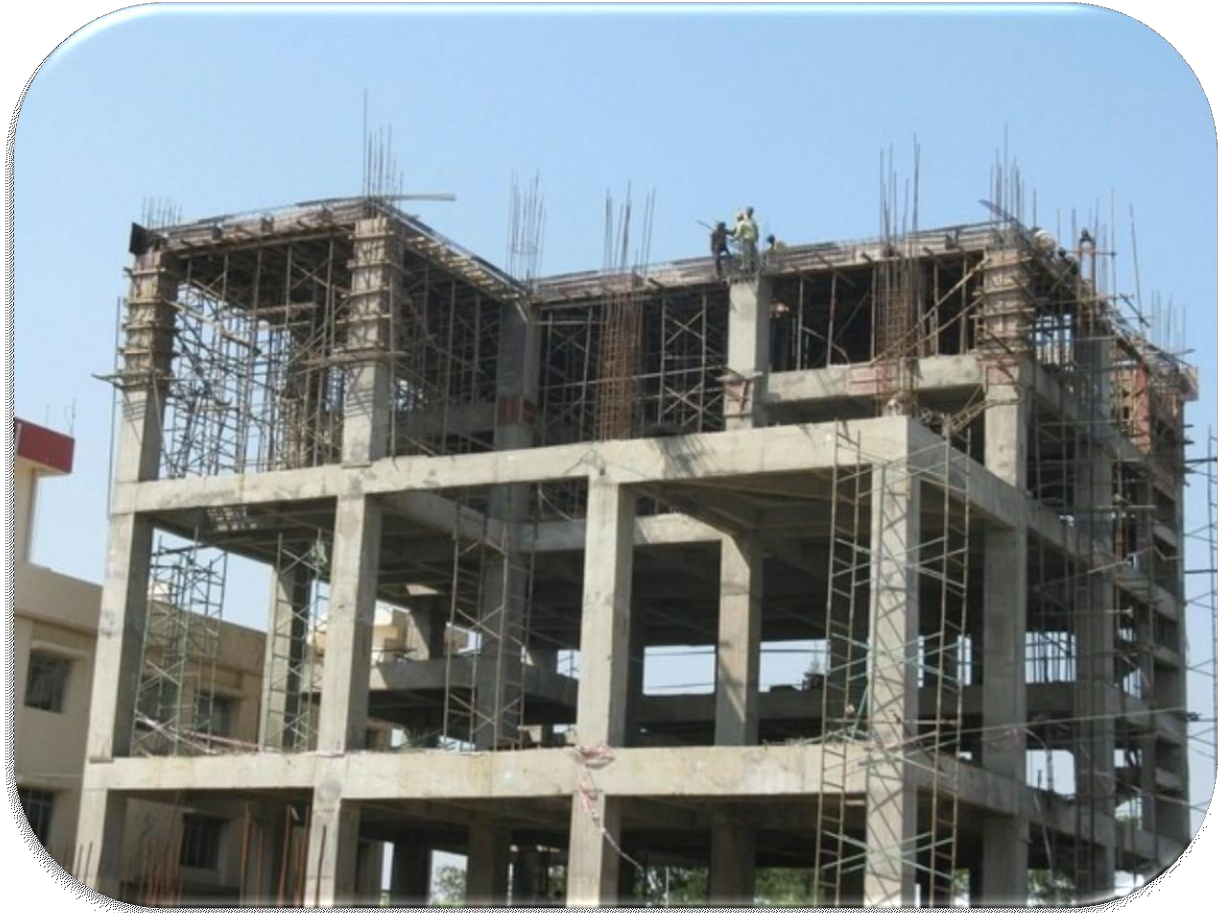
Reinforced concrete structures are structures that use the most universal construction material which is reinforced concrete. They constitute many important infrastructures and projects such as buildings, bridges, stadiums, industrial, and geotechnical infrastructures. Some examples of reinforced concrete structures are foundations, walls, cores, slabs, columns, and beams. Figure 1.3 shows an example of building made of reinforced concrete structures.

Figure 1.3. Reinforced concrete building made of reinforced concrete elements such as beams, pillars. (Source: m.wikipedia.org/reinforcedconcretestructures)

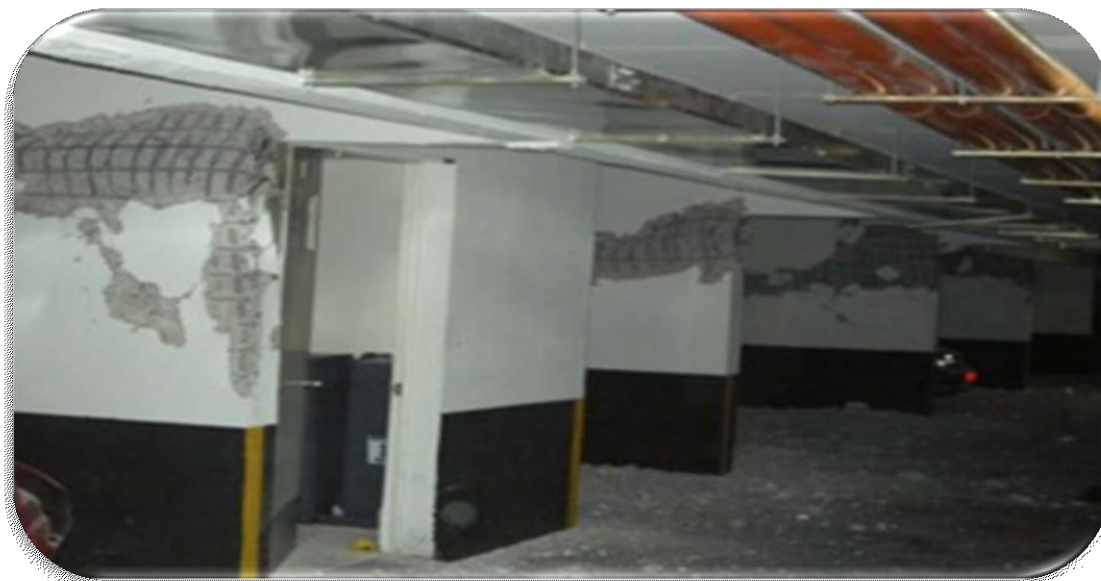
Figure 1.4. Flexural-compressional brittle failures on shear walls
(Carlos Videla, 2012)

Flexural or compressive brittle failure occurs when the imposed load exceeds the flexural capacity of the materials of the beam. It begins with the crushing of concrete at compression side followed by yielding of steel at tension side of the beam. It occurs when the beam is over-reinforced which means the beam reinforcement ratio is greater than balanced reinforcement ratio. This type of failure is sudden and does not provide warning i.e. brittle, (Wang C. K., 1983), Figure 1.4 indicates flexural-compressional brittle failures on shear wall.

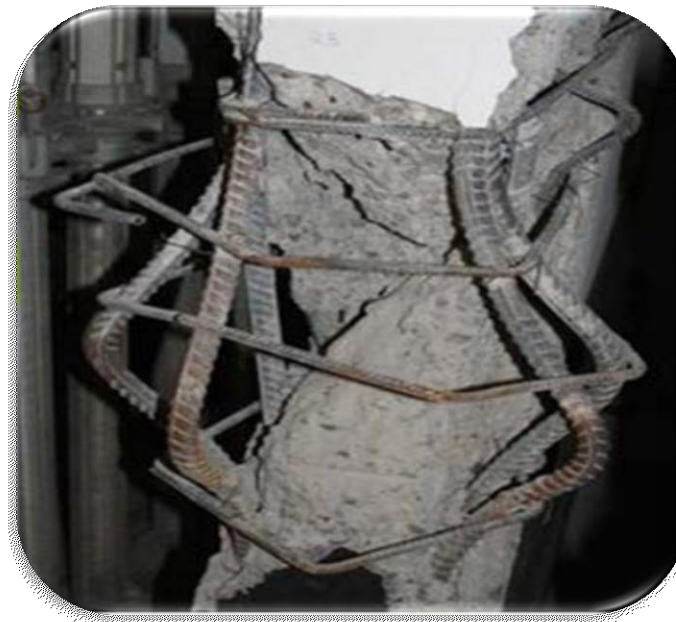
Figure 1.5. Concrete crushing and rebar buckling on a column element.
(Carlos Videla, 2012)

These are two types of phenomena observed in columns when axial loads are applied in the downward direction. Crushing means breaking and failure of short columns and when subjected to high compressive stress and buckling is the failure of long column structure when subjected to high buckling stress. Figure 1.5 indicates concrete crushing and rebar buckling on a column element.

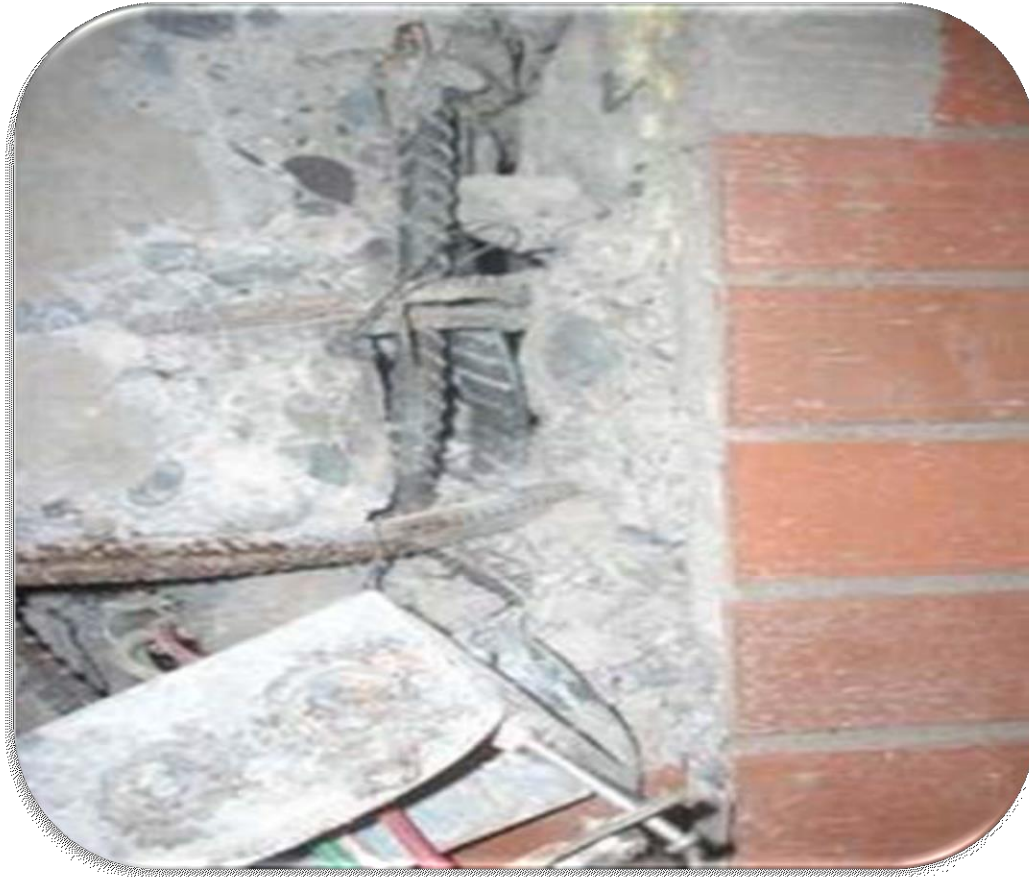
Figure 1.7. Splice failure on an RC building
(Carlos Videla, 2012)

Reinforced concrete structures are designed to behave monolithically. Properly designed splices of individual reinforcing bars are a key element in transmitting forces through the structure and creating a load path. A lap splice is the predominant method used for splicing reinforcement bars. Failure to slice correctly the bars leads to splice failure. Figure 1.7 indicates splice failure on a reinforced concrete building.

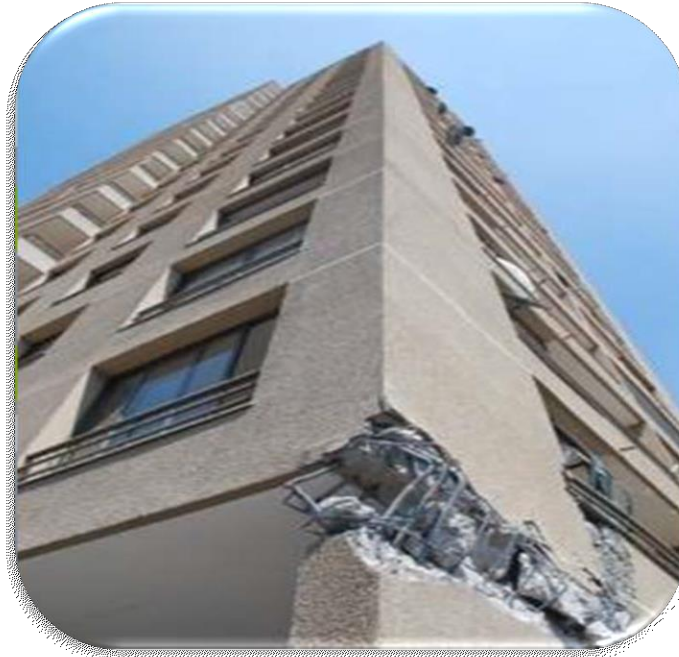
Figure 1.8. Soft floor failure on a reinforced concrete building.
(Carlos Videla, 2012)

This refers to one level of a building that is significantly more flexible or weak in lateral load resistance than the stories above it and the floors or foundation below it. This condition can occur in any construction type and is typically associated with large openings in the walls or exceptionally tall story height in comparison to the adjacent stories. These soft stories can present a very serious risk in the event of an earthquake, both in human safety and financial liability. Figure 1.8 indicates soft floor failure on a reinforced concrete building.

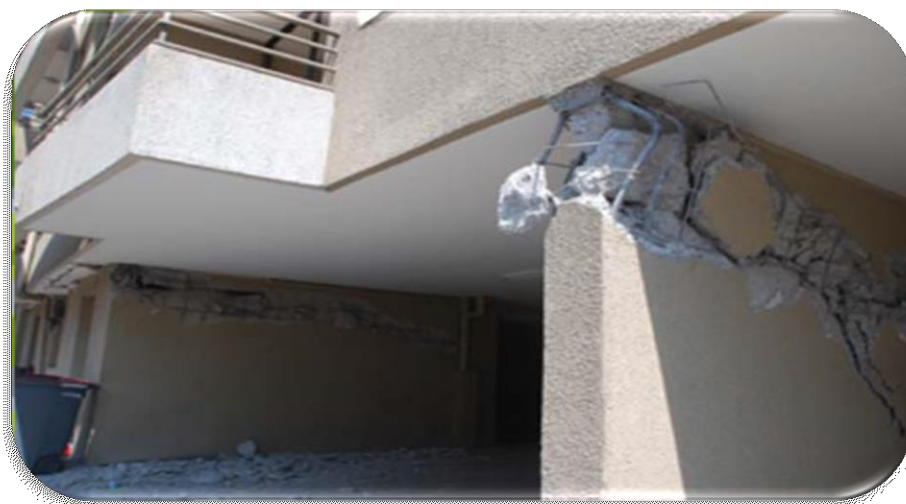
Figure 1.9. Failure of shear wall due to lack of confinement bars
(Carlos Videla, 2012)

On the first storey column and shear walls of multi-storey buildings, heavy damages mostly occur because of a lack of sufficient transverse reinforcement. This failure also occurs due to insufficient confinement of concrete at beam-column joint. Figure 1.9 indicates failure on a shear wall due to lack of concrete confinement bars.

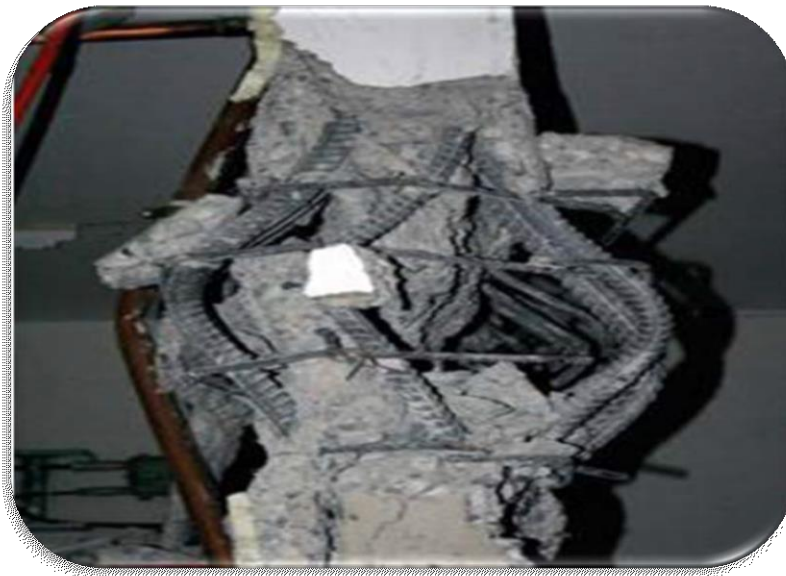
Figure 1.10. Failure of RC column due to poor detailing.
(Carlos Videla, 2012)

Reinforcement detailing is the drawing of a reinforced concrete structure, which includes showing the size, location, type, placement, splices, and termination of the reinforcement. Deficiency in the reinforcement detailing can cause structural failures. Figure 1.10 indicates failure of RC column due to poor detailing.

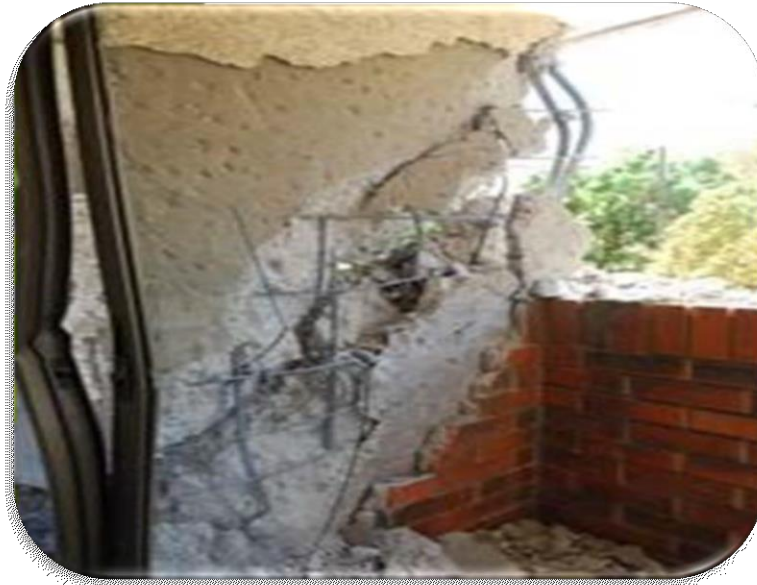
Figure 1.11. Shear failure of an RC wall
(Carlos Videla, 2012)

Shear failure occurs when the beam has shear resistance lower than flexural strength and the shear force exceeds the shear capacity of different materials of the beam. A shear load is a force that tends to produce a sliding failure on a material along a plane that is parallel to the direction of the force. Since shear failure is usually sudden with little or no advanced warning, the design for shear must ensure that the shear strength for every member in the structure exceeds the flexural strength. Providing proper shear reinforcement along the beam will reduce the possibility of shear failure along the beam. Figure 1.11 indicates shear failure of an RC wall, (*Madeh Izat Hamakareem* , 2001)

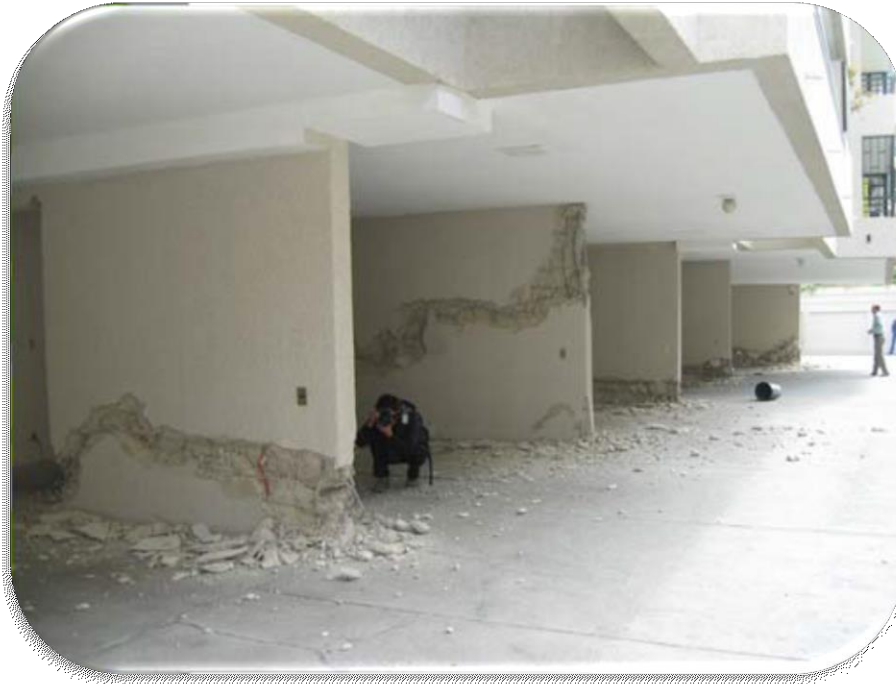
Figure 1.12. Failure of a Reinforced concrete shear wall due to slenderness
(Carlos Videla, 2012)

A wall whose H/t ratio is greater than 30 can be considered to be a slender wall. Compression tests on small walls elements indicate that these walls without any cross ties or boundary zones reinforcement may have a compression strain as low as 0.001. Concrete crushing occurs very suddenly with little or no prior damage. Providing nominal cross ties like those provided in gravity-load columns transform the failure mode to a more gradual one and increases the compression strain capacity of concrete walls to traditional assumed value of 0.003 for unconfined concrete. Figure 1.12 indicates failure of a RC shear wall due to the slenderness.

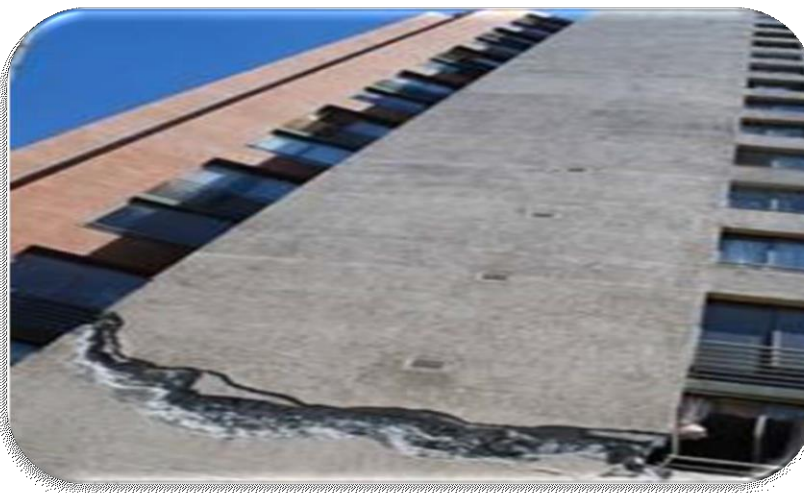
Figure 1.13. Indicate failure of a RC shear wall due to heavy loads
(Carlos Videla, 2012)

This is the inability of the wall to support a designed structural load without breaking. This means that the material that makes up the wall is stressed beyond its strength limit causing fracture or excessive deformation. Figure 1.13 indicates failure of a RC shear wall due to heavy loads. (Jones D.R.H, 2001).

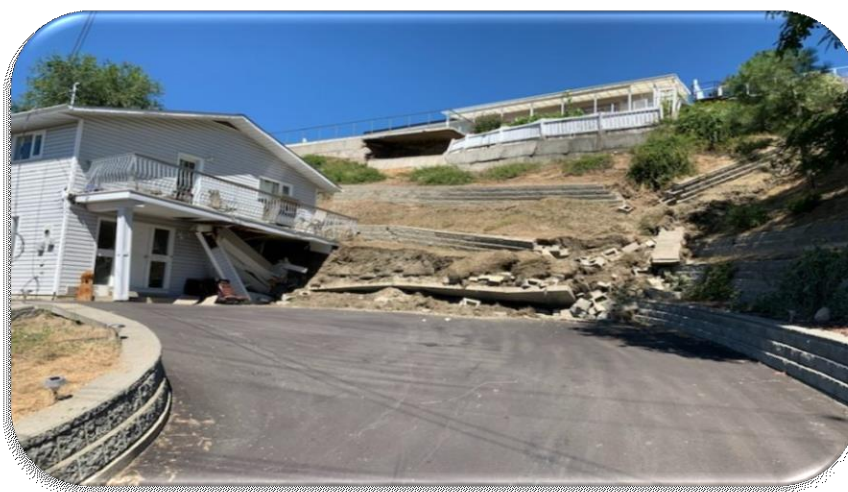
Figure 1.17. Slope stability failure
(Source: civilblog.org)

The process of sliding down large soil mass along a plane or a curved surface with respect to the remaining mass is known as slope failure. There are different types of slope failure which are translational failure, rotational failure, wedge failure and compound failure. Generally, slope failure occurs mainly for two reasons: firstly, an increase in shear force due to an increase in the slope of the soil mass or due to a sudden dynamic force applied to soil mass like an earthquake or due an external load applied and secondly a decrease in shear strength of soil which can happen due to an increase in pore water pressure. Fig 1.17 illustrates such failure.

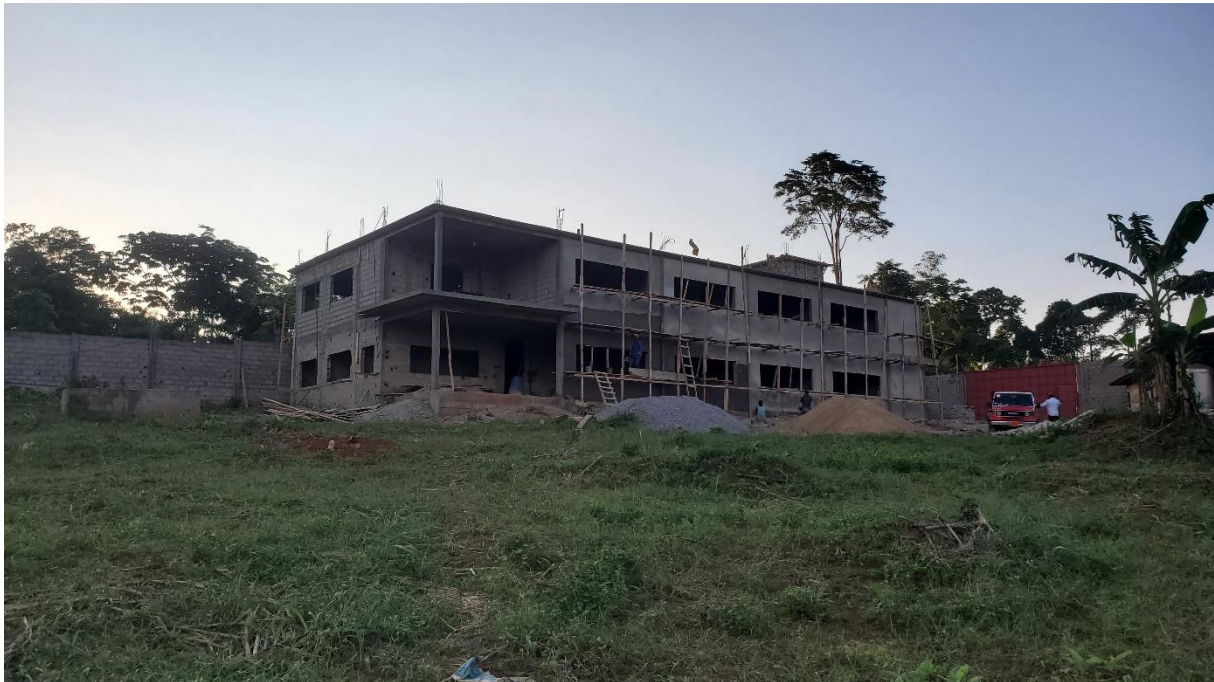
The industrial building is an R+1 that will be used for the production of fruit drinks, in a 1000 m² piece of land. The building has a total length of 30.26m and total width of 13.56m. Initially the building was designed for a ground level and one floor, but with time to exploit the roof floor of the building the proprietor wants to remodel the building by adding a new floor and use the floor for dancing and sporting activities. During the site visit the sections of the load bearing elements were measured and the detailing observed for the elements such as pillars. To carry out the investigation the company in charge of the construction of the industrial building provided the floor plans and the reinforcement of the load bearing elements of the building. Figure 3.2 gives us an image of the building.

Figure 3.2. Nsimalen industrial building

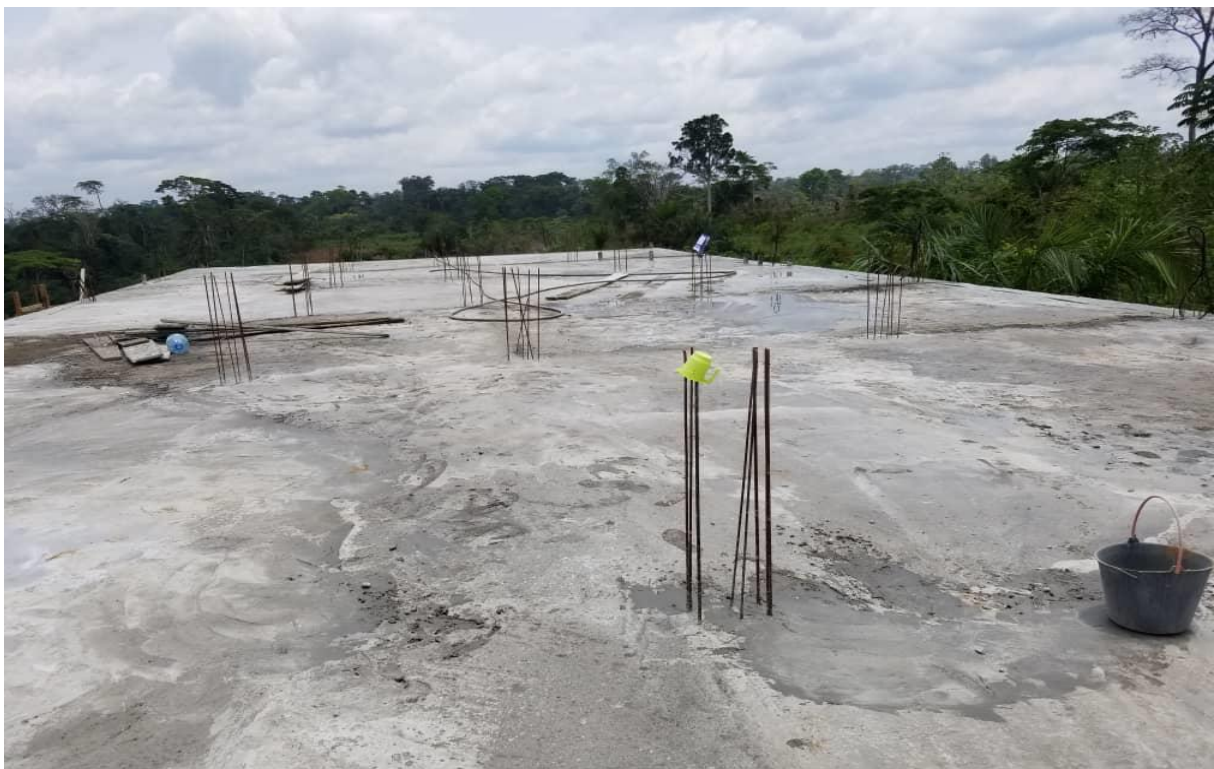
The roof before remodeling was captured using a phone camera as illustrated by the figure 3.3.

Figure 3.3. Industrial building roof plan

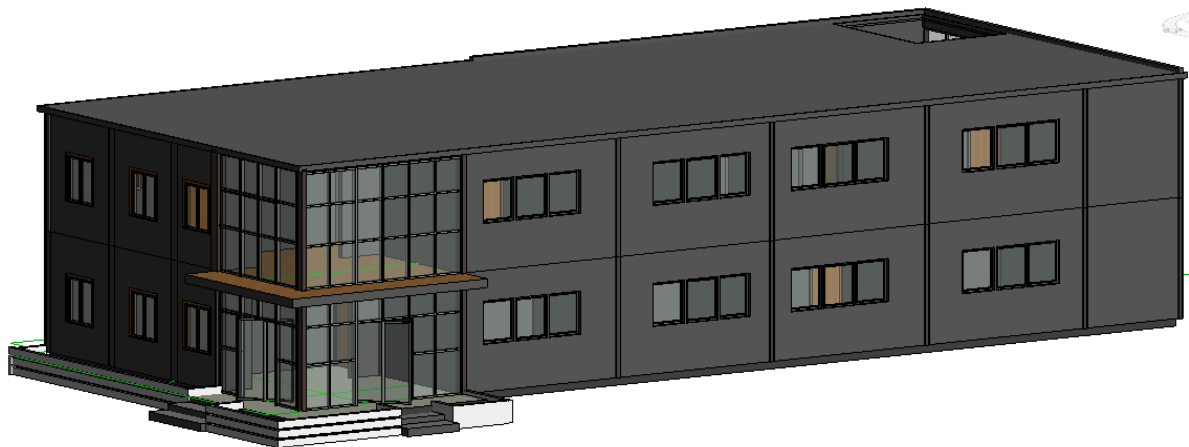
Figure 3.7. Nsimalen industrial building 3d model before remodelling

The Nsimalen industrial building 3d model before remodelling is illustrated by figure 3.7.

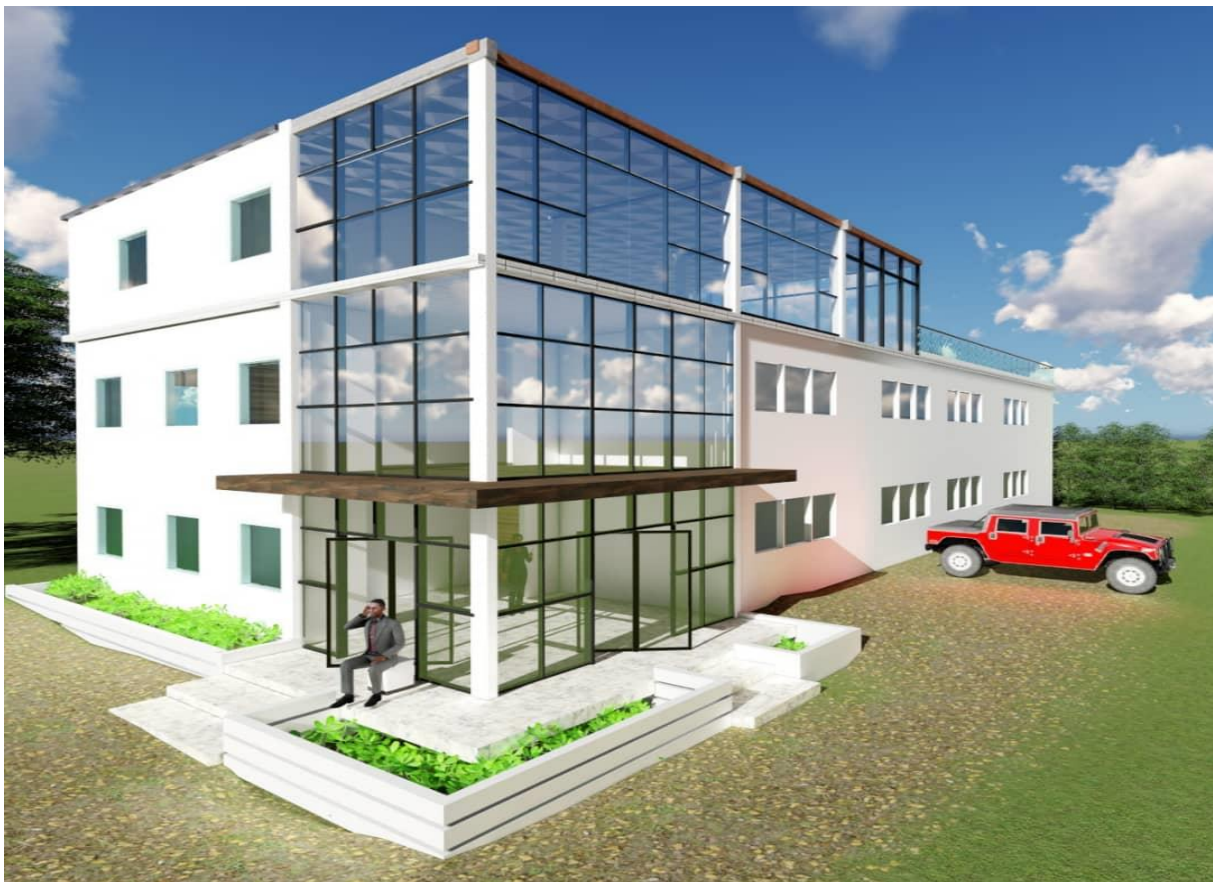
Figure 3.9. Nsimalen industrial building 3d model after remodeling

The Nsimalen industrial building 3d model after remodelling is illustrated by figure 3.9.

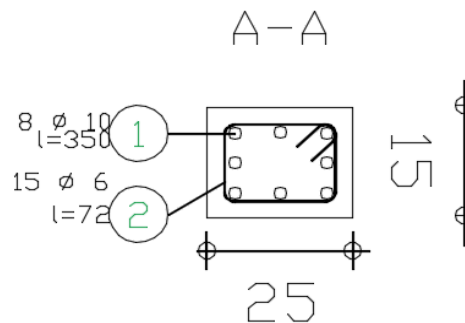
Position	Reinforcement	shape	steel
①	8 $\phi 10$ l=350		HA 400
②	15 $\phi 6$ l=72		RL 235

The cut A-A is extracted from the figure 3.10, structure reinforcement distribution. The details of the column are explained by the figure 3.12.

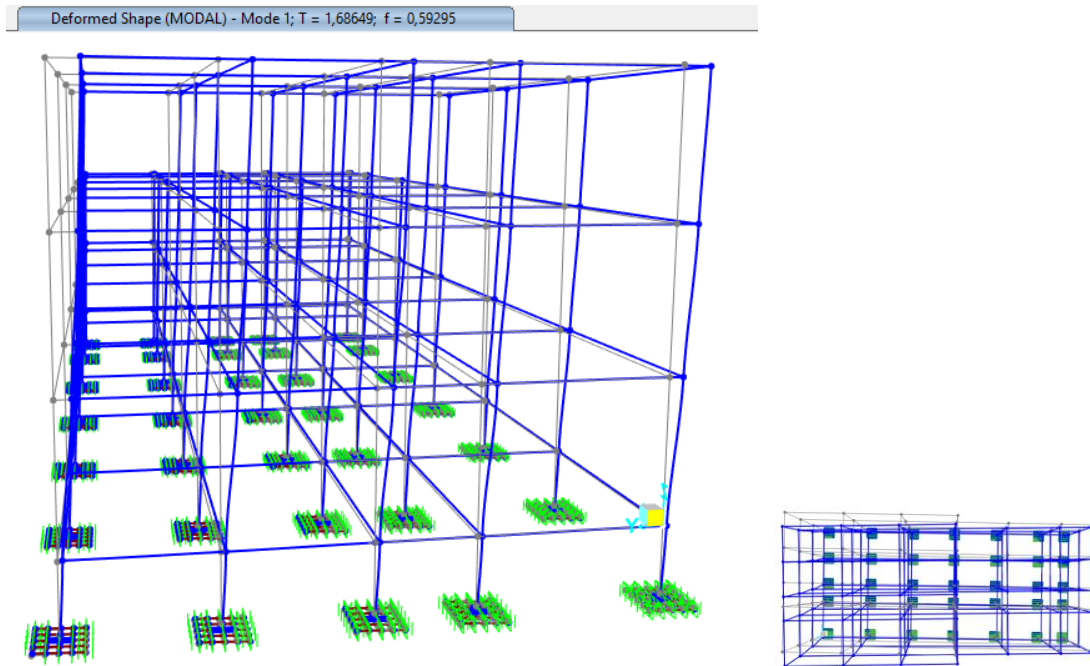
Figure 3.21. First vibration mode (Translational)

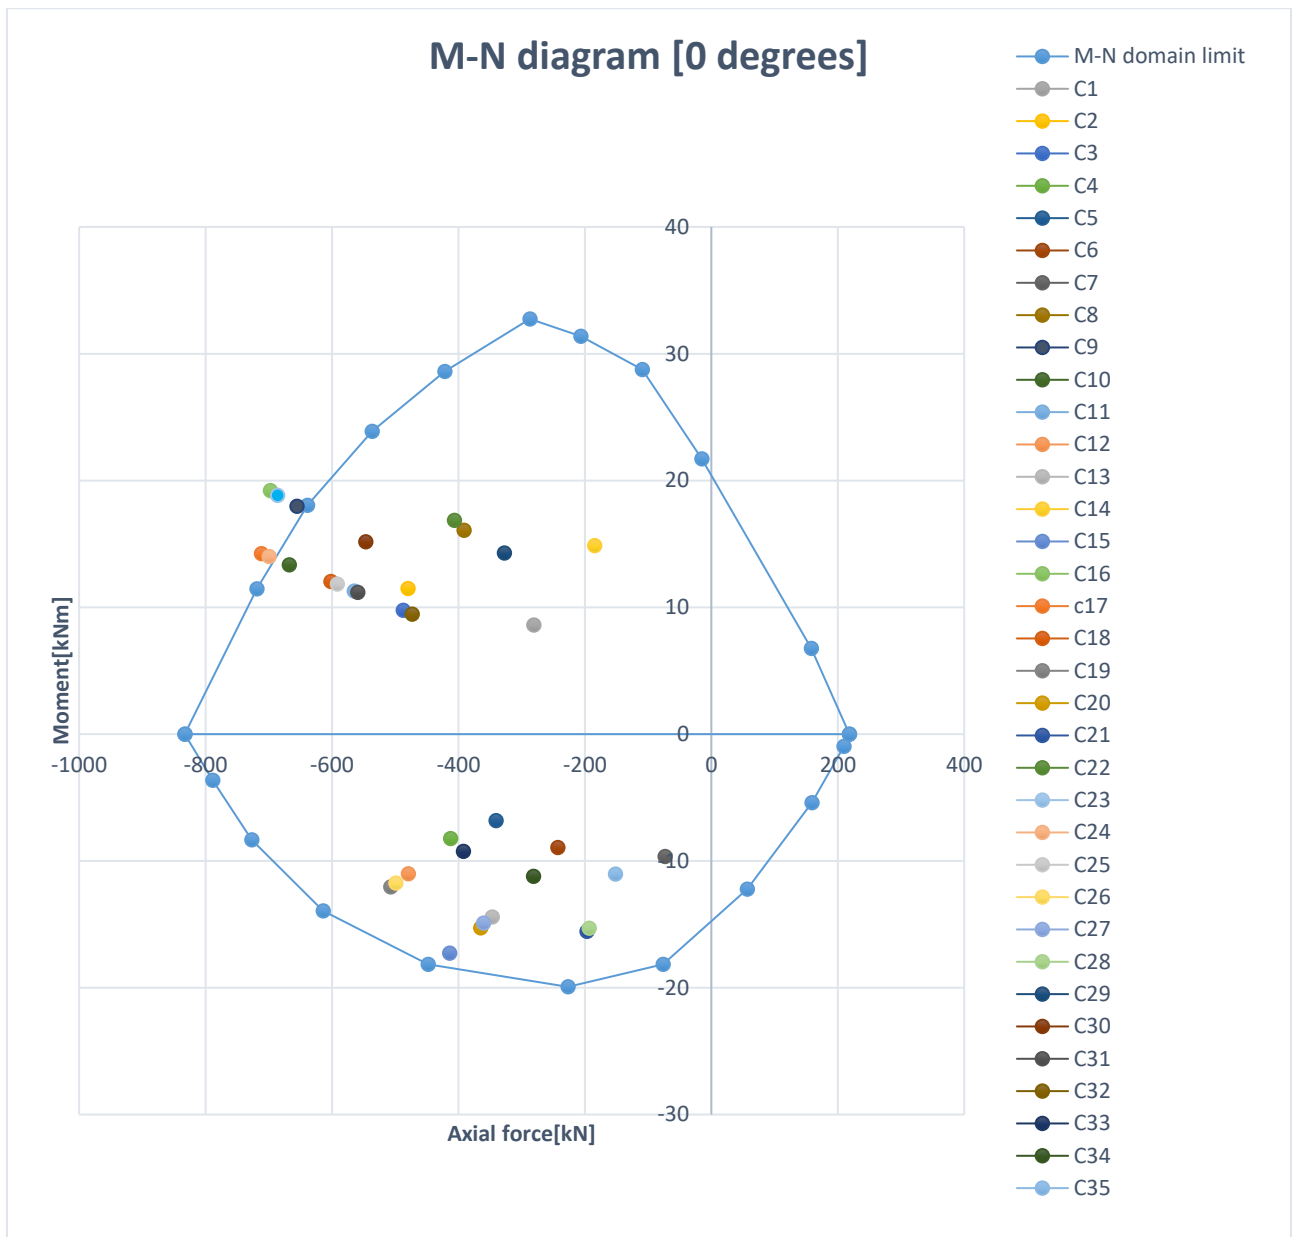
Figure 3.30. M-N interaction diagram for columns verification
