UNIVERSITY OF PADUA
DEPARTMENT OF CIVIL ENVIRONMENTAL AND
ARCHITECTURAL ENGINEERING

**MASTER THESIS IN
CIVIL ENGINEERING**

**SEISMIC STRENGTHENING TECHNIQUES FOR OLD REINFORCED
CONCRETE JOINTS WITH NEAR SURFACE MOUNTED CFRP
LAMINATE AND STRAIN HARDENING CEMENTITIOUS
COMPOSITES**

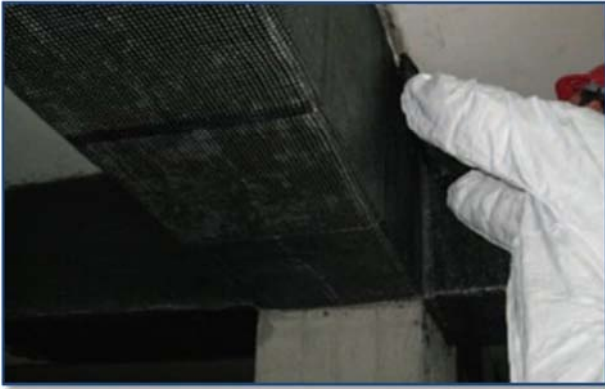
Figure 2.3 - Externally bonded FRP concrete columns [7]

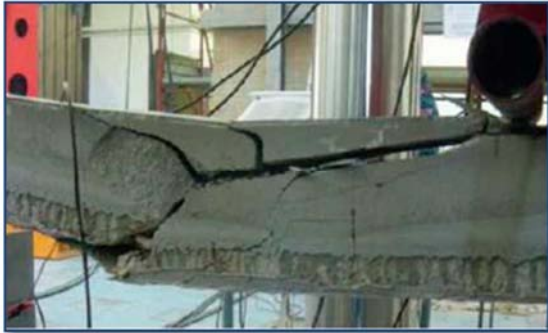
Figure 2.8 – Failure mode of beam strengthened with steel fabric [13]

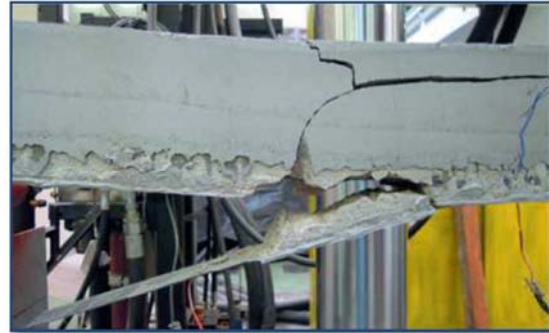
Figure 2.9 - brittle failure mode due to epoxy-concrete debonded [13]

Interesting results were also obtained using steel strip glued with epoxy and cement where the corresponding load increase was approximately 100%. It is also important notice the different failure modes observed. Figure 2.9 shows the failure using CFRP laminate with epoxy; it was characterized by critical diagonal cracking and concrete crushing, FRP debonding propagates along its longitudinal axis with the complete detachment of the concrete cover. This failure mode is due to low resistance of subtract compared with the high tensile strength of the fibers leading to a brittle failure of the retrofitting. On the other side, the debonding did not occur when the steel was used as the external reinforcing system.

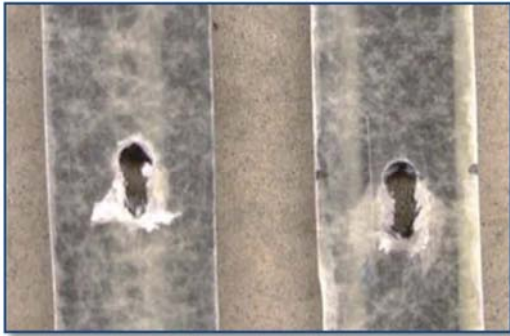
Figure 2.10 - FRP strips failures in MF-FRP system [14]

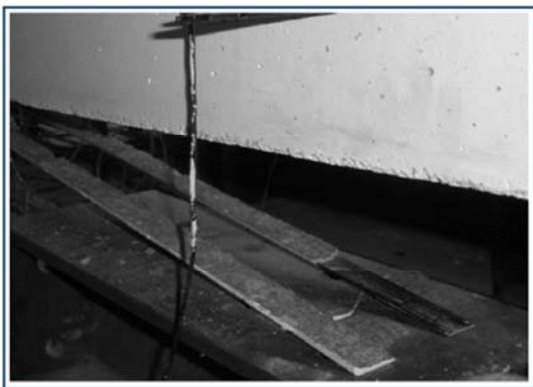
Figure 2.12 – MF-EBR FRP system, bearing failure mode [15]

This better result was affected by the presence of the pre-stressed anchors. A good result was obtained not only in the maximum load reached but also in terms of deflection. In fact the deflection at failure was increased of 87% in the beam reinforced with MF-EBR and 37% in the beam reinforced with EBR technique. Also the ductility was better in the MF-EBR system. While peeling was the dominant failure mode in the EBR system (Figure 2.13), the MF-EBR FRP laminates failed by bearing (Figure 2.12).

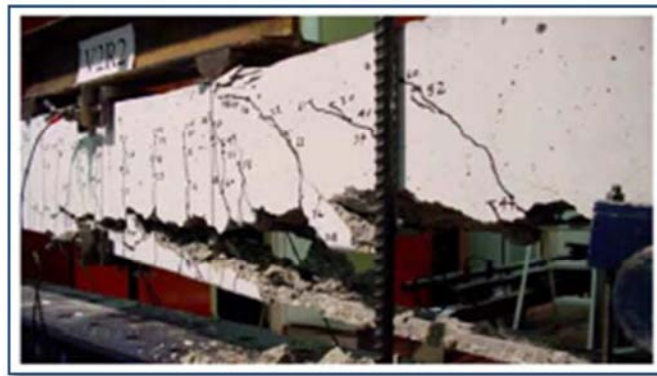
Figure 2.14 – NSM system, detachment of concrete layer [16]

In particular, the increase on the load at the onset of yielding of the conventional reinforcement was from 32% to 47%. The service load (the load for a deflection of $L/400$) was increased 45% while the ultimate load respecting to the corresponding reference beam was doubled. The deflection of the strengthened beam was reduced registering due to an increase in terms of stiffness of 28% (average value) for the service load and 32%. It is important to highlight that the beams have failed in a “ductile” flexural mode characterized by the yielding of the longitudinal reinforcement followed by the detachment of a layer of concrete at the bottom of the beam (Figure 2.14).

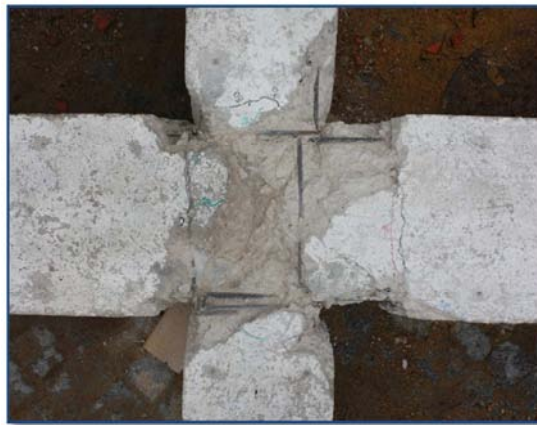
Figure 2.18 – RC joint with plane rebars designed only for gravity loads

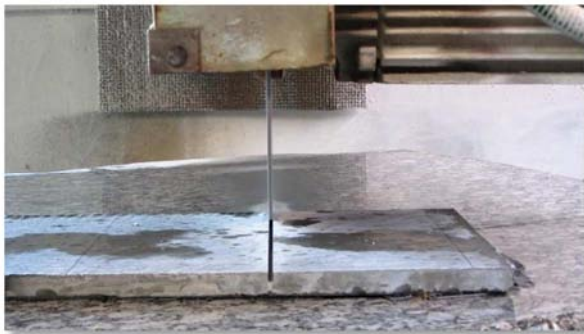
Figure 3.19 – Cutting 10mm depth

- Cutting grooves: the grooves were cut by using saw cut machines with dimensions of 10 mm of depth and 5 mm of width in one direction (Figure 3.19) and 20 mm of depth and 5 mm of width in the other direction (Figure 3.20). In this way two different strengthened layers are performed.

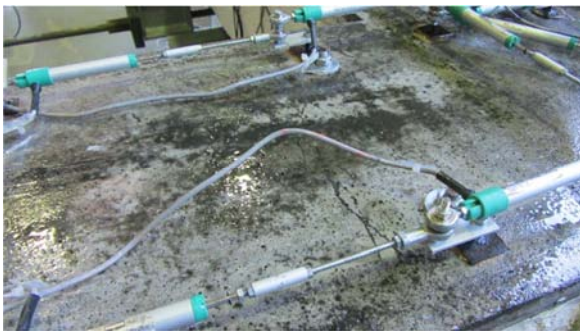
Figure 4.6 – Cracks on the beam

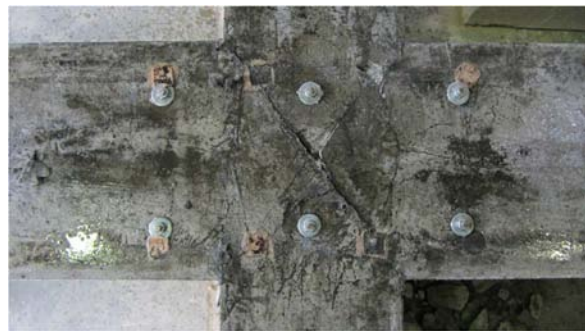
Figure 4.7 – Diagonal cracks in the joint region

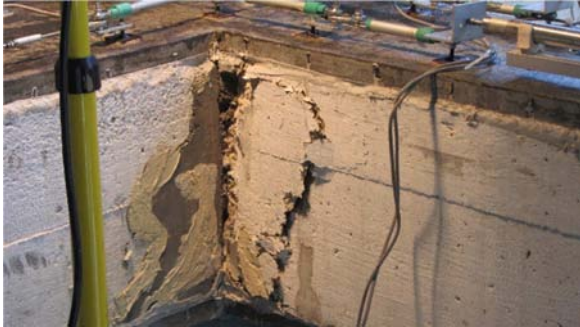
Figure 4.8 - Detachment of the old concrete cover

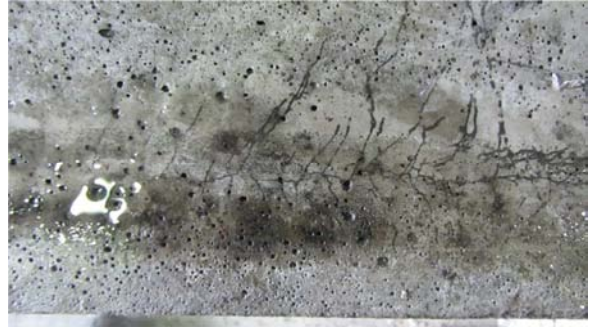
Figure 4.9 – Micro-crack on the SHCC panel along longitudinal carbon laminate

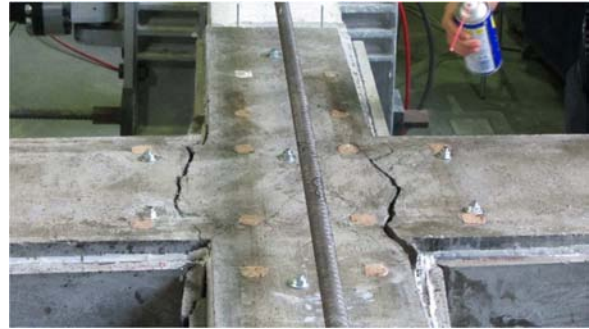
Figure 4.12 – Bending failure in the beam

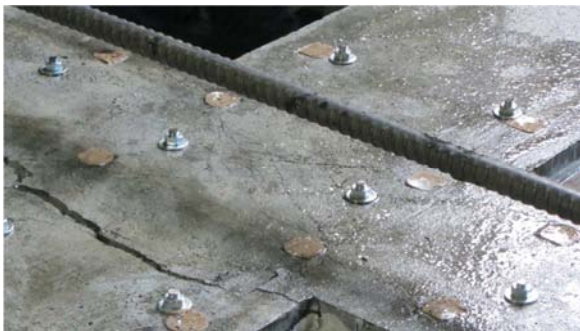
Figure 4.13 – Bending failure in the beam and several micro-cracks in the joint area

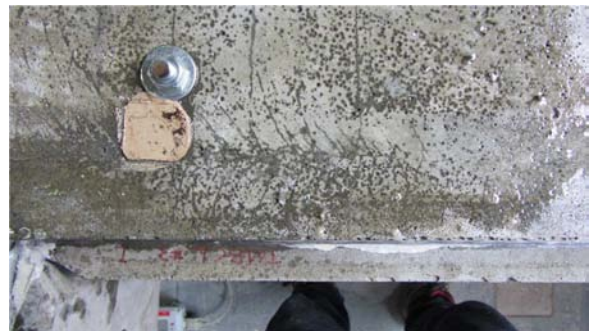
Figure 4.14 – Micro-cracks in SHCC panel along longitudinal carbon laminate location

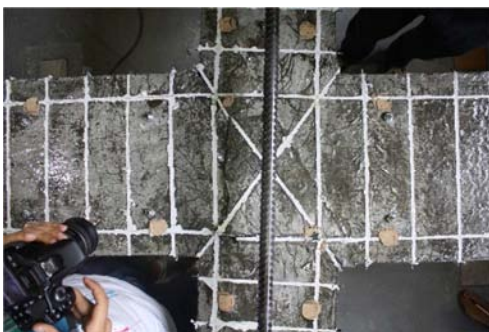
Figure 4.16 – Crack on the top surface, JPA-3

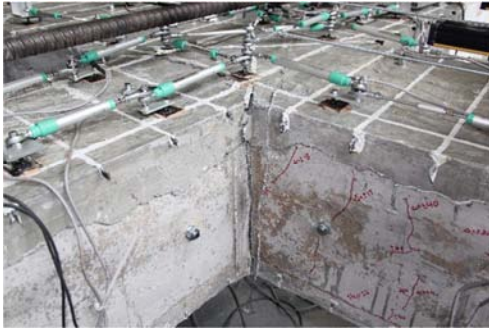
Figure 4.18 – Crack on the lateral surface, JPA-3

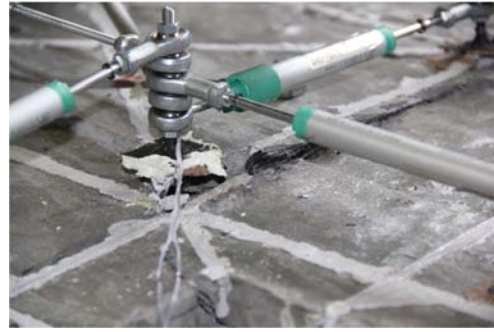
Figure 4.19 – Failure of the longitudinal bars, JPA-3

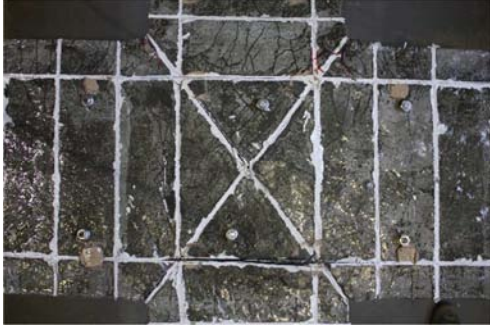
Figure 4.21 – Crack on the top surface, JPB joint

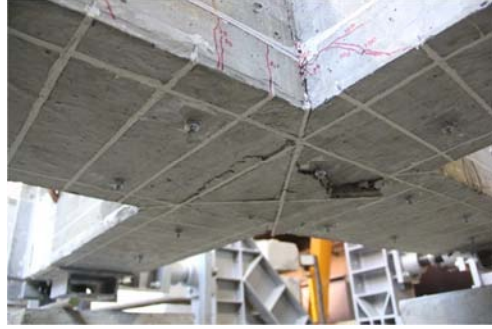
Figure 4.22 – Crack on the bottom surface, JPB joint
