UNIVERSITÀ  
DEGLI STUDI  
DI PADOVA

CORSO DI LAUREA MAGISTRALE IN INGEGNERIA MECCANICA

**THERMOMECHANICAL AND MICROSCOPY  
INVESTIGATION OF FATIGUE DAMAGE  
DEVELOPMENT IN A 3D E-GLASS/EPOXY WOVEN  
COMPOSITE**

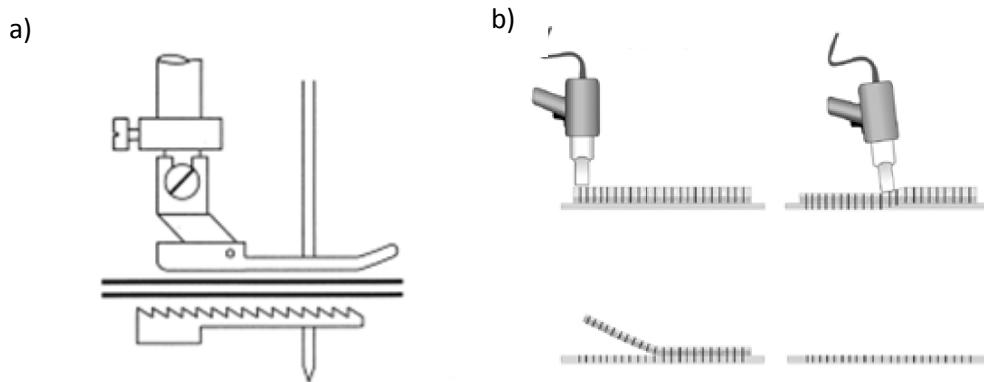
**Figure 1.3** Manufacturing process respectively of a) through thickness stitched and b) z-pinned composites

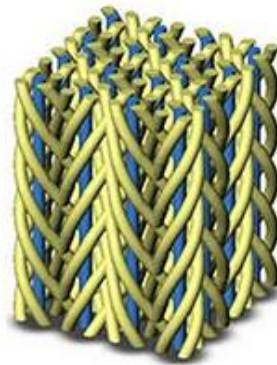
**Figure 1.6** Model of a 3D braiding composite: the colour yellow indicates braiding yarns while blue indicates axial yarns (aligned at  $0^\circ$  degree to length direction)

completing one machine cycle, as represented in Figure 1.6: in step 1 and 2 all the rows and columns move in alternating directions, then these carrier movements are reversed in steps 3 and 4. Whatever is the method of braiding used, the pattern is characterized by the angular orientation of the braider yarn,  $\theta_b$ , and the pitch length,  $h$ . The advantages of the use of this kind of fiber architecture include: the value of the angle formed by braiding yarns to axial direction minor than  $90^\circ$ , the possibility of the incorporation of axial yarns (aligned at  $0^\circ$ ), a wide obtainable range of thicknesses and a variety of shapes of which the unitary preforms can be produced.

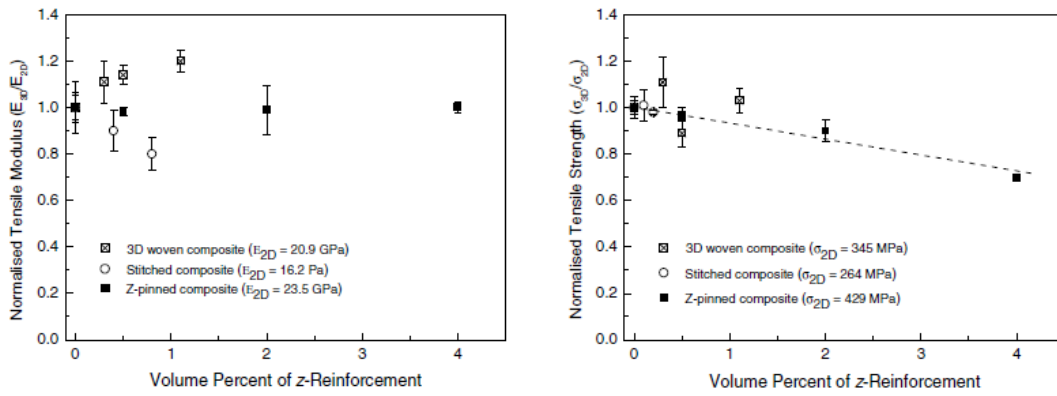
**Figure 1.10** Plot of volume content of z-reinforcement vs normalised tensile modulus and normalised tensile strength for the 3D woven, stitched and z-pinned composite.

In Figure 1.10, the values of modulus are shown, represented normalized to the values of their control composite material without z-reinforcement. In the graph reported always in Figure 1.10 on the right hand the values of the strength normalized to the value of their control material considered without z-reinforcement are reported. In the case of the strength, the decrease for the z-pinned composite is evident, registering a rate of approximately 7.5% for every 1% of z-pins. The reason of the reduction was attributed to the microstructural damage caused during the manufacturing process: when z-pin were inserted into the composite, in fact, fibres were crimped, distorted and broken, as already mentioned in §2.4. In the case of 3D woven composites, despite the scatter of the data, it can be affirmed that the average strength values are slightly higher and lower than their control material. The volume content in these materials was relatively low (<1%) and this may account for the constant strength values. In these cases, unlike the previous one, the z-reinforcements were inserted into dry fabric, minimizing the amount of damage and breakage and therefore their tensile strengths did not decrease rapidly with increasing z-reinforcement content.

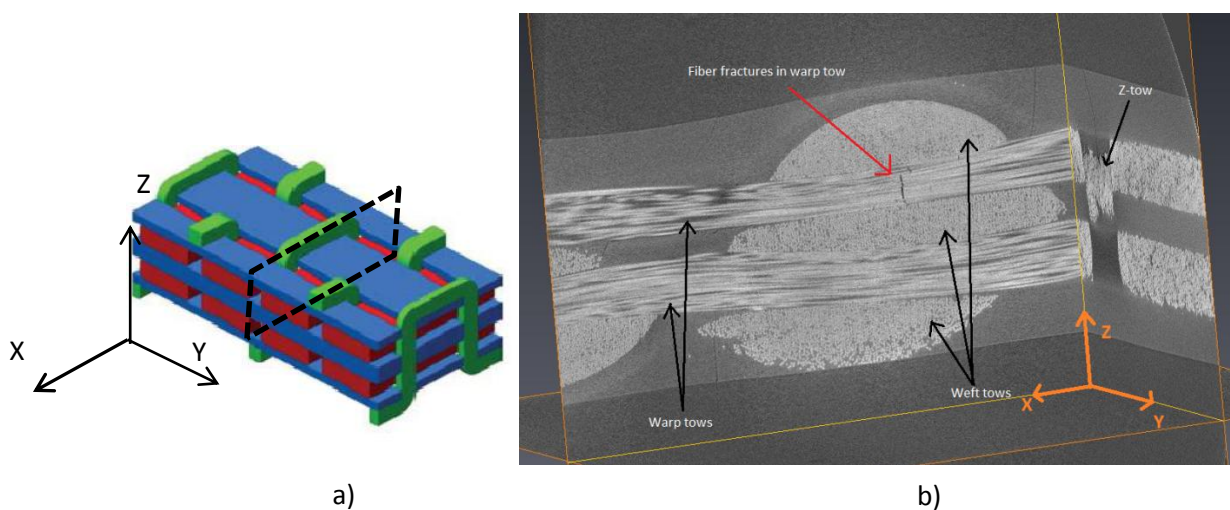
**Figure 1.13** a) Schematic of the 3D-78 architecture and b) CT section showing extensive fiber fracture towards the edge of a warp tow. Courtesy of Baiocchi (2013).

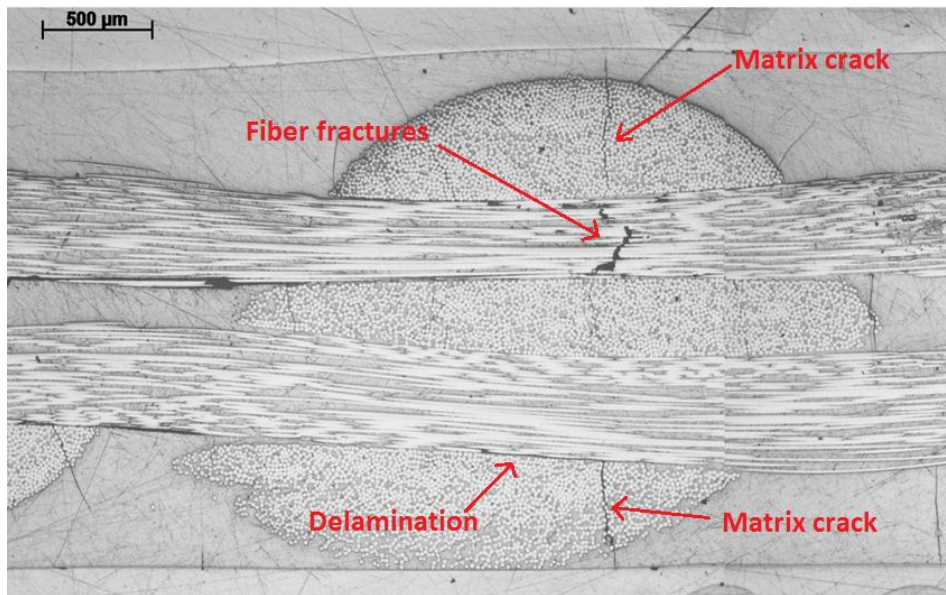
**Figure 1.14** Optical micrograph showing the same tow fracture as seen in Figure 1.13. Courtesy of Baiocchi (2013).

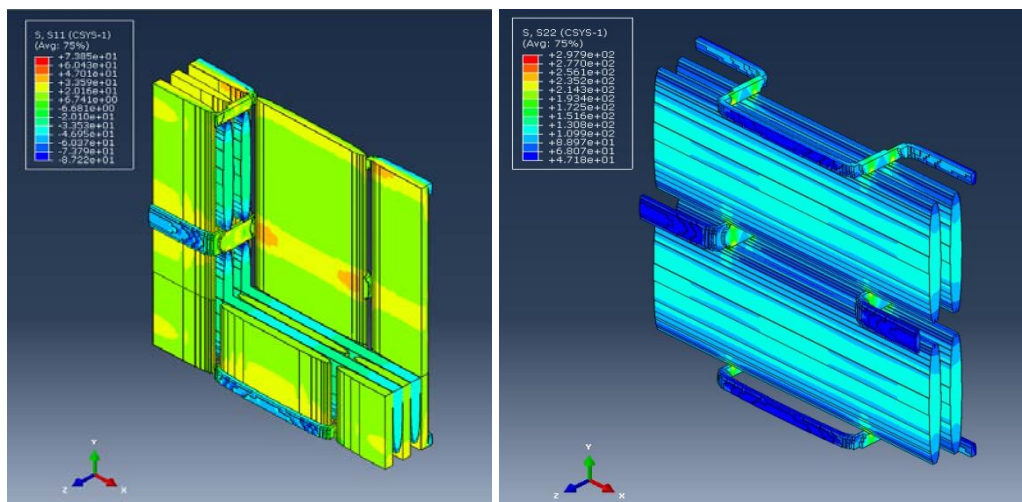
**Figure 1.16** Stress distribution in the fabric material in y direction. Courtesy of Topal (2014)

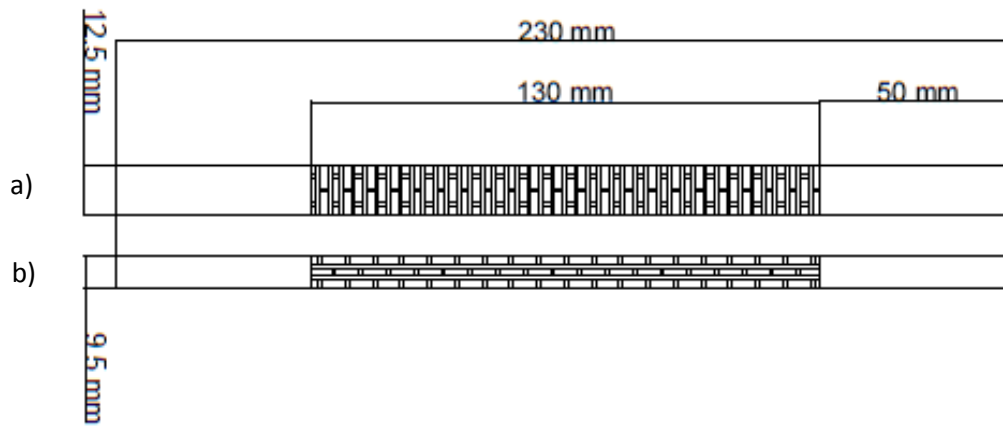
**Figure 2.2** Geometry and configuration of the fabric for specimens cut a) along the warp direction and b) along the weft direction.

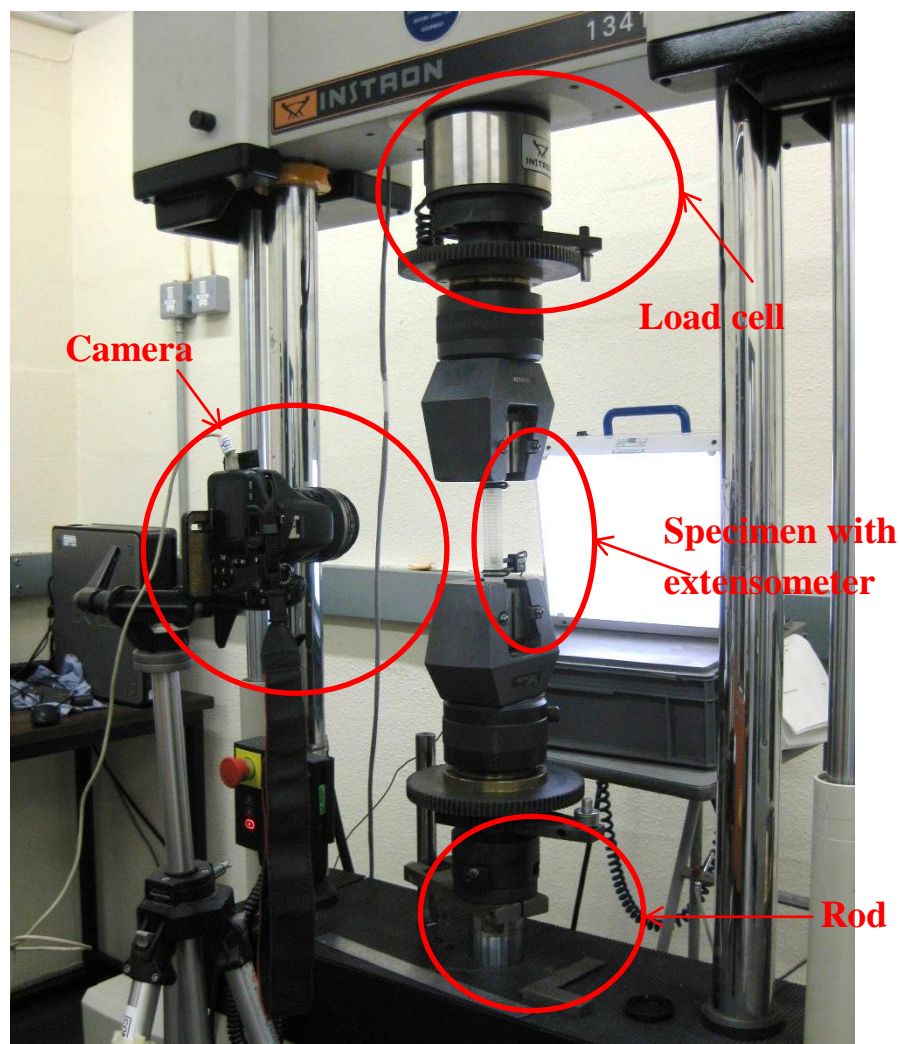
Figure 2.3 Quasi static and fatigue setup

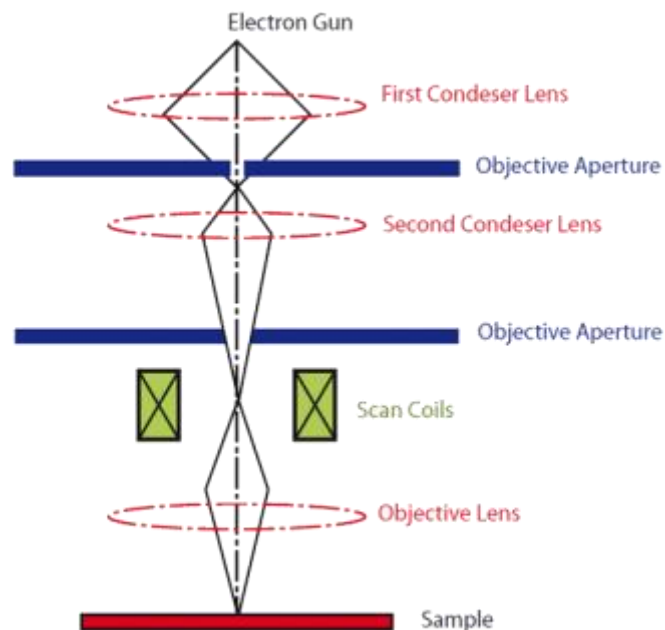
**Figure 2.4** Schematic diagram of a scanning electron microscope

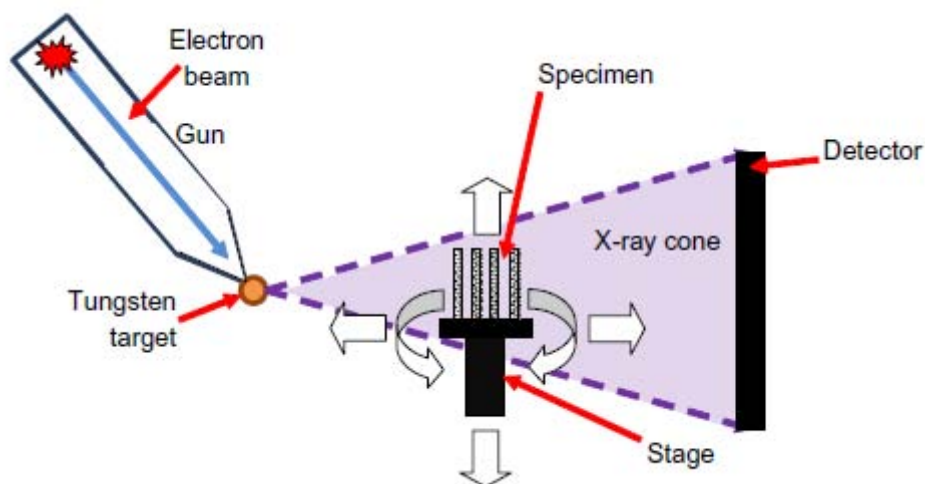
**Figure 2.5** Principles of operation of micro computed tomography. Courtesy of McCombe (2011)

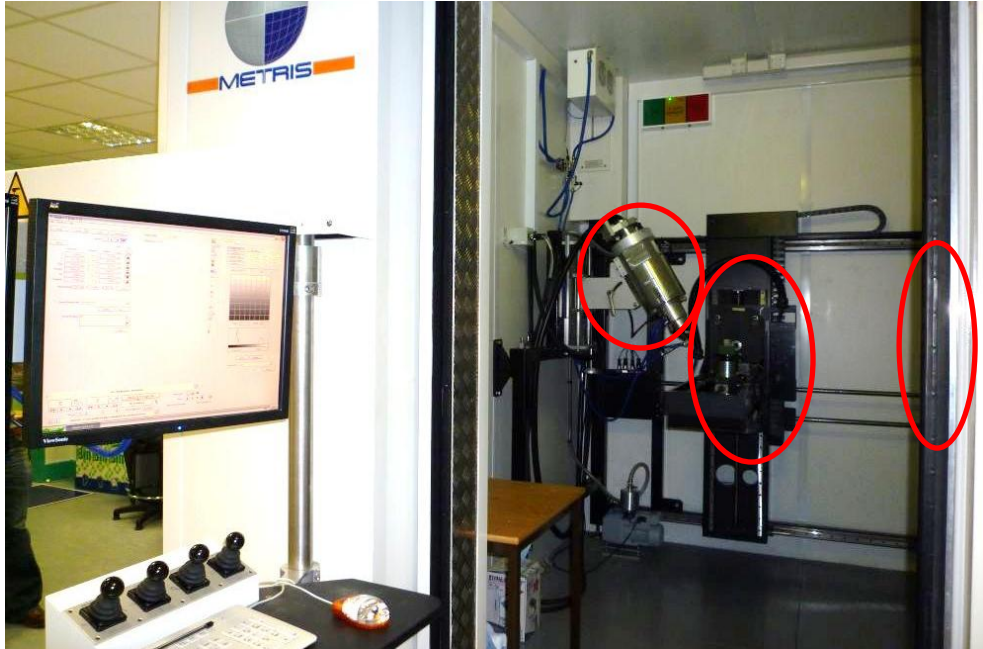
**Figure 2.6** Internal view of the Nikon Metrology 225/320 kV Custom Bay. X ray source, specimen stage and detector are highlighted with red circles

The machine was constituted principally by a X-ray source, a sample manipulator, which permitted the rotation of the specimen around its axes, a specimen stage and a detector, located opposite to the source respect to the sample. The Custom Bay allowed to analyse specimen with a cross section variable from 3-230 mm. Each scan took a time variable from 5 to 120 mm and image resolution was approximately  $1/2000^{\text{th}}$  of the sample diameter so voxel sizes ranged from 5 to 100  $\mu\text{m}$ . With the term voxel, it is indicated the basic unit of computed tomography reconstruction, i.e. the smallest distinguishable box-shaped part of a three-dimensional space. The name is due to the combination of the terms pixel and volume.

The machine used for the Micro CT analysis was a Nikon Metrology 225/320kV Custom Bay, present at the Manchester X-ray Imaging facility (MXIF) shown in Figure 2.6.

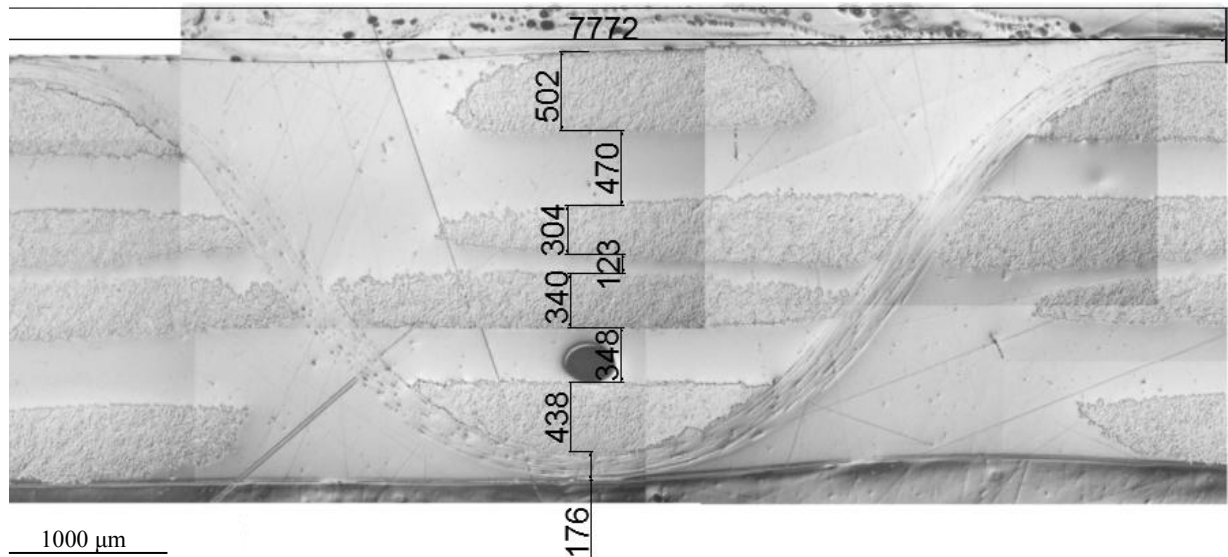
**Figure 3.3** Magnification of microscope image of section A-A reported in Figure 3.2, where considered section is indicated with dashed lines. Note: the units are  $\mu\text{m}$ .

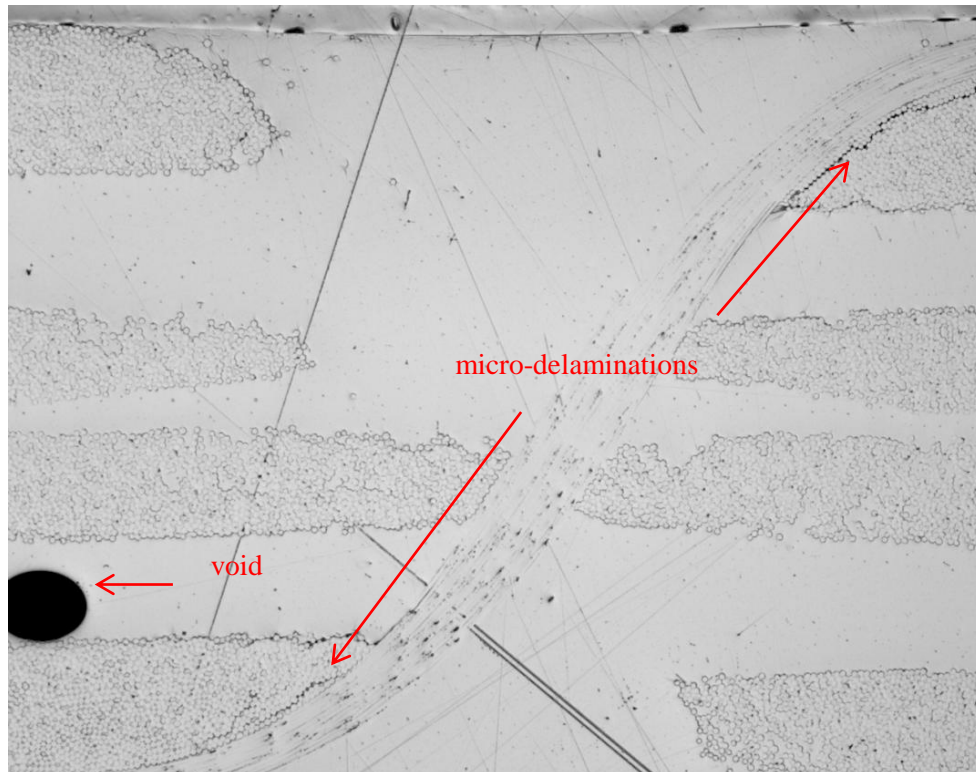
**Figure 3.6** Representation of defects of the fabricated composite present into untested specimen: air bubbles trapped into the specimen and micro-delamination at the z-tow and weft tows interface.

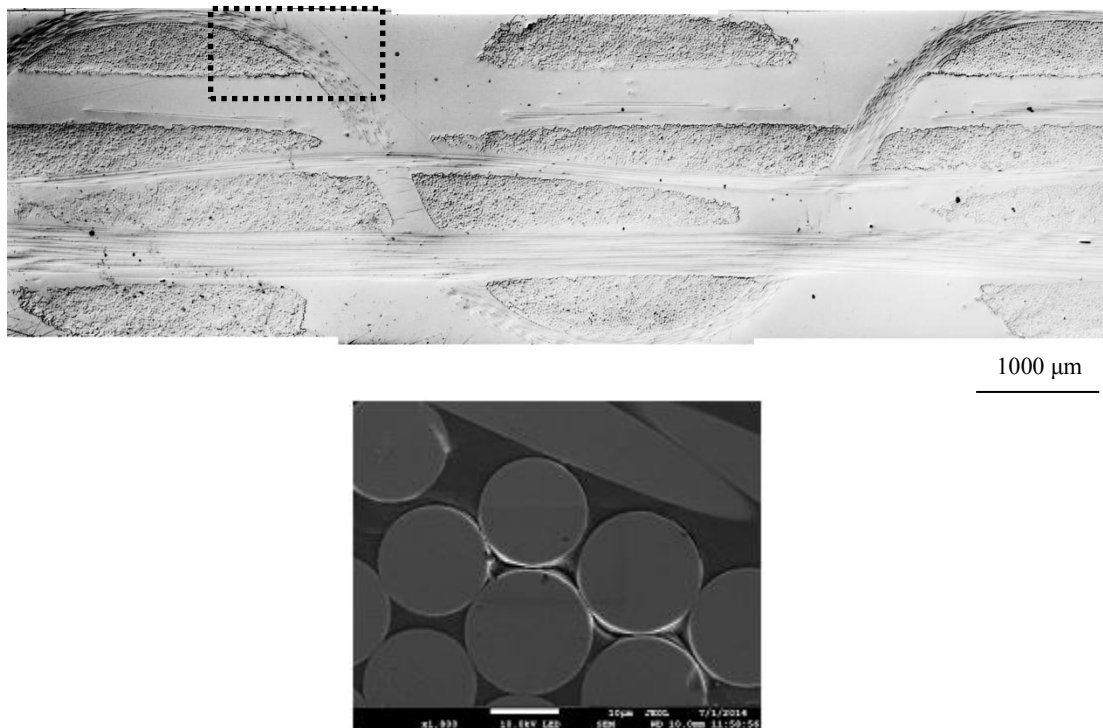
**Figure 3.8** Optical and SE micrograph images taken from composite 3D -96 untested specimen

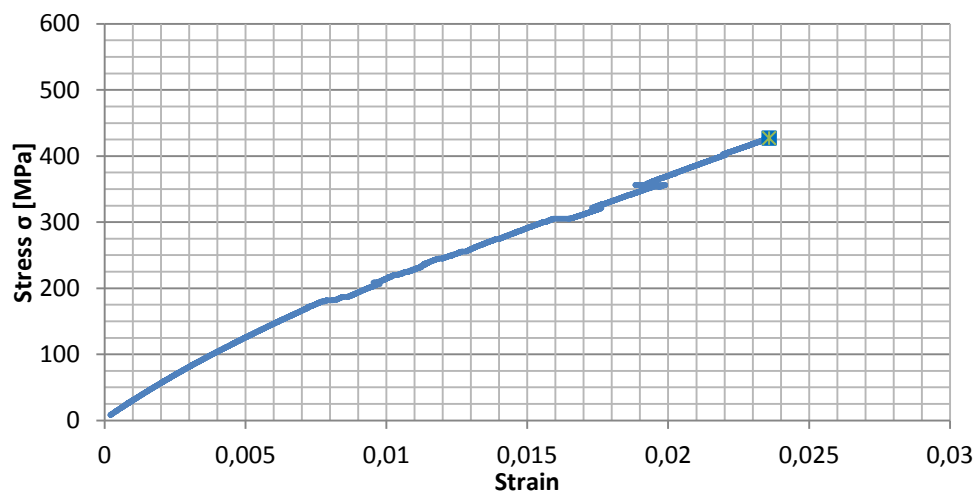
**Figure 4.1** Typical stress-strain curve of a specimen tested along warp direction.

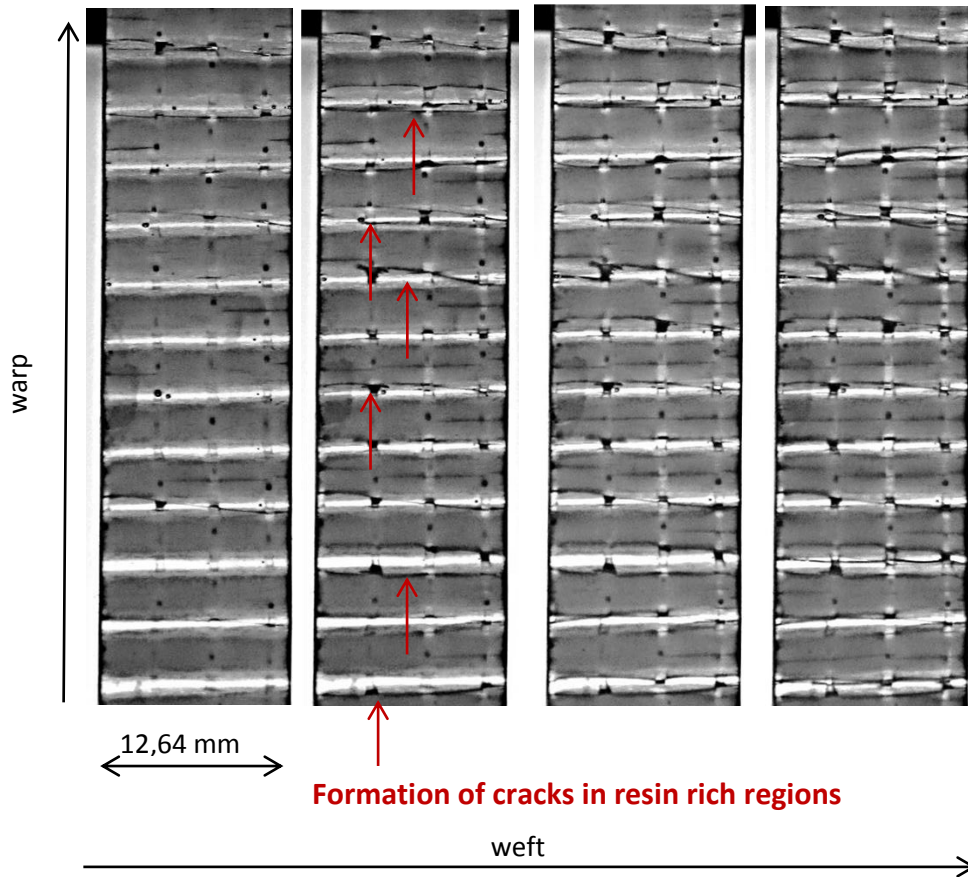
**Figure 4.3** Damage development in 3D- 96 composite loaded in warp direction. Accumulation of cracks until the achievement of saturation of Z-bundle-boundary crack (indicated by arrows) is seen. Corresponding strain levels are respectively 1.0%, 1.2% ,1.4% and 1.6%.

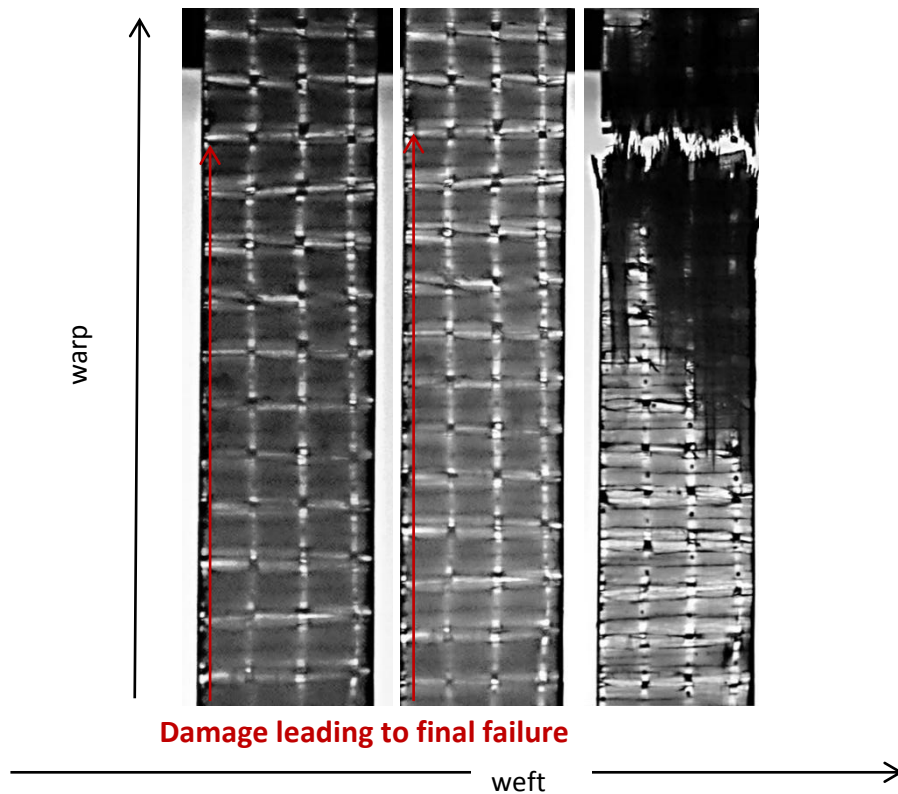
**Figure 4.4** Damage development in 3D-96 composite loaded in warp direction. Damage formation that brings to final failure has been captured into these transmitting light photos. Correspondent strain level is 2.64%.

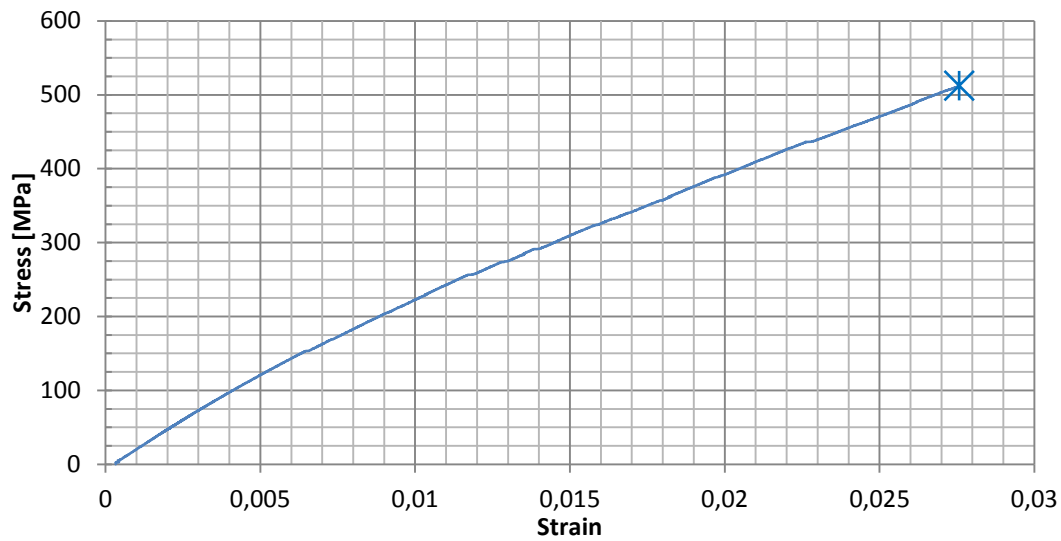
**Figure 4.5** Stress-strain curve of a specimen tested in weft direction

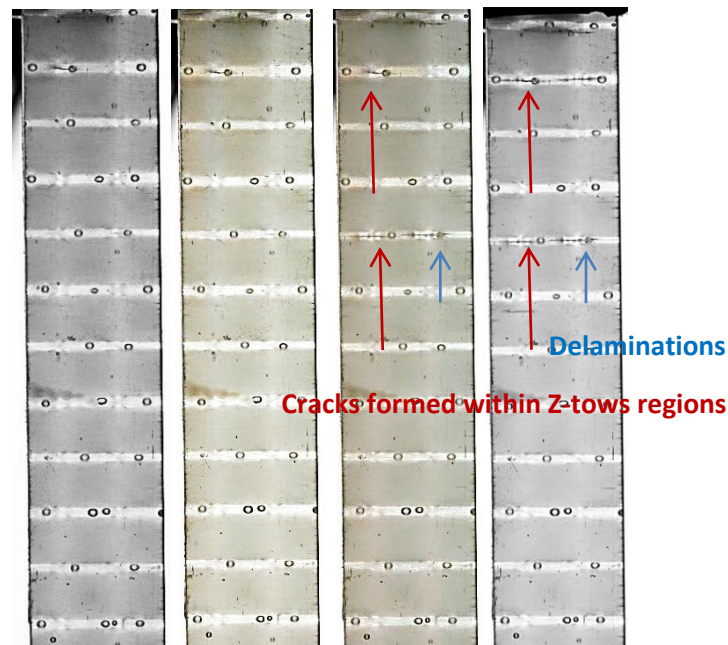
**Figure 4.6** Damage development in 3D- 96 composite loaded in weft direction. Formation of cracks in correspondence of a Z-tows (indicated by arrows) is reported in transmitted light photos. These are taken respectively in correspondence of 0.84%, 0.88%, 0.97% and 1.01% strain levels.

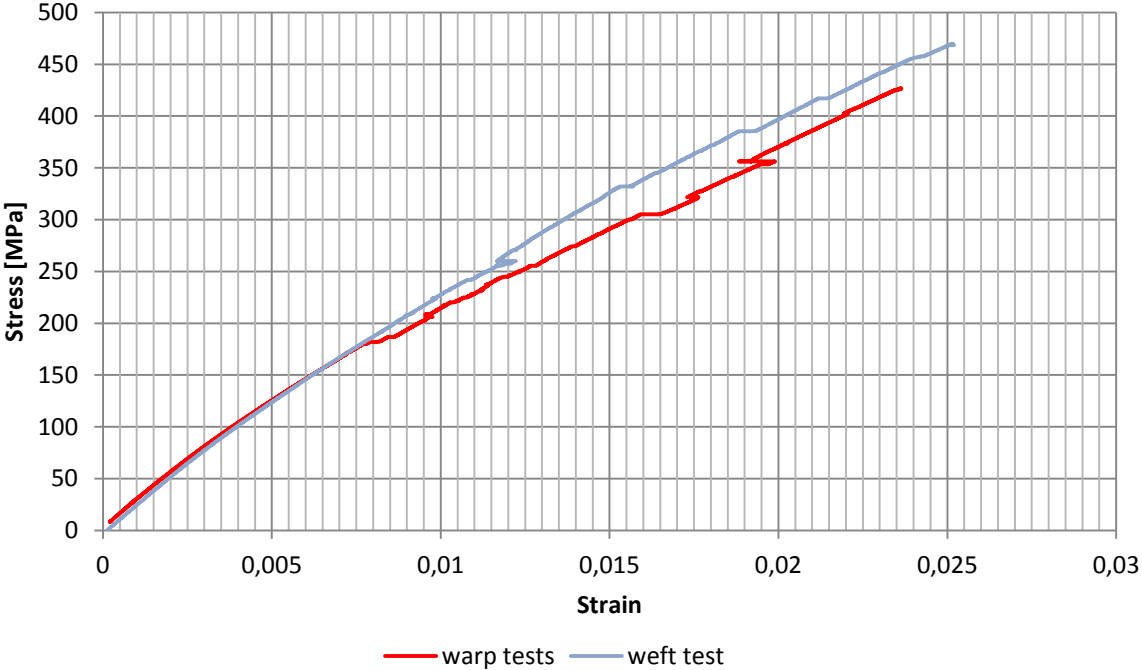
**Figure 4.9.** Typical stress strain curves obtained for warp test and weft test

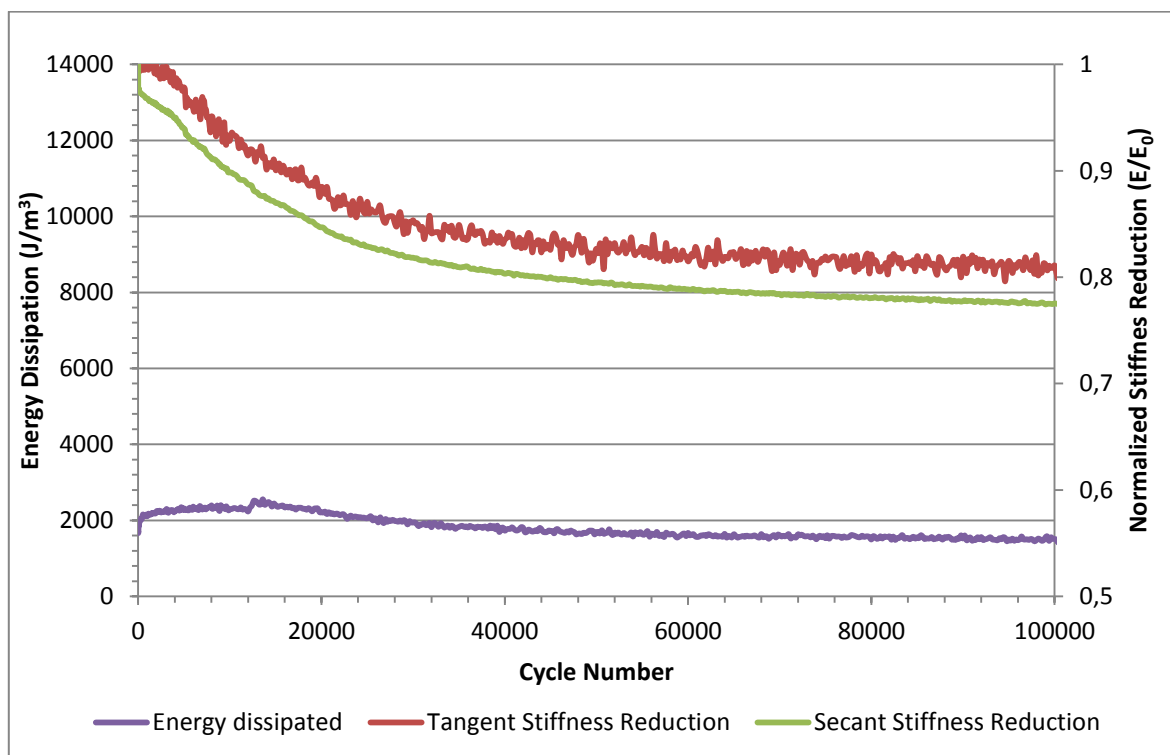
**Figure 5.2** Energy dissipation and stiffness reduction calculated considering either the secant or the tangent to hysteresis cycle. The peak stress imposed to the loading cycles is equal to 100MPa.

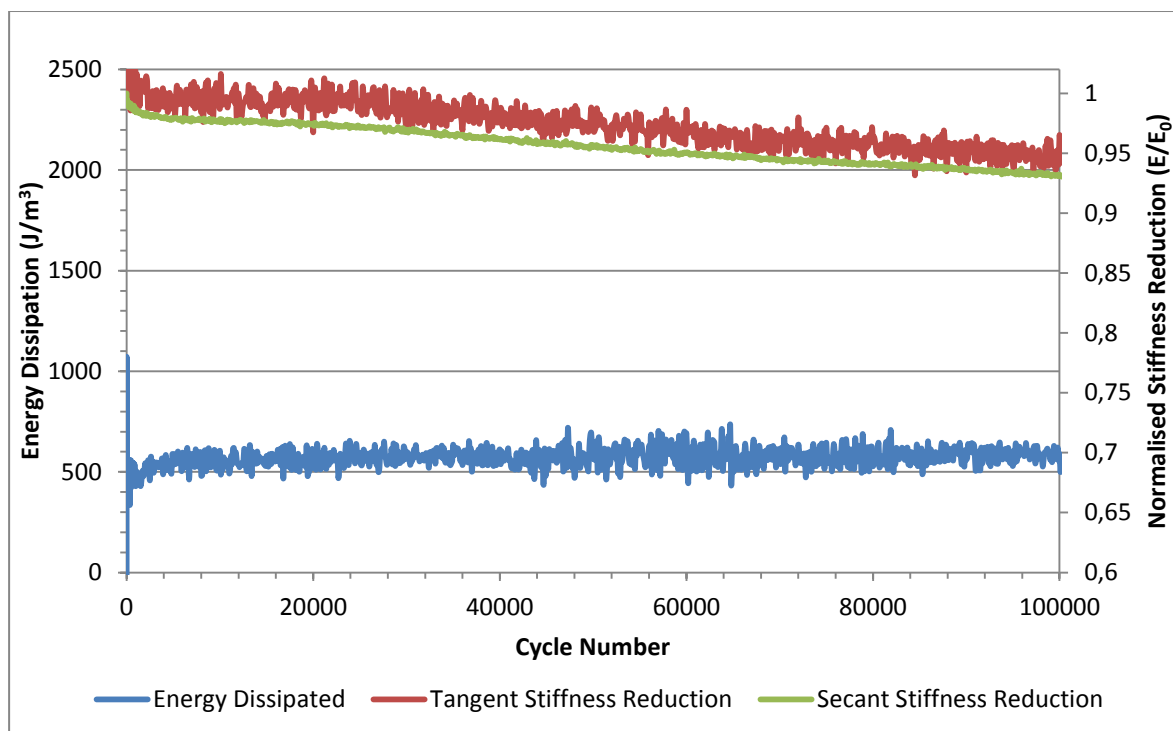
**Figure 5.3** Energy dissipation and stiffness reduction calculated considering either the secant or the tangent to hysteresis cycle. The peak stress imposed to the loading cycles is equal to 75MPa.

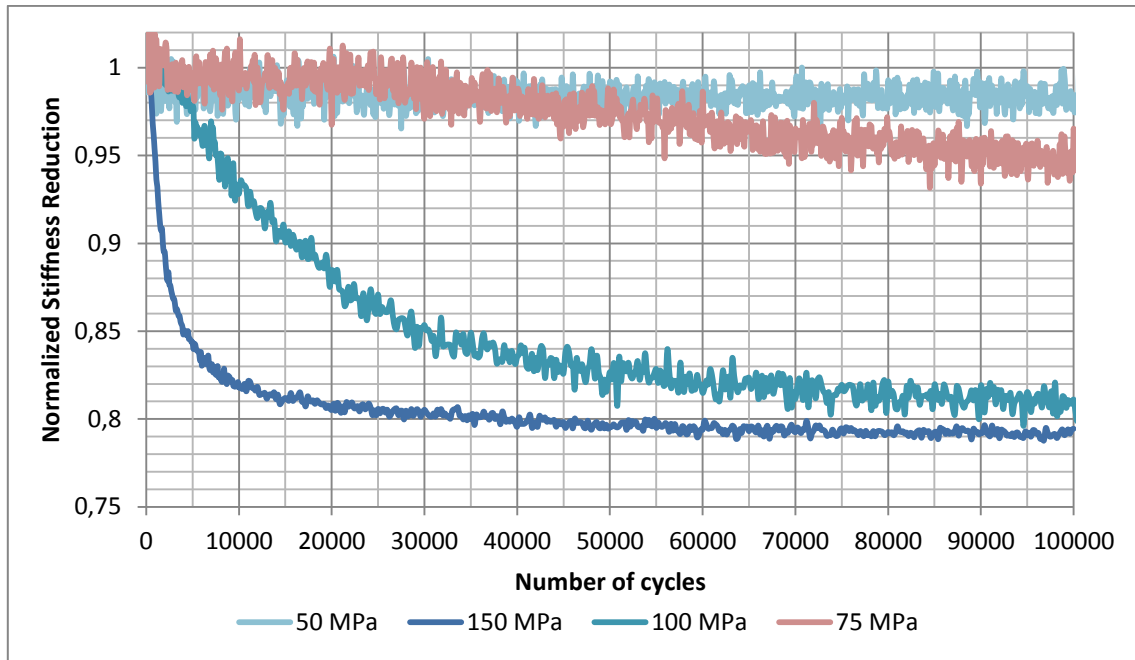
**Figure 5.6** Comparison of stiffness reduction curves at peak stress levels of 50, 75, 100, 150 MPa

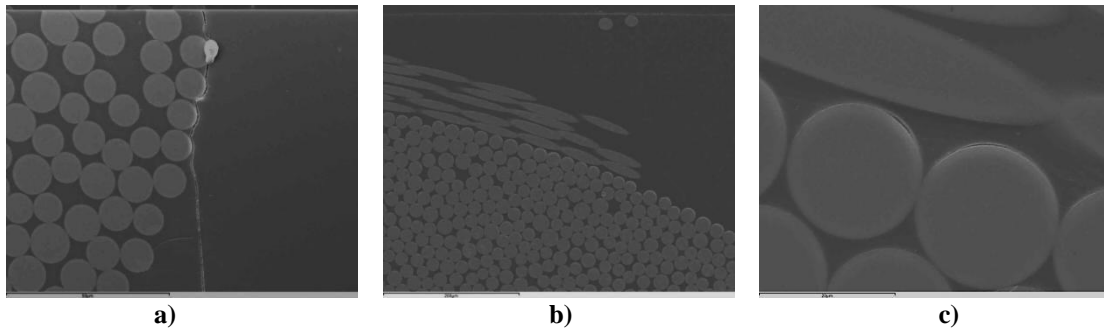
**Figure 5.8** SEM images of specimen fatigue tested at a peak stress of 50MPa.

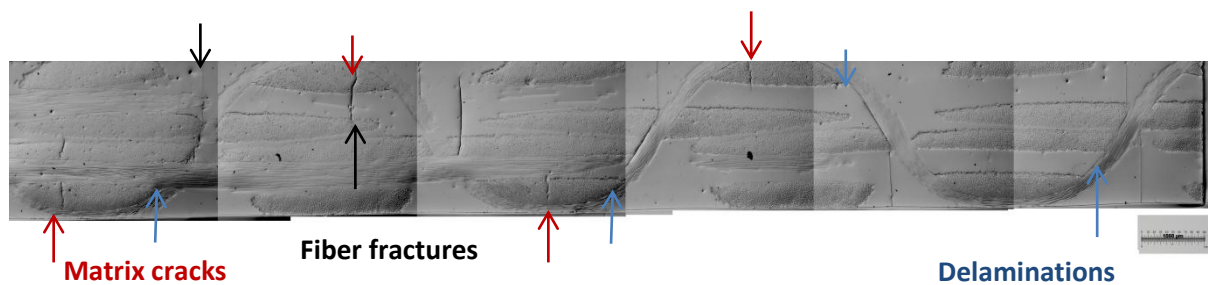
**Figure 5.9** Optical micrograph images of specimen fatigue tested at a peak stress of 75 MPa.

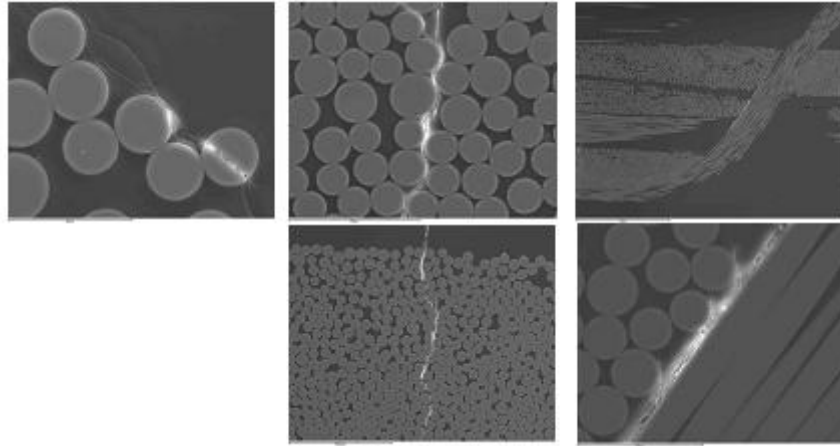
**Figure 5.10** SEM images of specimen fatigue tested at a peak stress of 75MPa.

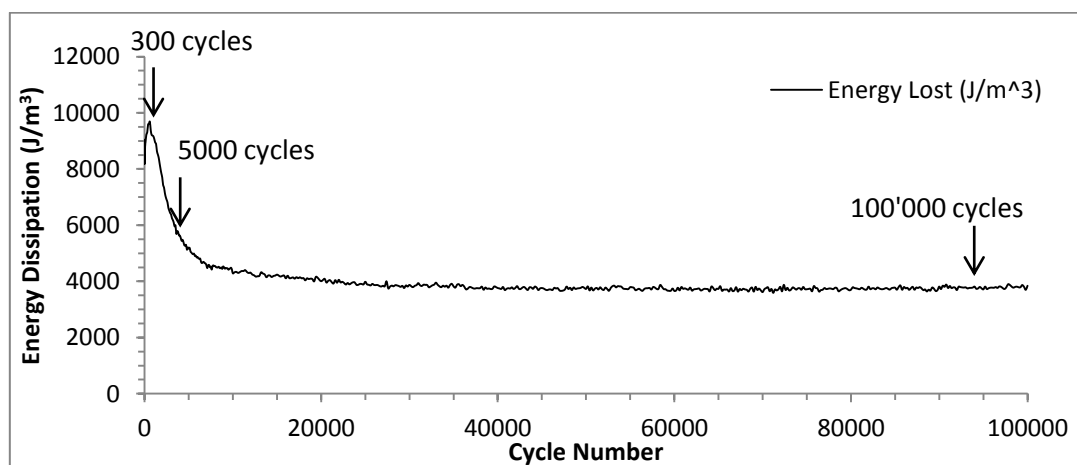
**Figure 5.12** Energy curve recorded for a test carried out with a peak stress of 150 MPa. Arrows indicate the number of cycles considered representative for each phase of increase, decrease and stabilization of energy.

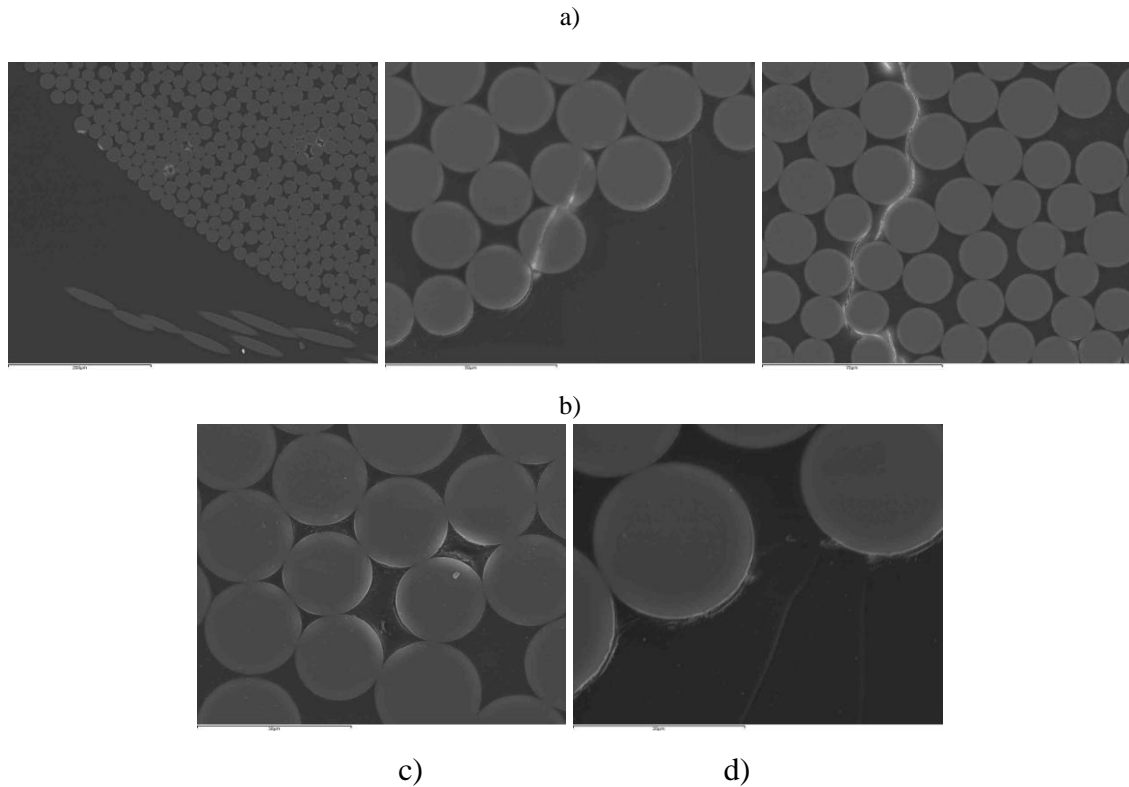
**Figure 5.13** Optical and SEM microscope images of the same specimen tested with a maximum stress of 150 MPa after 300 cycles.

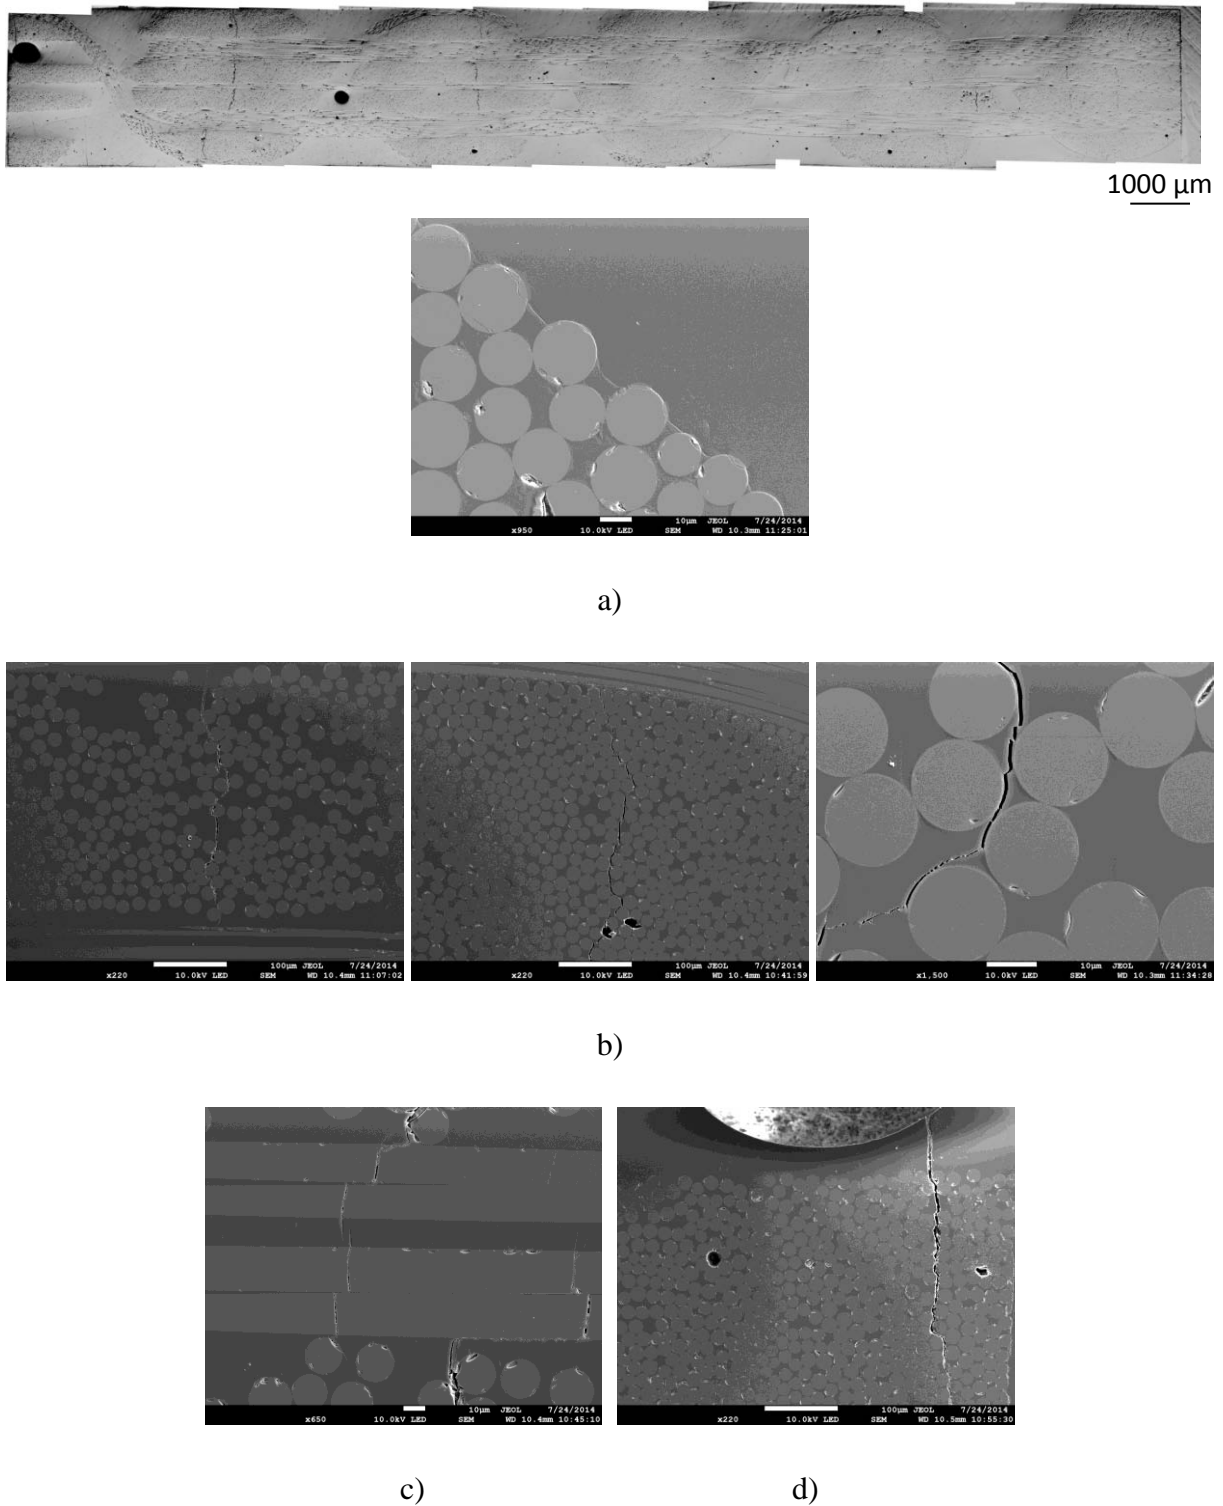
**Figure 5.14** Optical and SEM microscope images of the same specimen tested with a maximum stress of 150 MPa for 5000 cycles.

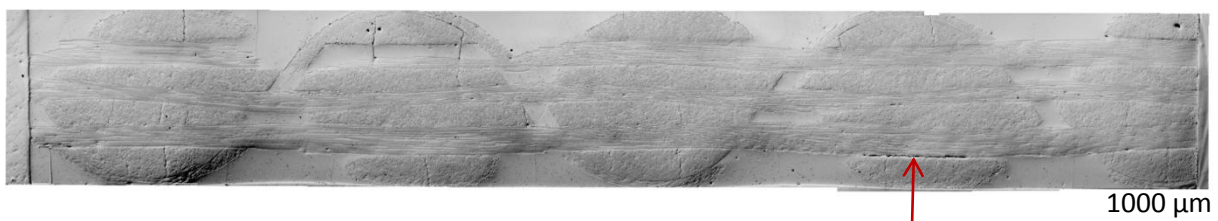
The final test carried out at the same peak stress level was stopped after 100000 cycles; despite the elapse of numerous cycles, the energy dissipation curve had a stable value up to this point. Optical micrograph images and correspondent magnifications of areas of interest of these, taken always by means of scanning electron microscopy, are shown in Figure 5.16.

**Delaminations opposite to the Z-crown**

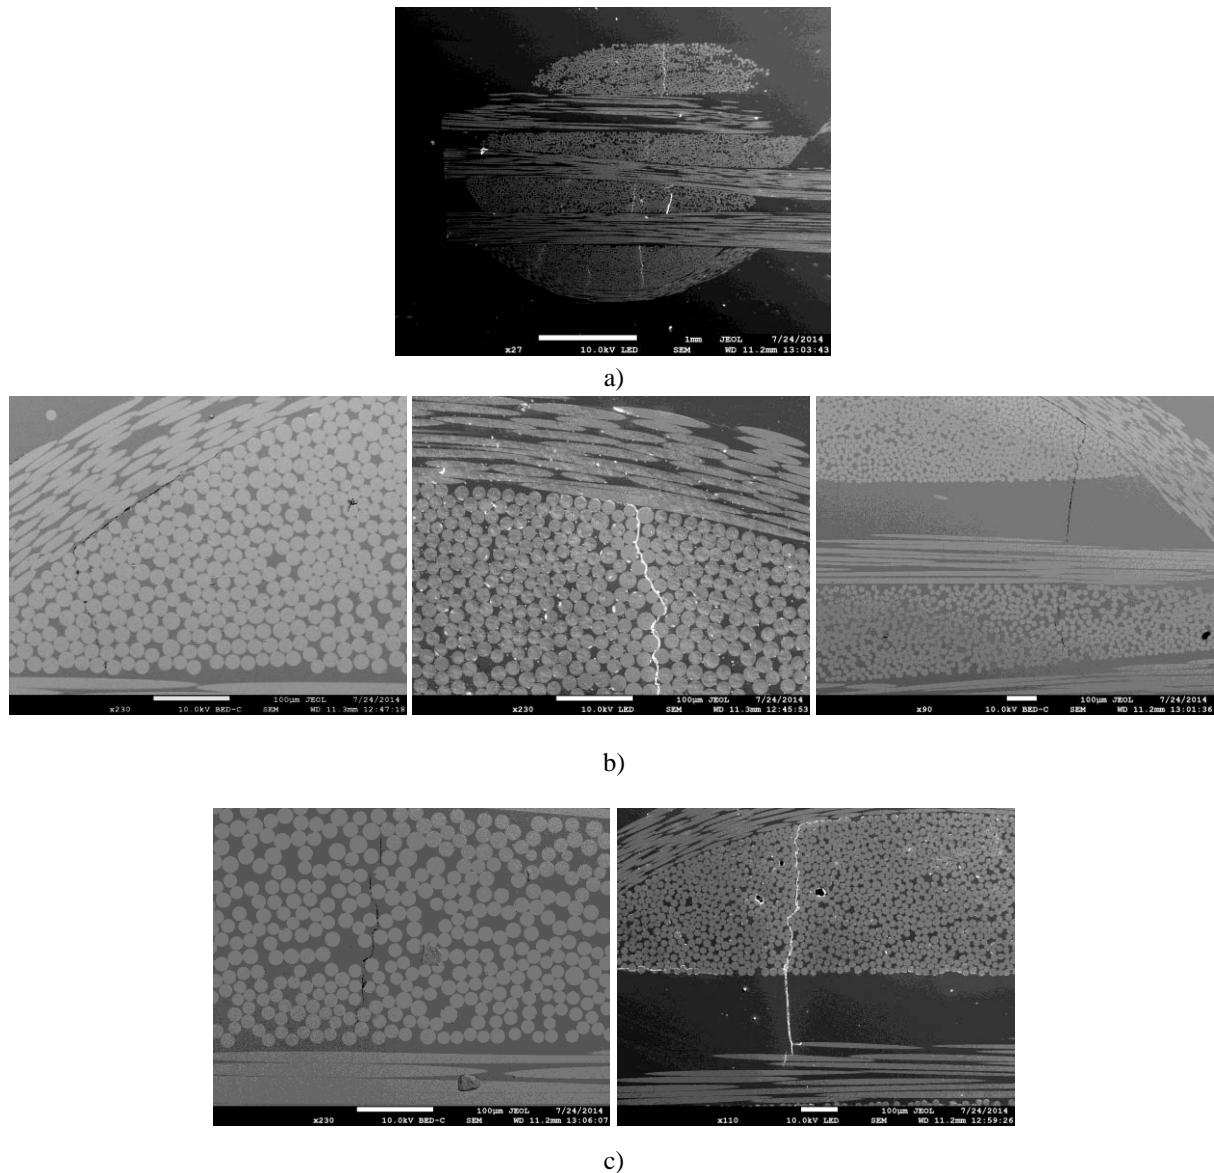
**Figure 5.15** Optical and SEM microscope images of the same specimen tested with a maximum stress of 150 MPa for 100000 cycles.

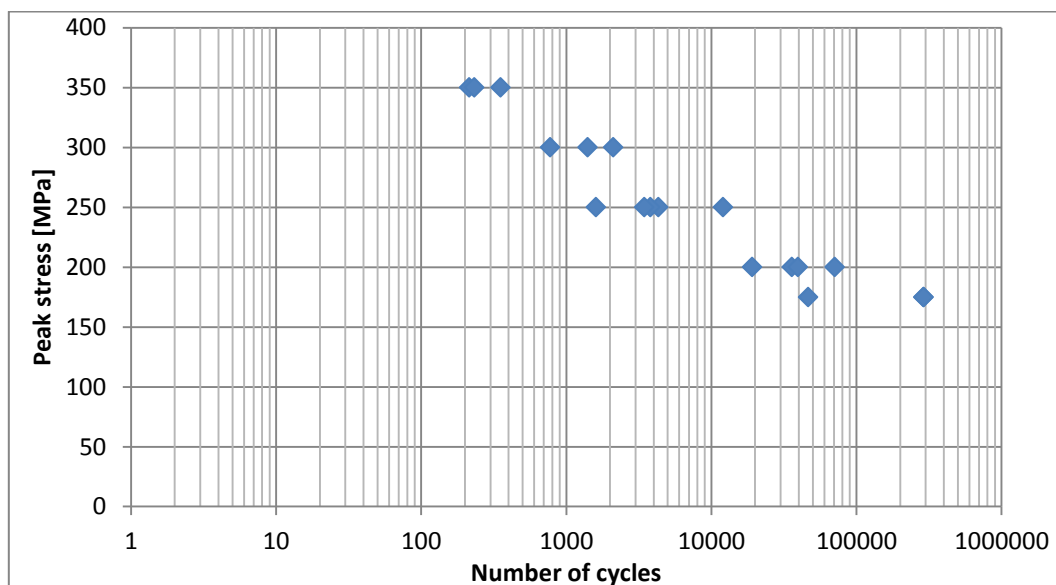
**Figure 6.1** S-N curve for specimens tested along warp direction: number of cycles are reported vs values of peak stress
