UNIVERSITÀ  
DEGLI STUDI  
DI PADOVA

CORSO DI LAUREA MAGISTRALE IN INGEGNERIA MECCANICA

**THERMOMECHANICAL AND MICROSCOPY  
INVESTIGATION OF FATIGUE DAMAGE  
DEVELOPMENT IN A 3D E-GLASS/EPOXY WOVEN  
COMPOSITE**

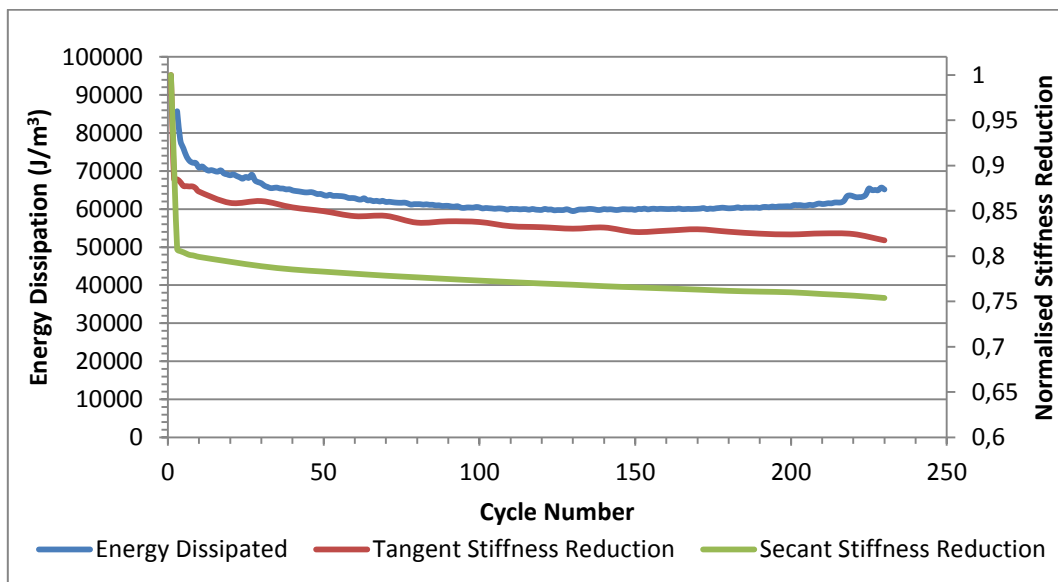
**Figure 6.4** Energy dissipation and stiffness reduction vs elapsed number of cycles for a test performed at a peak stress of 350 MPa. The specimen failed after 232 cycles in a region near the grips.

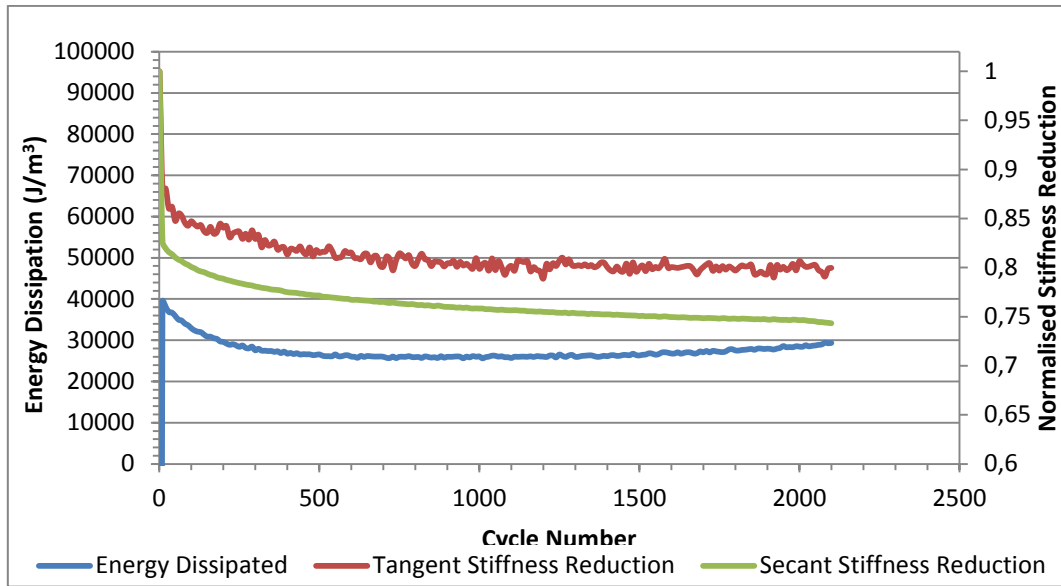
**Figure 6.5** Energy dissipation and stiffness reduction vs elapsed number of cycles for a test performed at a peak stress of 300 MPa. The specimen failed after 2109 cycles in a region near the grips.

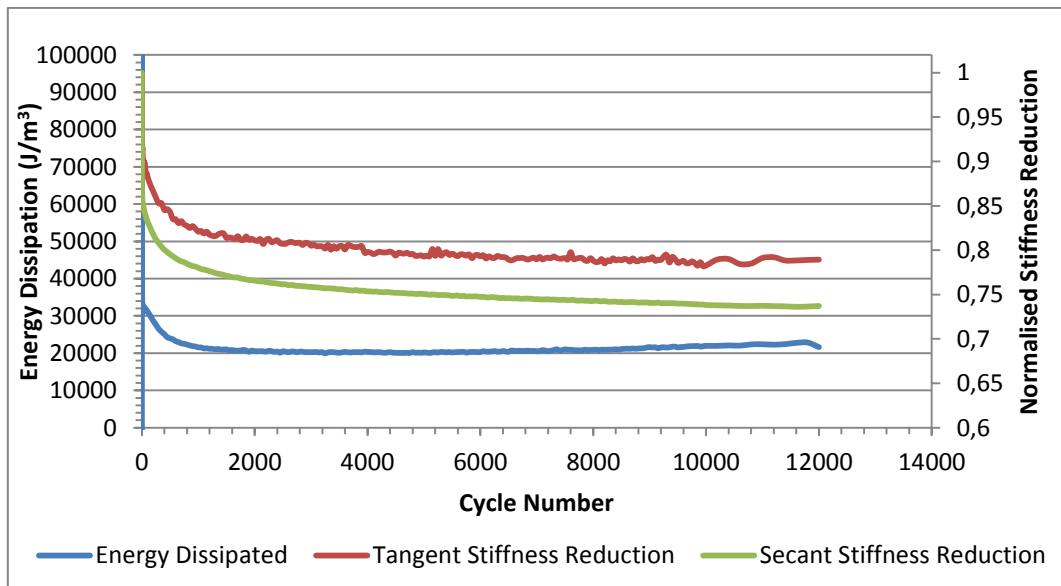
**Figure 6.6** Energy dissipation and stiffness reduction vs elapsed number of cycles for a test performed at a peak stress of 250 MPa. The specimen failed after 12056 cycles in a region near the grips.

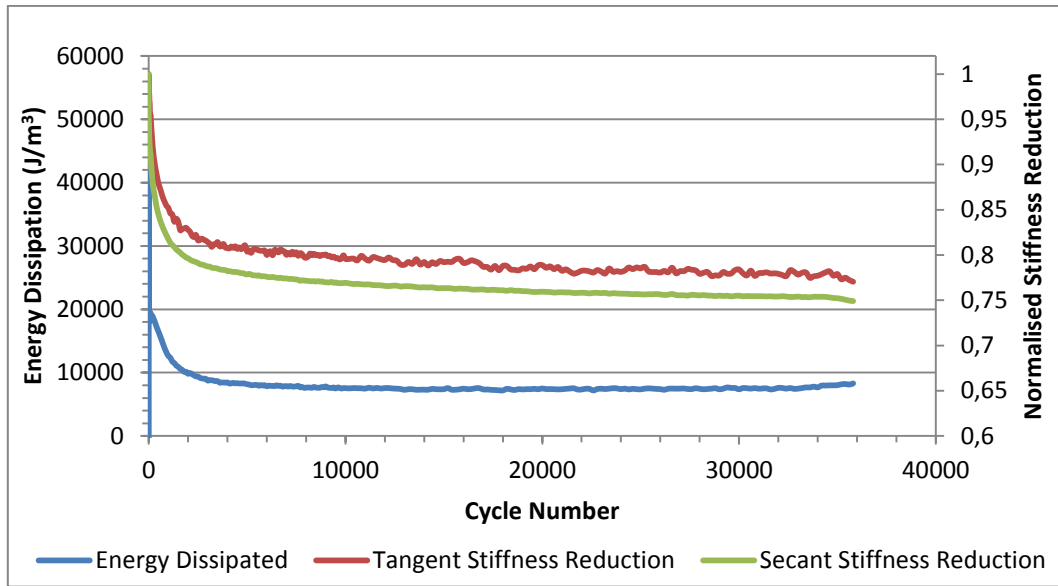
**Figure 6.7** Energy dissipation and stiffness reduction vs elapsed number of cycles for a test performed at a peak stress of 200 MPa. The specimen failed after 35200 cycles in a region near the grips.

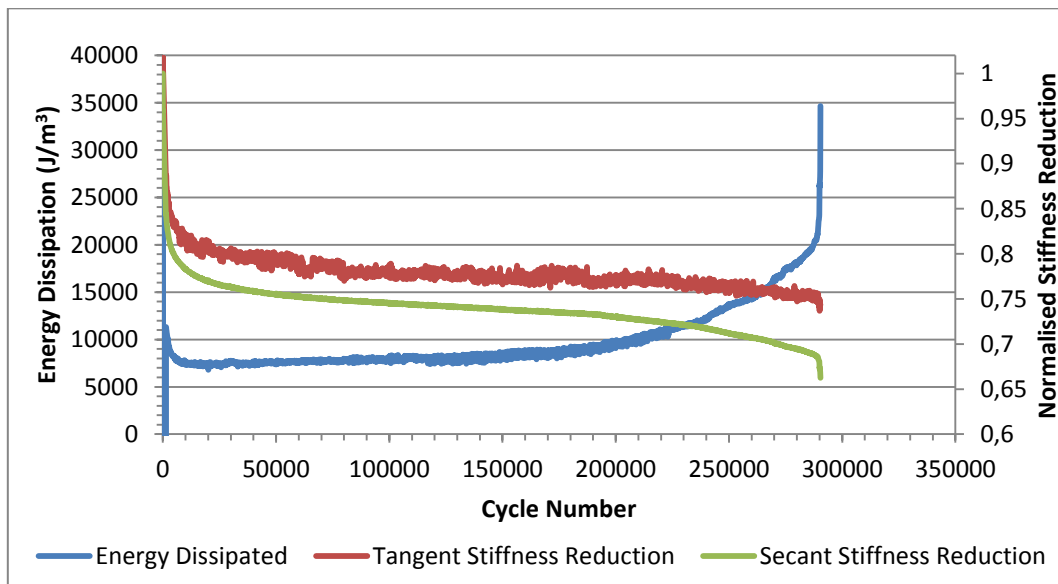
**Figure 6.8** Energy dissipation and stiffness reduction vs elapsed number of cycles for a test performed at a peak stress of 175 MPa. The specimen failed after 290400 cycles into the gauge region.

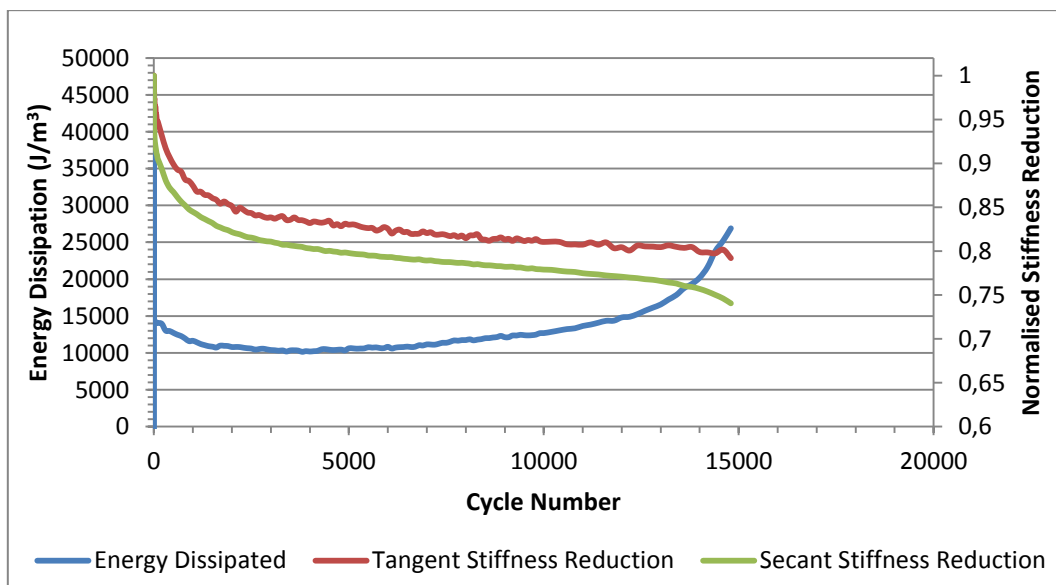
**Figure 6.9** Normalized stiffness reduction and energy dissipation with number of cycles for a specimen cycled with a peak stress of 200 MPa.

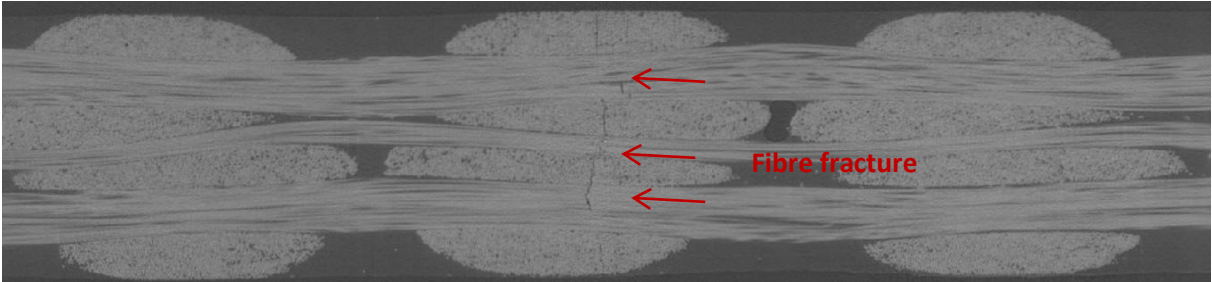
**Figure 6.11** CT section (A-A plane) showing extensive fibre fracture in the middle and low warp yarns

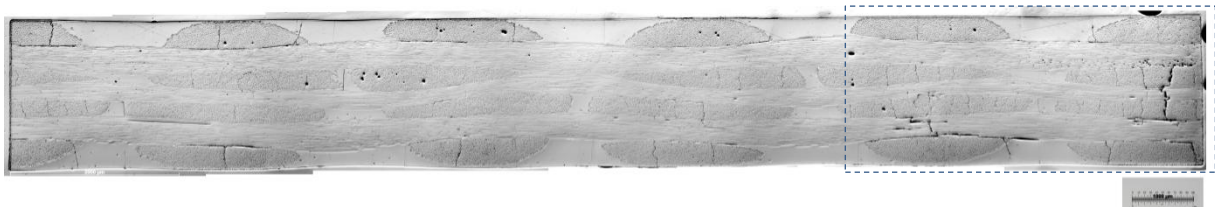
**Figure 6.13** *Optical micrograph of sectioned and polished specimen showing extensive fibre fracture located into middle and low warp yarns*

These observations are similar to those of Baiocchi, except the observation of fibre fractures in the central warp tow are new (Baiocchi's 3D composite did not have a central warp tow). This may be due to the minor number constituting central warp tow, which makes it more prone to be subjected to early damage. Optical light images taken from the same specimen permitted to confirm the X-ray images, as shown in Figures 6.13 and 6.14.

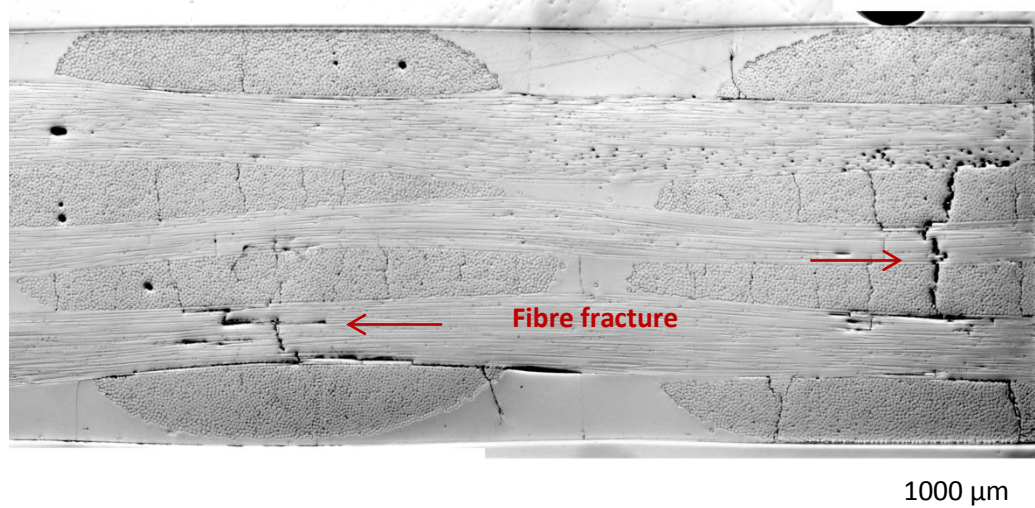
**Figure 6.14** Magnification of the optical micrograph of sectioned and polished specimen showing extensive fibre fracture located into middle and low warp yarns

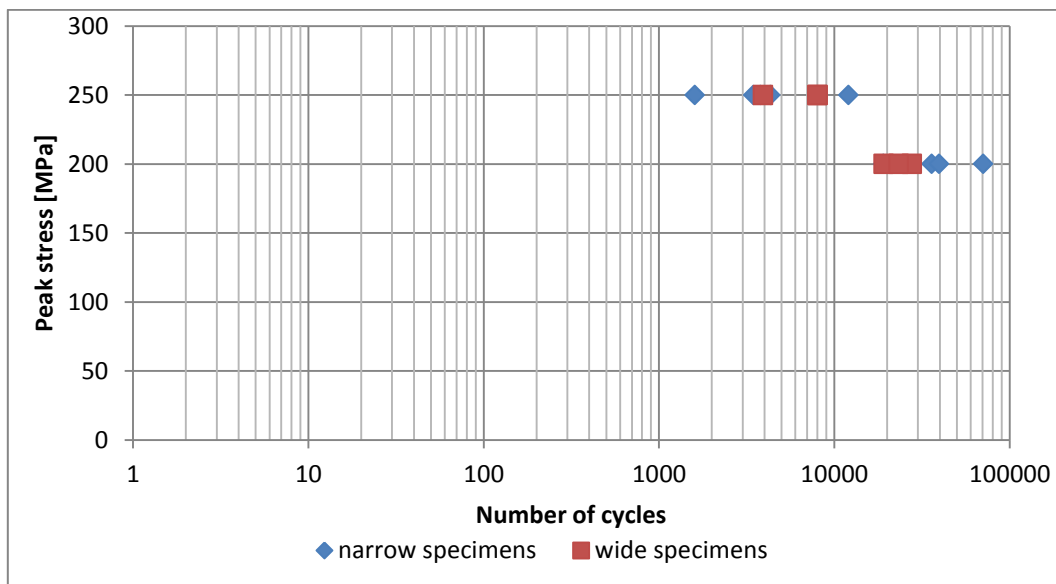
**Figure 6.15** S-N curve comparison between narrow and wide specimens

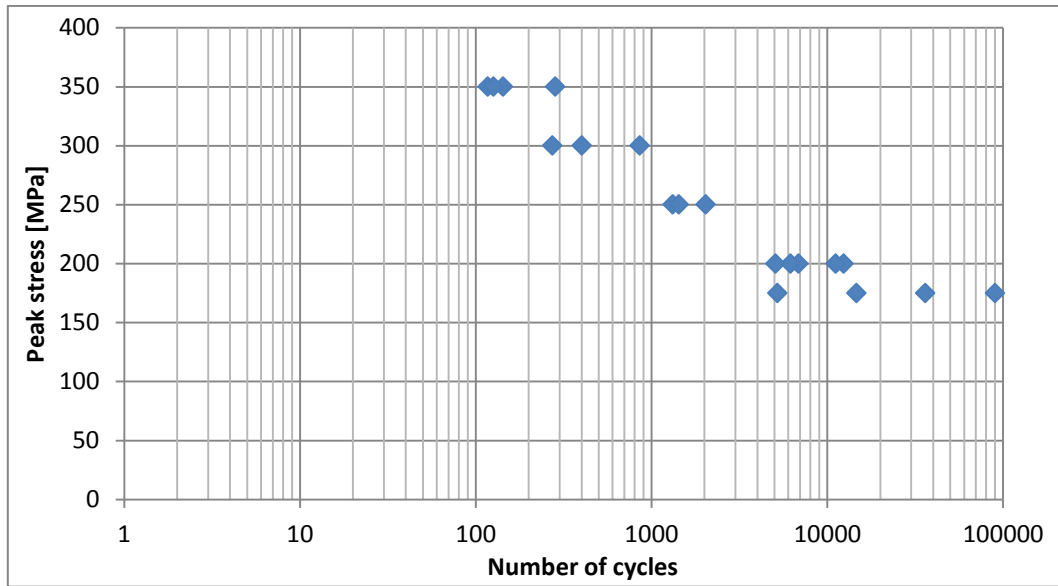
**Figure 6.16** *S-N curve for the 3D-96 specimens loaded into weft direction: number of cycles are reported vs values of peak stress.*

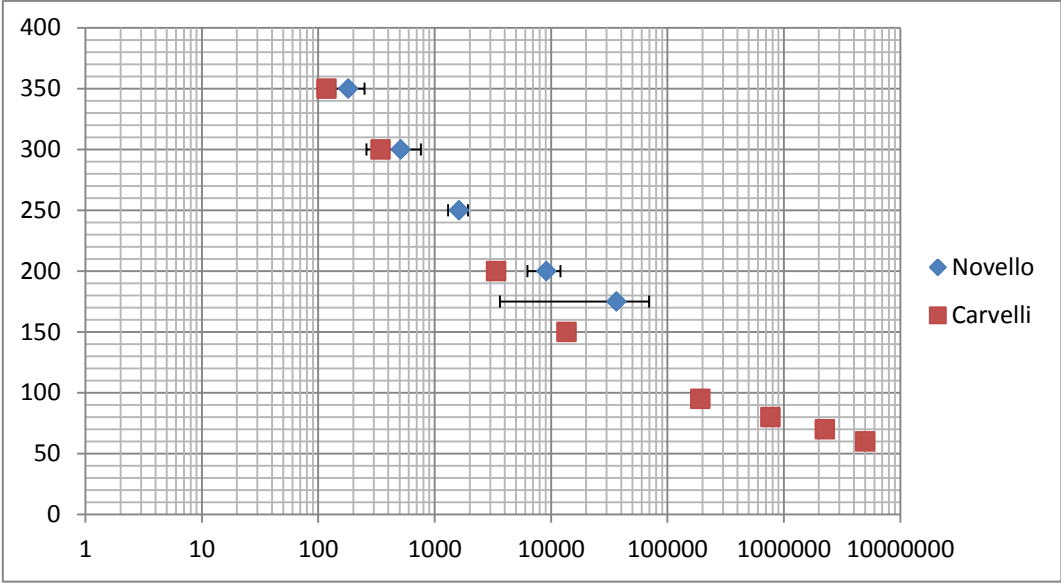
Figure 6.18 Comparison between S-N curve obtained from experimental work and S-N curve drawn from literature data (Carvelli et al.).

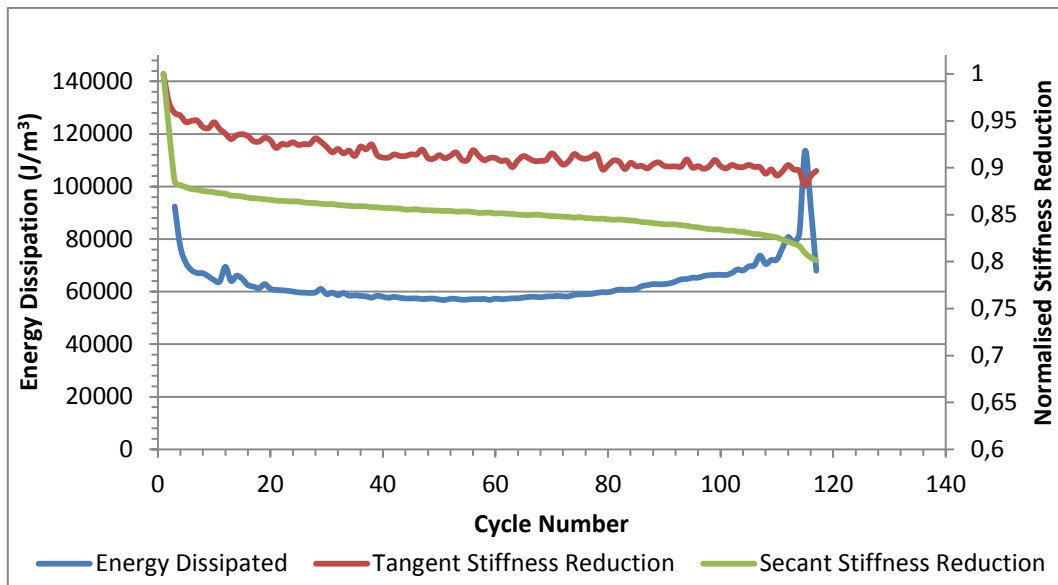
**Figure 6.19** Energy dissipation and stiffness reduction vs elapsed number of cycles for a test performed at a peak stress of 350 MPa. The specimen failed after 117 cycles in the gauge region.

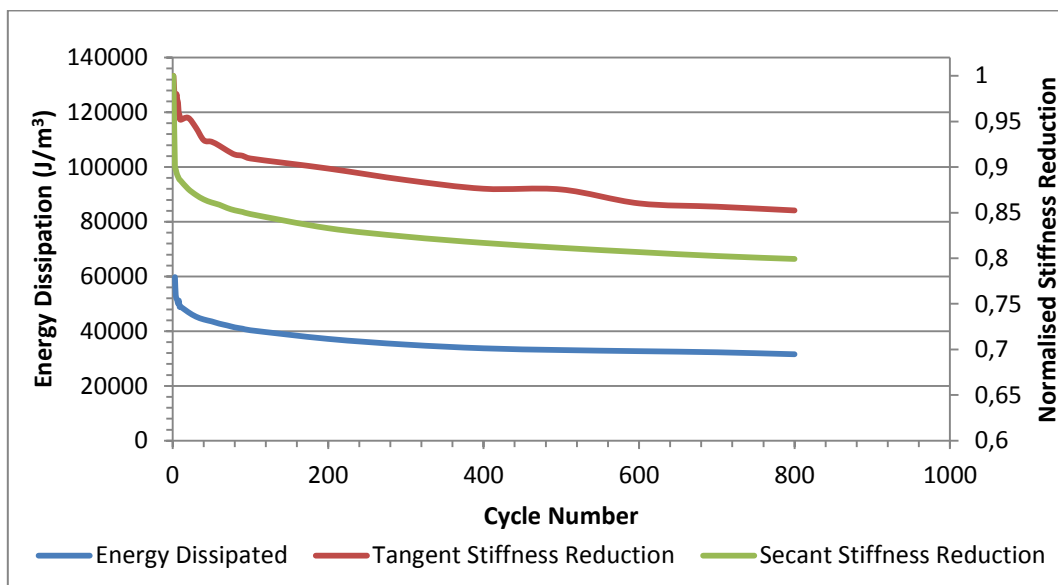
**Figure 6.20** Energy dissipation and stiffness reduction vs elapsed number of cycles for a test performed at a peak stress of 300 MPa. The specimen failed after 859 cycles in a region near the grips.

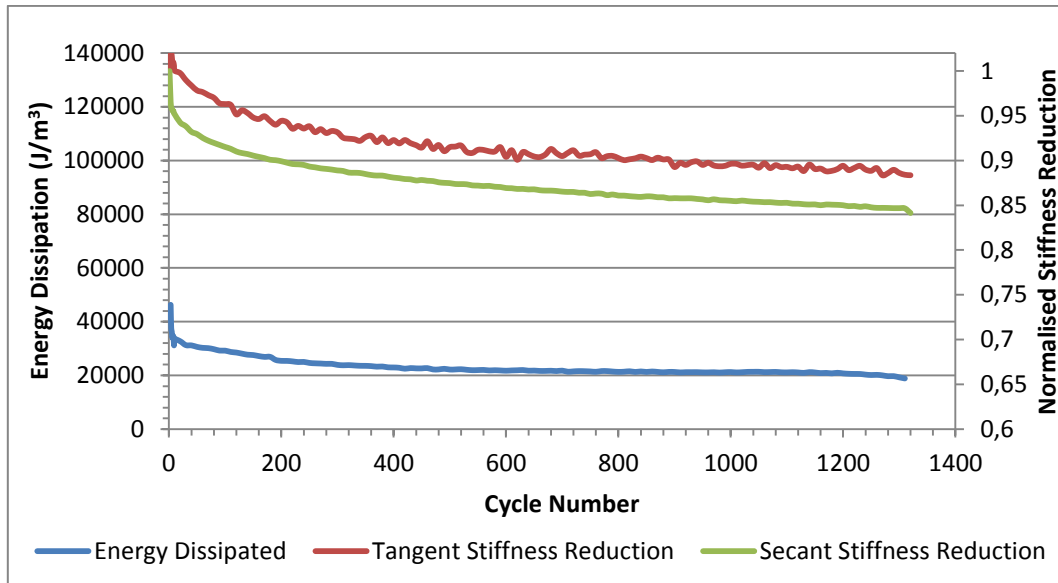
**Figure 6.21** Energy dissipation and stiffness reduction vs elapsed number of cycles for a test performed at a peak stress of 250 MPa. The specimen failed after 1321 cycles in a region near the grips.

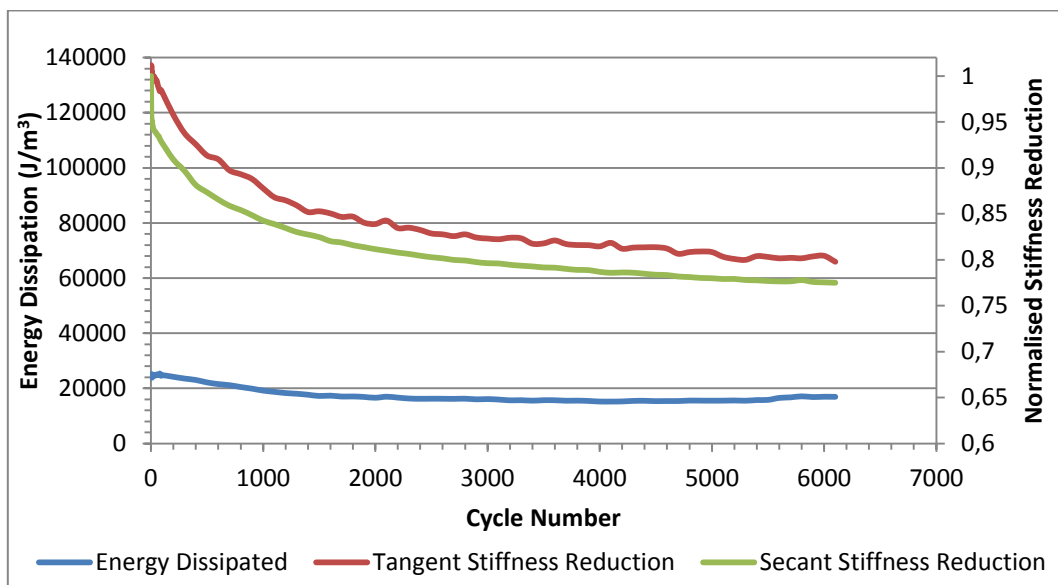
**Figure 6.22** Energy dissipation and stiffness reduction vs elapsed number of cycles for a test performed at a peak stress of 200 MPa. The specimen failed after 6177 cycles in the gauge region.

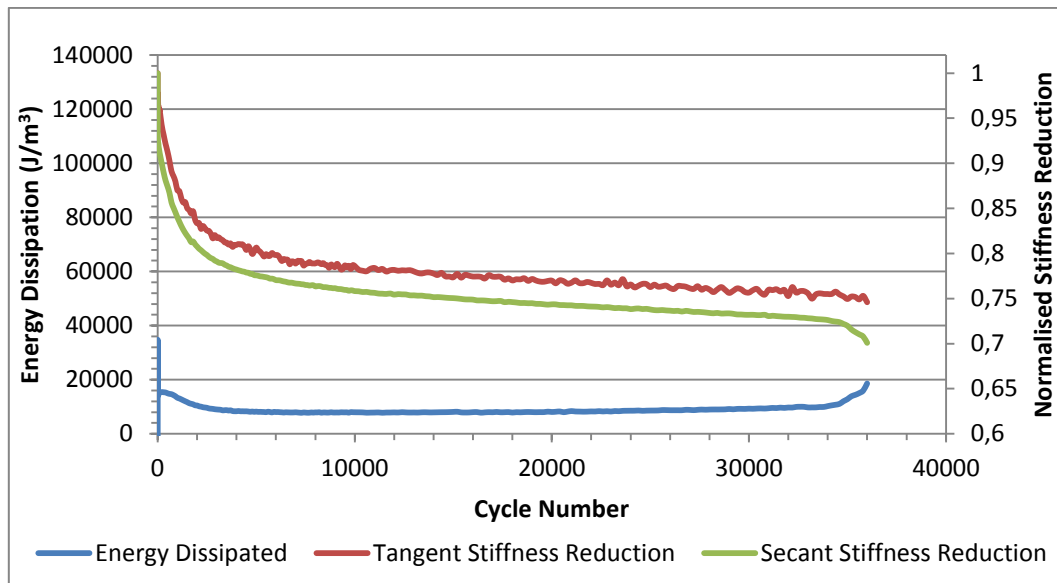
**Figure 6.23** Energy dissipation and stiffness reduction vs elapsed number of cycles for a test performed at a peak stress of 175 MPa. The specimen failed after 36112 cycles in the gauge region.

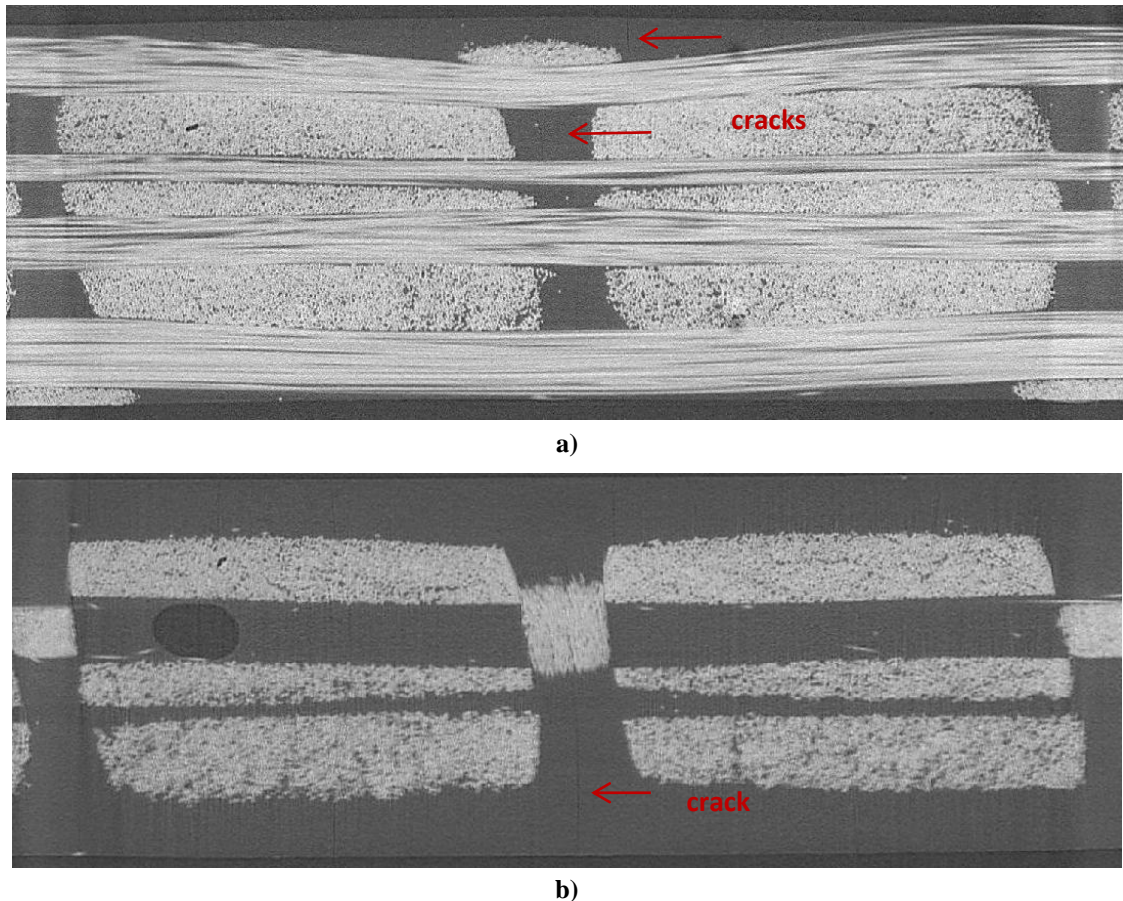
**Figure 6.24** CT images showing a) warp tows, weft tows and z-tows sections (plane Y-Z, in correspondence of weft tows) and b) warp tows and z-tows sections (plane Y-Z, in correspondence of resin rich channels).

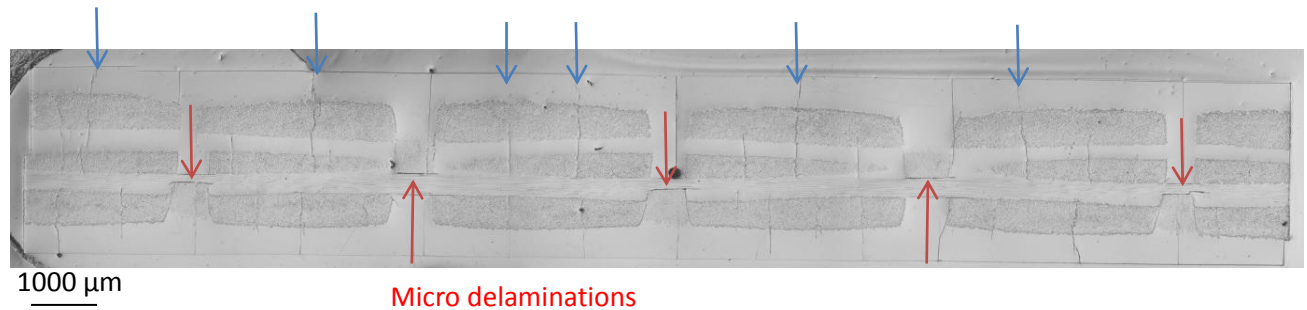
**Figure 6.25** Optical micrographs showing matrix cracks and micro delaminations between z-tows and underlying weft tows

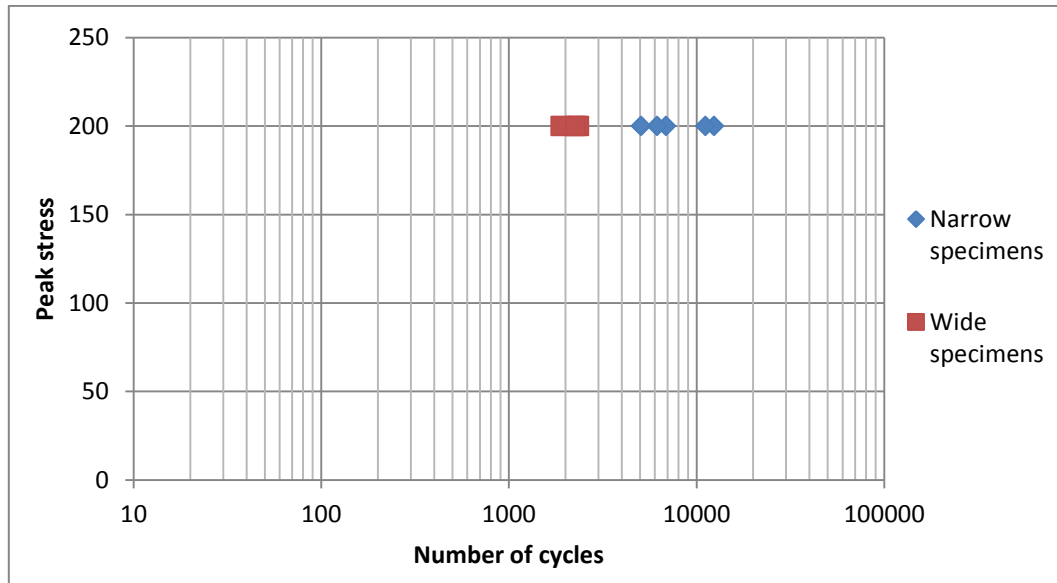
**Figure 6.27** *S-N curve comparison between narrow and wide specimens*

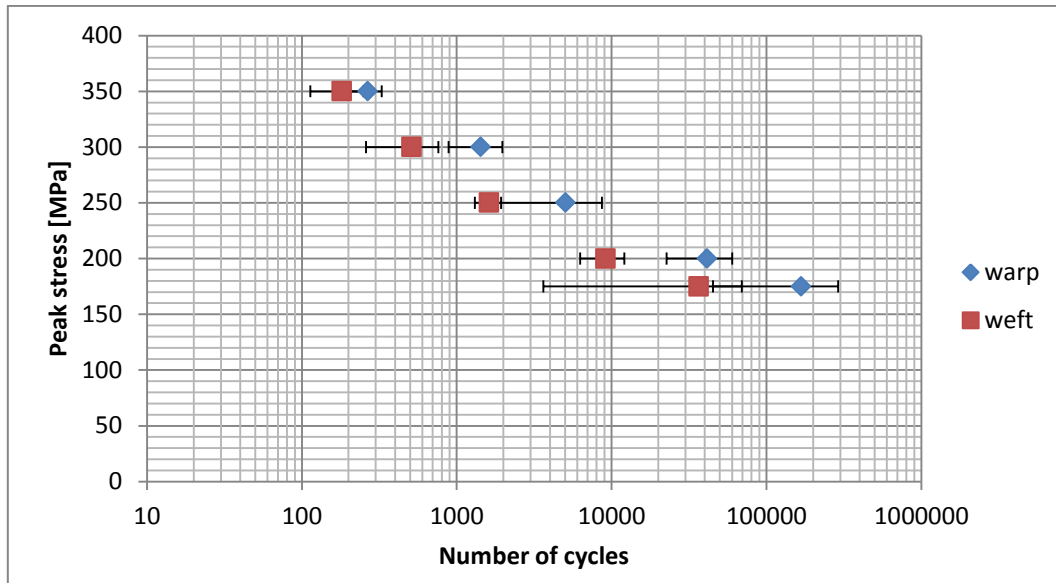
**Figure 6.28** Comparison between average S-N curves obtained cycling specimens respectively along the direction parallel to warp and weft tows.

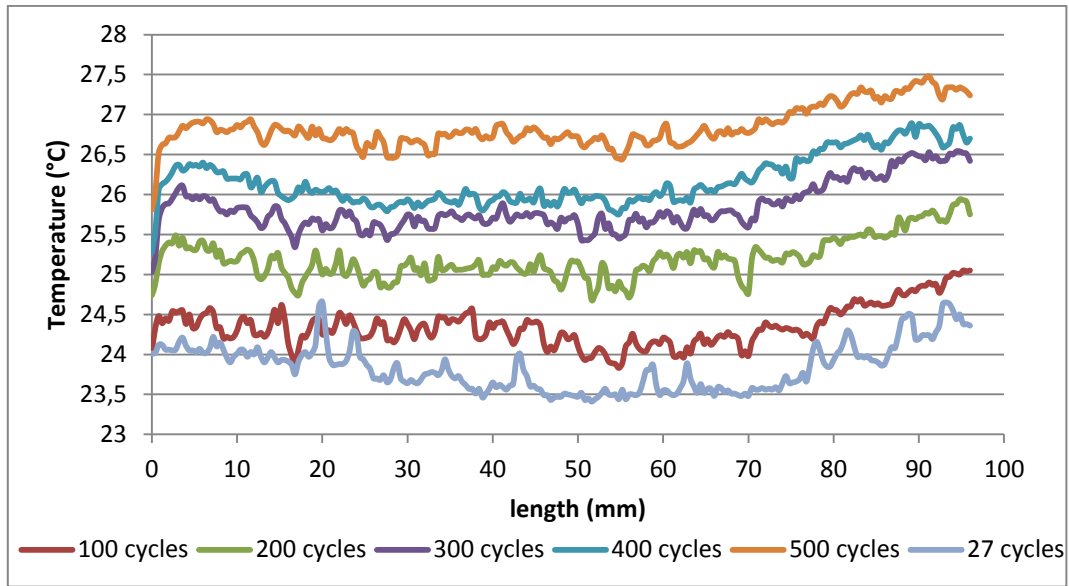
**Figure 7.1** Temperature profile development measured along a line on the surface of the specimen at the elapsing of cycles. The x-axis represents the x coordinate of the point where temperature has been measured in mm.  $X=0$  corresponds to the left extremity of the line.

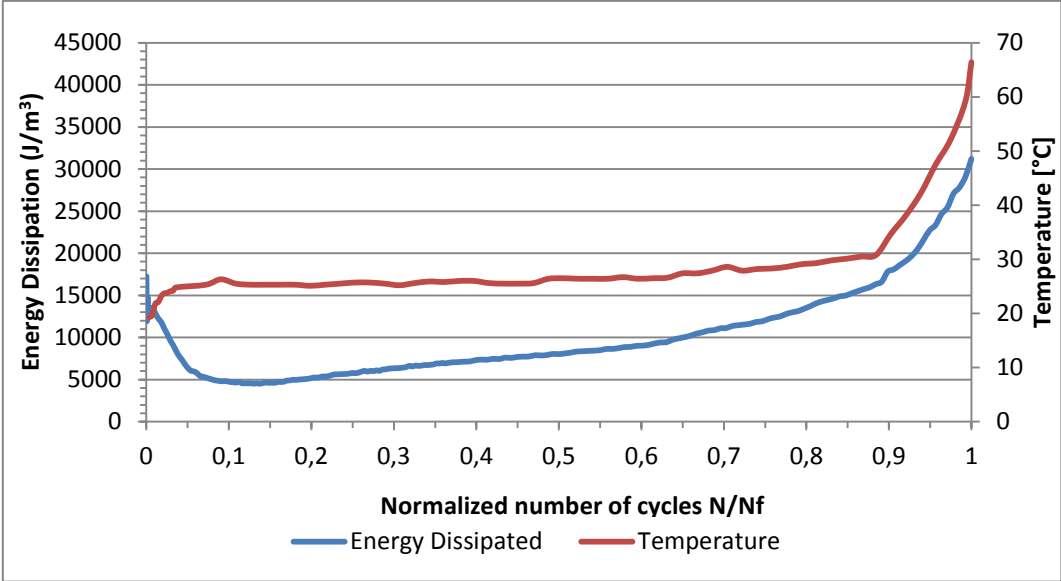
Figure 7.4 Evolution of maximum temperature compared with energy dissipated per cycle; specimen failed after 27751 cycles

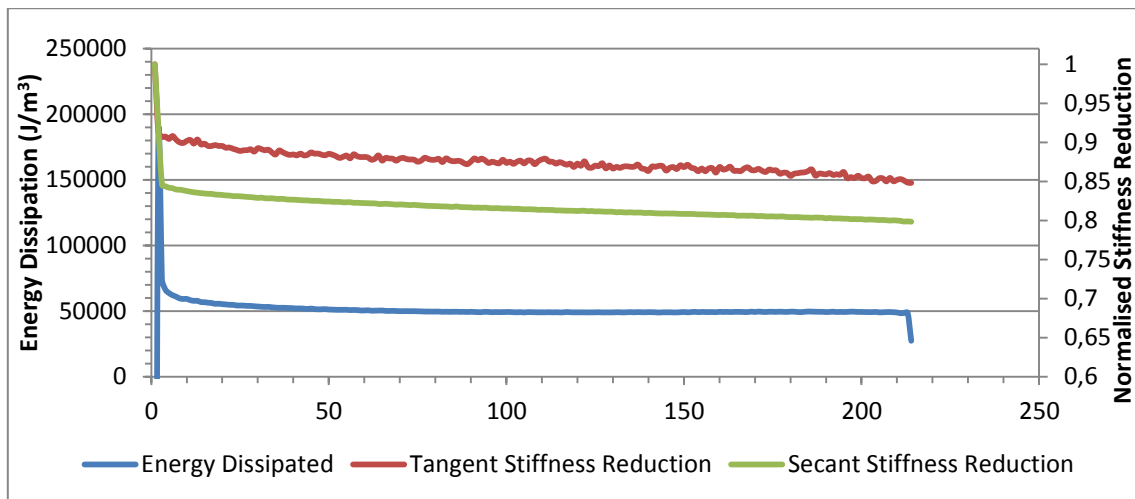
**Figure C.1** Energy dissipated and stiffness reduction curve of 3D 96 fatigued along warp direction, fatigued with peak stress of 350MPa and failed after 211 cycles

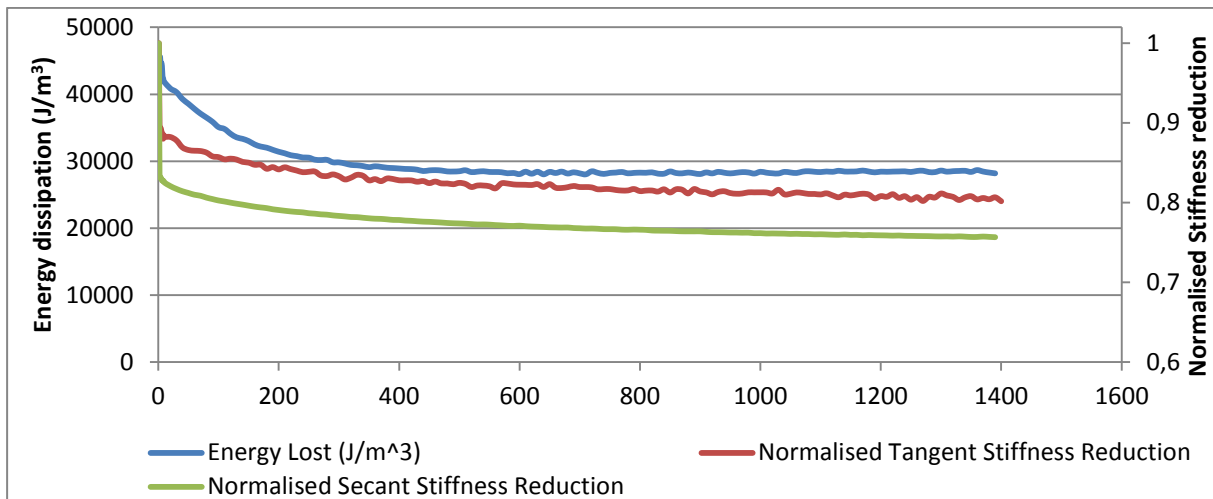
**Figure C.2** Energy dissipated and stiffness reduction curve of 3D 96fatigued along warp direction, fatigued with peak stress of 300MPa and failed after 1400 cycles

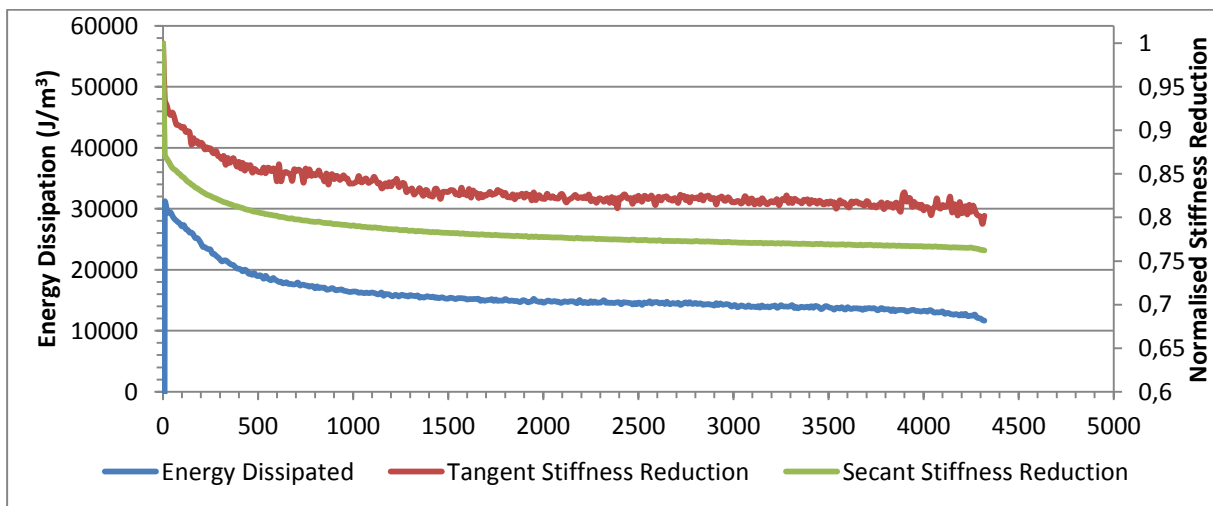
**Figure C.3** Energy dissipated and stiffness reduction curve of 3D 96fatigued along warp direction, fatigued with peak stress of 250MPa and failed after 4320 cycles

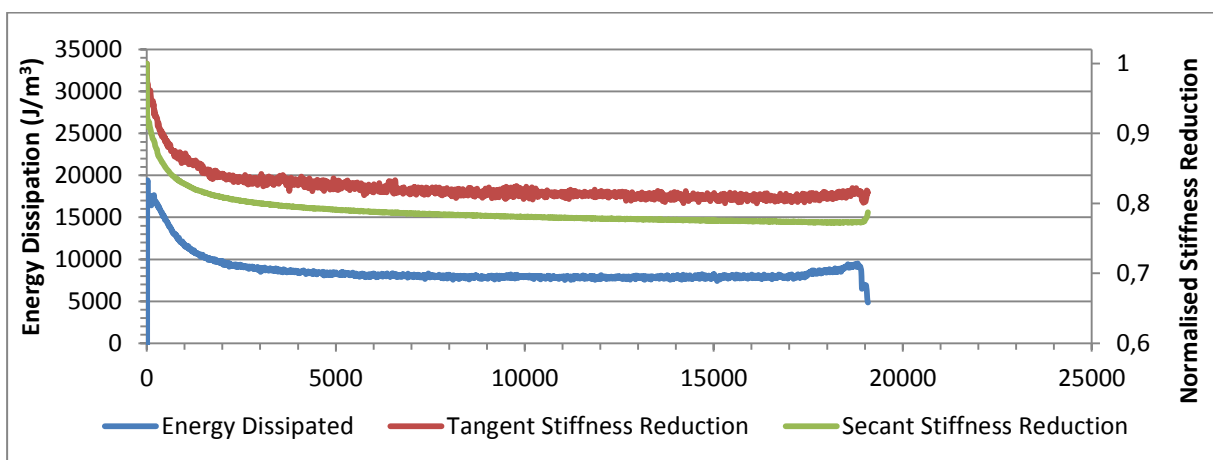
**Figure C.4** Energy dissipated and stiffness reduction curve of 3D 96fatigued along warp direction, fatigued with peak stress of 200MPa and failed after 19080 cycles

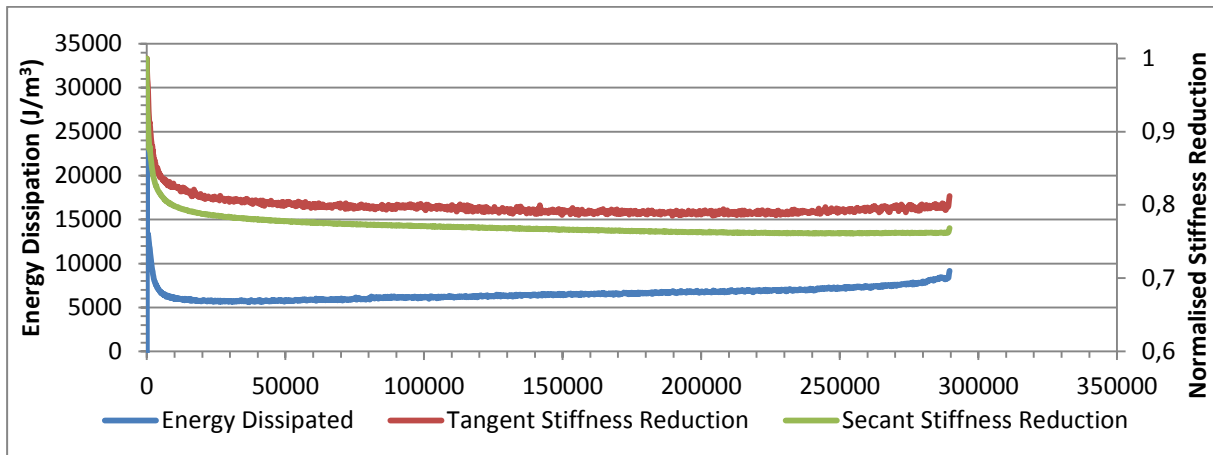
**Figure C.5** Energy dissipated and stiffness reduction curve of 3D 96fatigued along warp direction, fatigued with peak stress of 175MPa and failed after 289600 cycles

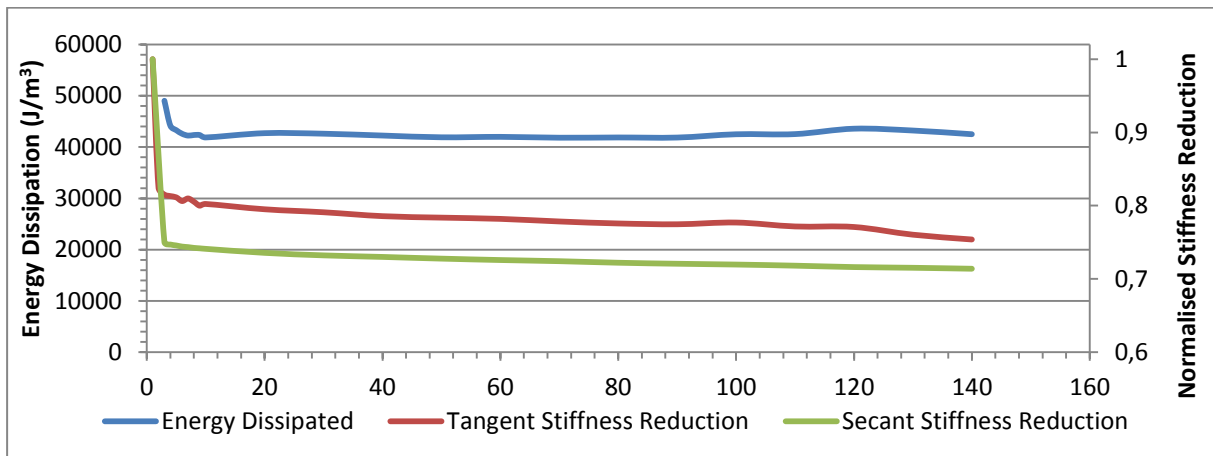
**Figure C.6** Energy dissipated and stiffness reduction curve of 3D 96fatigued along weft direction, fatigued with peak stress of 350MPa and failed after 147 cycles

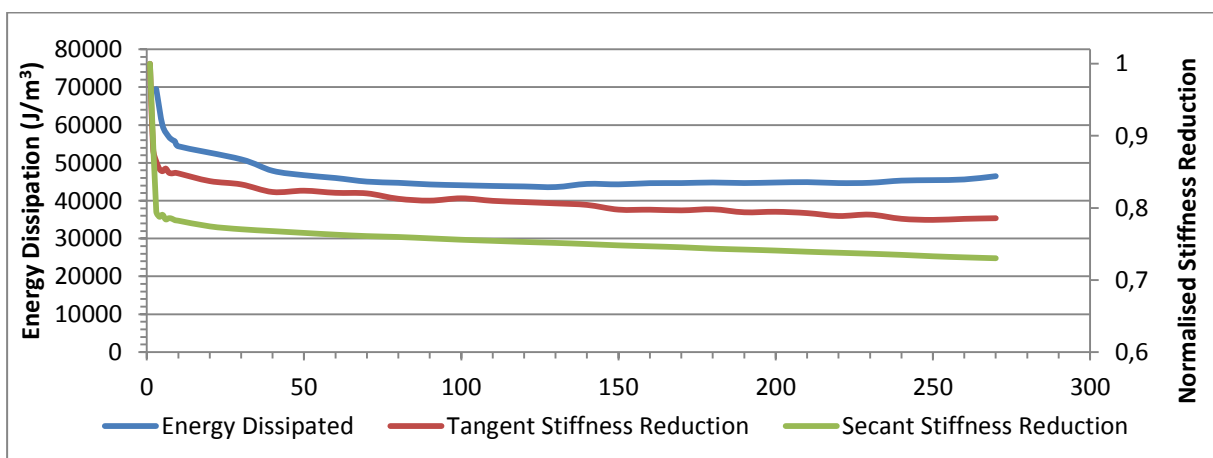
**Figure C.7** Energy dissipated and stiffness reduction curve of 3D 96fatigued along weft direction, fatigued with peak stress of 300MPa and failed after 270 cycles

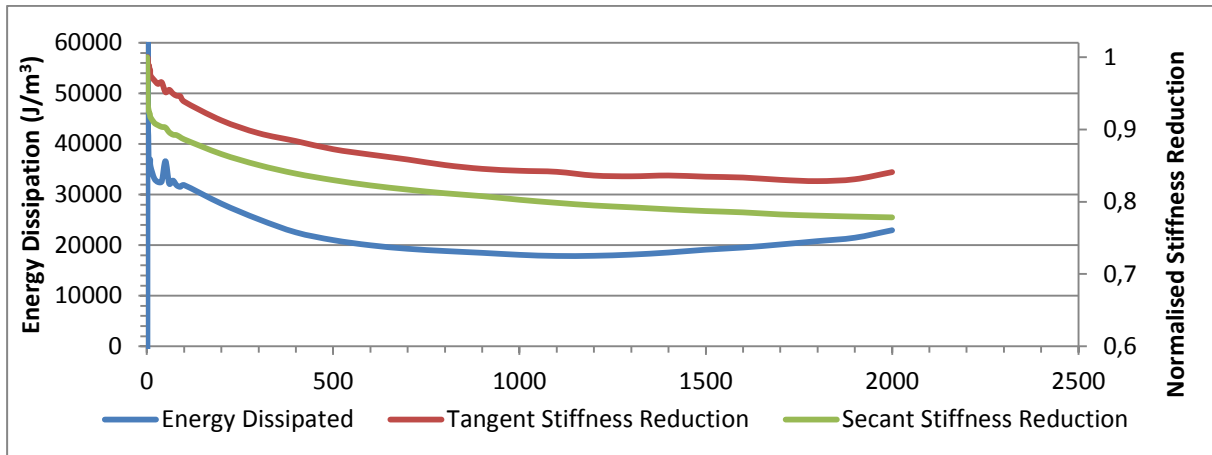
**Figure C.8** Energy dissipated and stiffness reduction curve of 3D 96fatigued along weft direction, fatigued with peak stress of 250MPa and failed after 2000 cycles

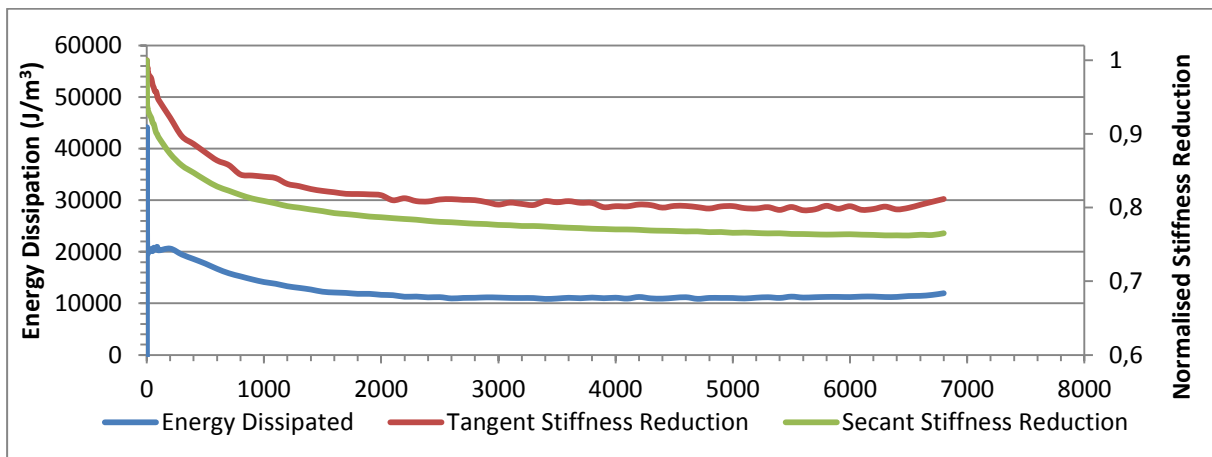
**Figure C.9** Energy dissipated and stiffness reduction curve of 3D 96fatigued along weft direction, fatigued with peak stress of 200MPa and failed after 6800 cycles

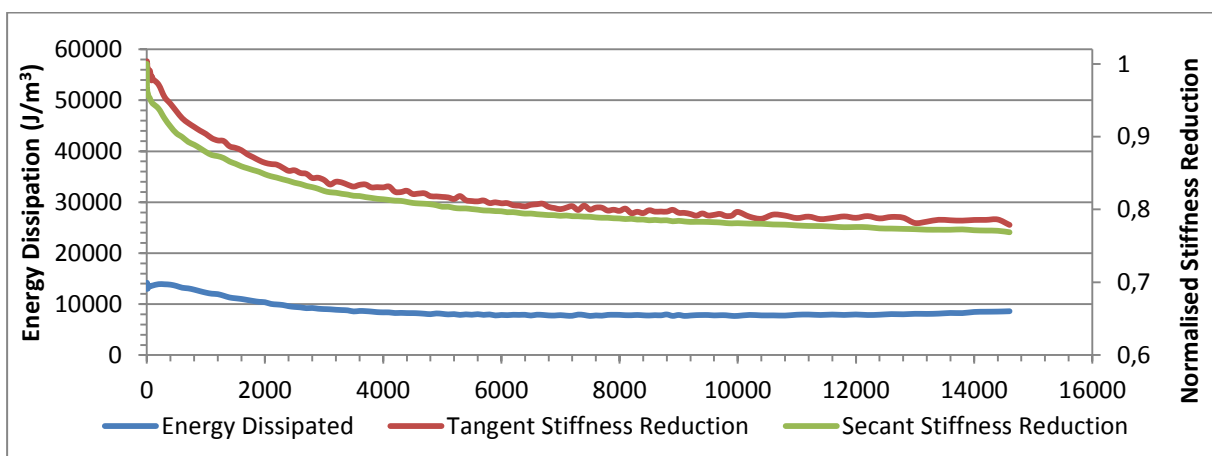
**Figure C.10** Energy dissipated and stiffness reduction curve of 3D 96fatigued along weft direction, fatigued with peak stress of 175MPa and failed after 14600 cycles

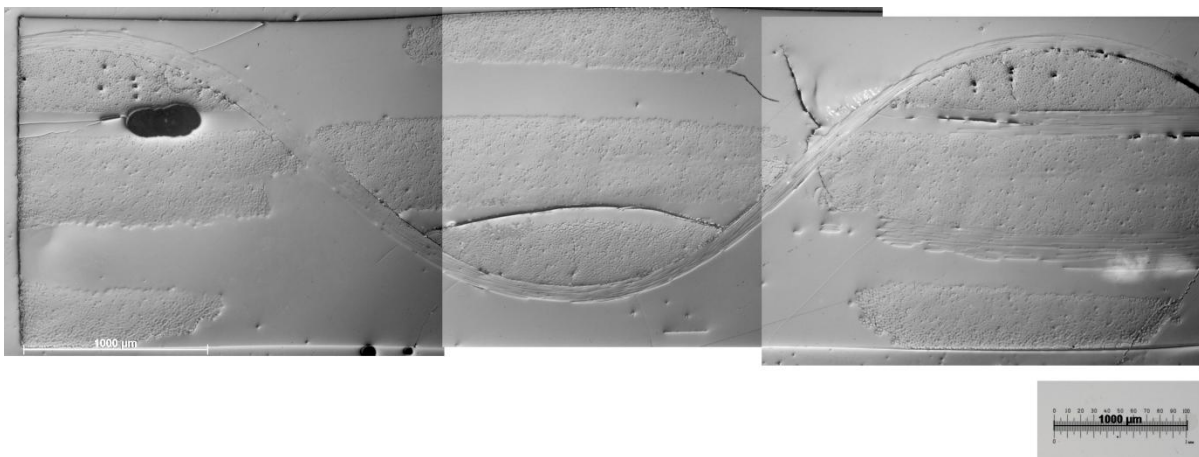
**Figure D.4** Micrograph image taken from a specimen fatigued at a peak stress level of 200 MPa along the weft direction until final failure of the specimen.

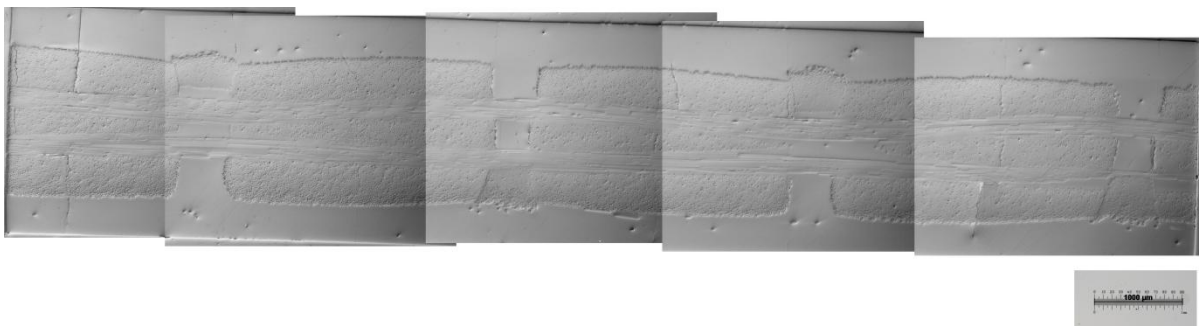
**Figure D.5** Micrograph image taken from a specimen fatigued at a peak stress level of 200 MPa along the weft direction until final failure of the specimen. The section plane is orthogonal to the warp direction.

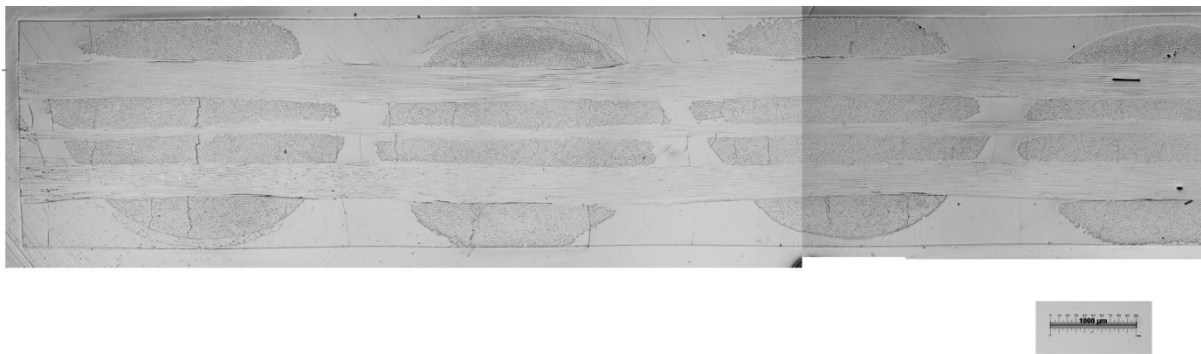
**Figure D.7** Micrograph image taken from a specimen fatigued at a peak stress level of 200 MPa along the warp direction until final failure of the specimen.
