UNIVERSITÀ DEGLI STUDI DI PADOVA

Tesi di Laurea

**STUDY ON TRANSVERSE CRACKING IN AERO -
ENGINE GRADE POLYMER COMPOSITE UNDER
QUASI-STATIC LOADING**

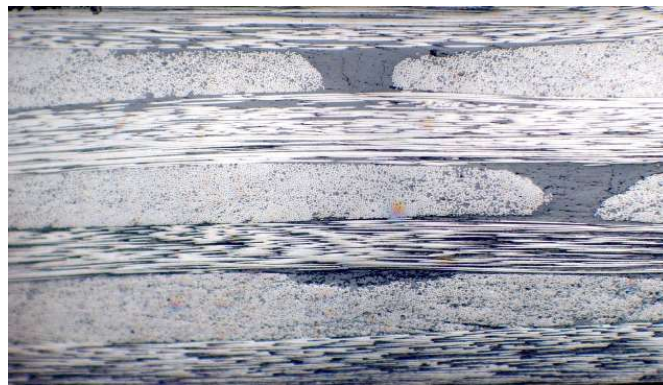
Fig. 3 Microstructure of cross-ply sample edge

The as-built specimens underwent a primary microstructure analysis in both of the edges using an optical microscope to inspect for surface defects resulting from manufacturing, cutting, and grinding processes that may impact sample performance during testing. Minor defects, such as small scratches and few voids are identified and their effect on the stiffness was successively studied since they have the potential to evolve into cracks over time. Then, major defects, such as cracks that extend beyond half of the thread region, were reported and acknowledged as compromising the mechanical performance, as they have the potential to propagate and initiate larger cracks.

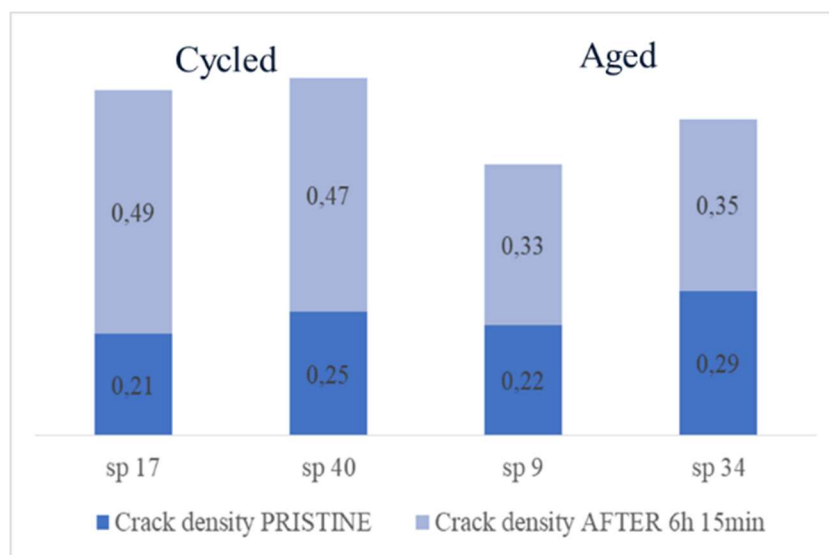
Fig. 10 Comparison crack density before and after 15 cycled and before and after 6h and 15min aging

The same cooling procedure was performed at the end of the aging process after 1000 hours. The graph in Fig.10 below displays the crack density data recorded before and after the 6 hours and 15 minutes aging period, compared with crack density data of the cycled specimens.

It should be noted that also in this case for the aged specimens, the increase in the number of cracks can be attributed more to the opening of pre-existing cracks in the threads rather than the formation of new cracks.

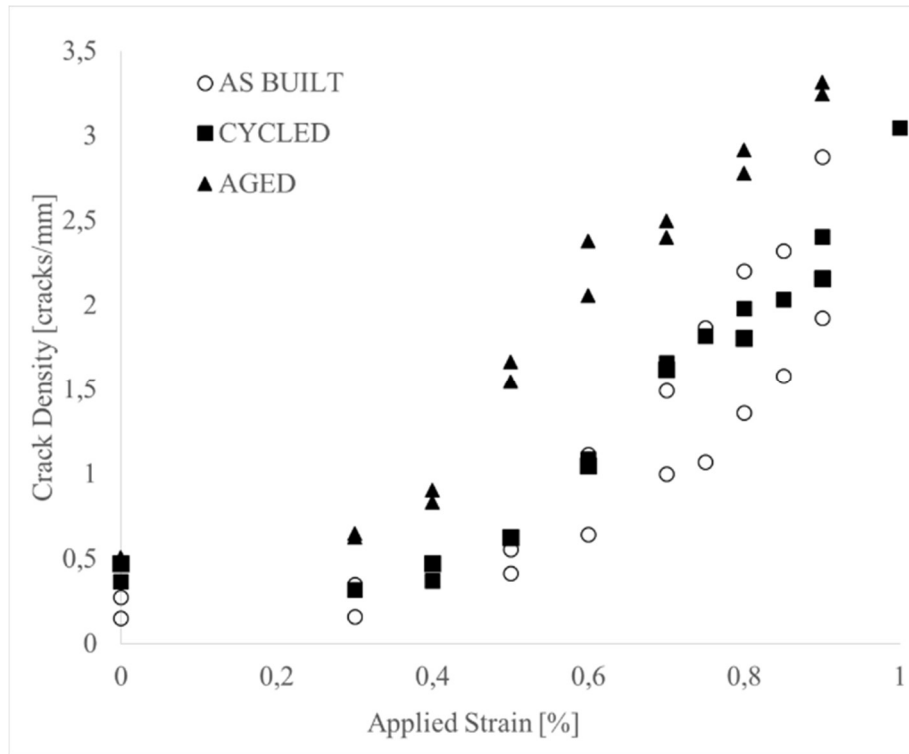
Fig. 12 Crack density evolution vs applied strain during quasi-static tests at room temperature

From Fig.12 it is evident that there are distinct differences among the data points for the as-built, cycled, and aged specimens. Notably, for the same applied mechanical strain, the crack density is slightly higher for the thermally cycled specimen compared to the as-built specimen, and even higher for the aged specimen. This indicates that the previous thermal treatments induced visible damage in the microstructure, resulting in a reduction of mechanical properties and a decrease in cracking resistance.

Moreover, it is evident that the aged specimens exhibit lower mechanical performance in terms of cracking resistance compared to the cycled specimens. This is expected, considering the more significant impact of 1000 hours of exposure at 150 °C compared to the relatively shorter duration of 6 hours and 15 minutes in the thermal cycling treatment; also because 15 cycles are not enough to induce considerable damage.

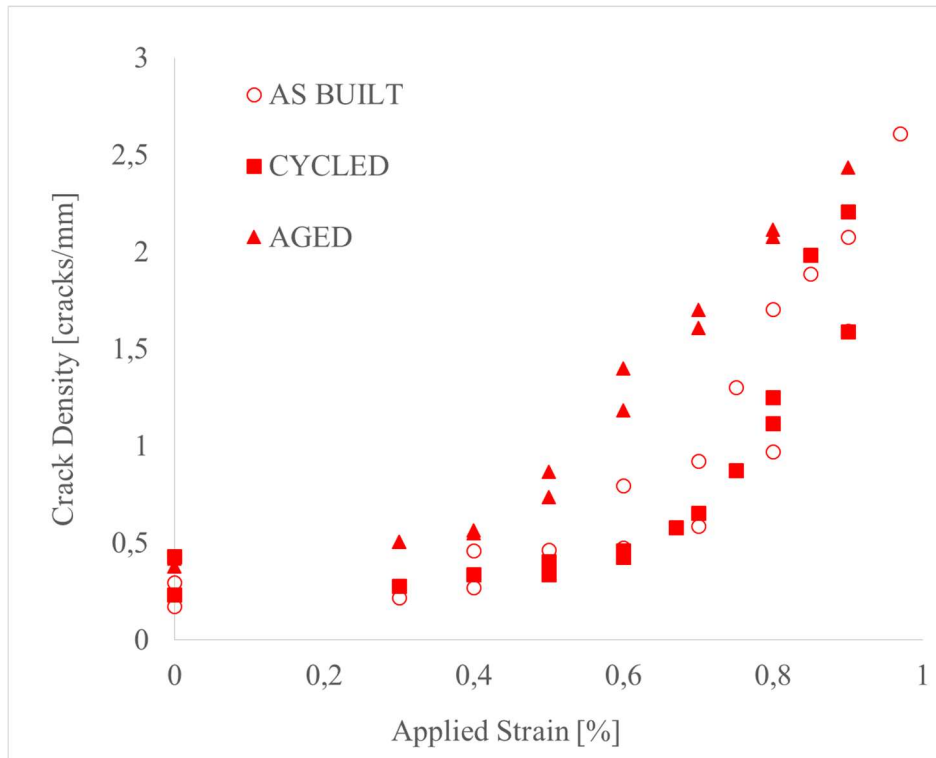
Fig. 16 Crack density evolution vs applied strain during quasi-static tests at elevated temperature (150°C)

The following graphs in Fig.16 illustrate the evolution of crack density as a function of applied mechanical strain during the elevated temperature testing. The graph versus thermo-mechanical transverse stress in 90 layers follows the same trend.

Also in this case the damage consists of cracks originating from the threads and propagating into the bundles, or within the bundles only; delamination occurs around 0.7% as well. As shown in Fig.16, aged specimens display higher damage levels for the same applied mechanical strain, which aligns with previous observations. However, an unexpected result is observed for the cycled specimens in the graph above, where the crack density data points coincide with those of the as-built samples. This is probably due to scatter of data or to errors during the experimental execution of the tests.

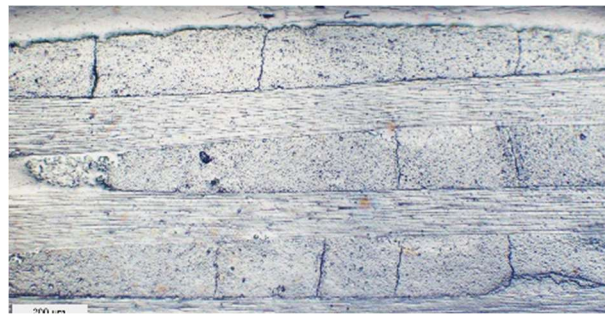
Fig. 17 90 layers cracks in (a) as-built, (b) cycled, (c) aged, after 0.7% strain quasi-static tests at elevated temperature

Below, in Fig.17, are reported comparative pictures captured by optical microscope for a representative portion of each sample type (as-built, cycled and aged) at a strain level of 0.7%. It can be noticed that, as anticipated by the crack density data, the as-built and cycled specimens exhibit a relatively similar damage in terms of number of cracks, whereas the aged specimens display a more pronounced level of damage.

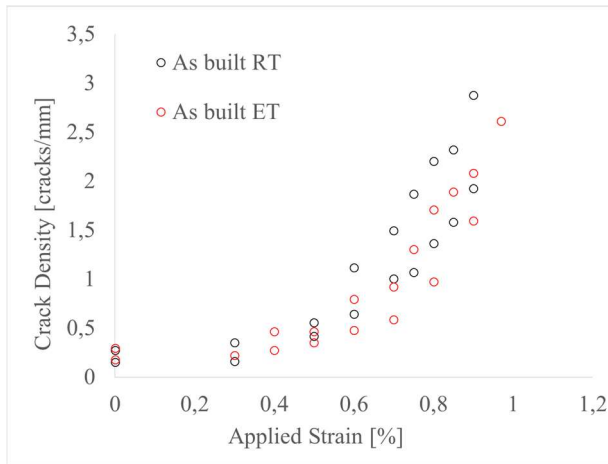
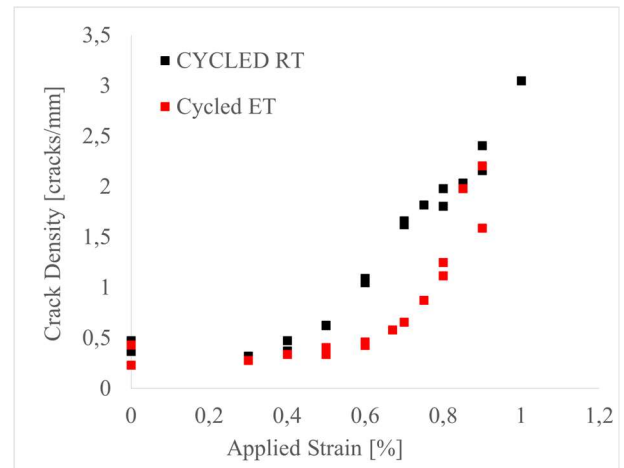
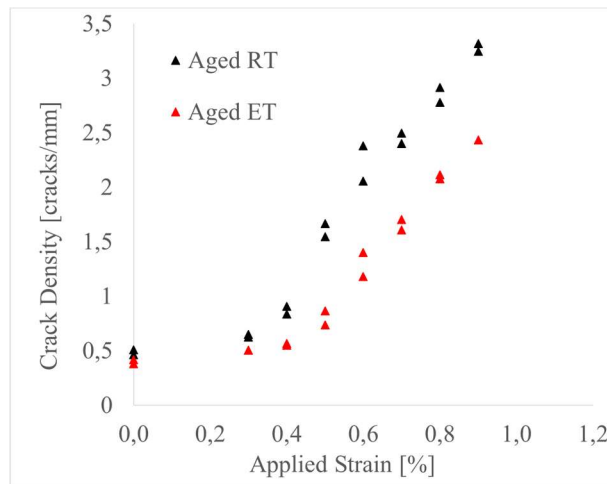
Fig. 18 Crack density vs Applied strain for (a) as-built, (b) cycling, (c) aging.

An important analysis to conduct now is the comparison of crack density, considering both applied mechanical strain and thermo-mechanical transverse stress in 90 layer, between the room temperature and elevated temperature tests. Intuitively, a higher damage level was expected in elevated temperature tests; however it was observed the opposite, like shown in the following graphs (Fig.18) of crack density versus applied mechanical strain, for as-built, cycling and aging. In the pictures, the black data-points are referred to quasi-static tests at room temperature and the red data-points to elevated temperature (150°C).

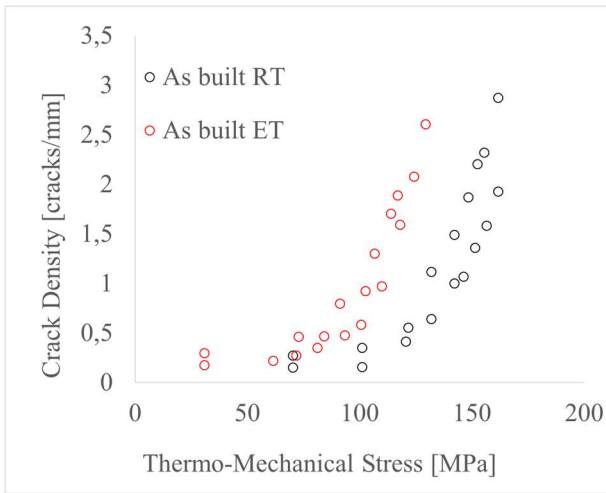
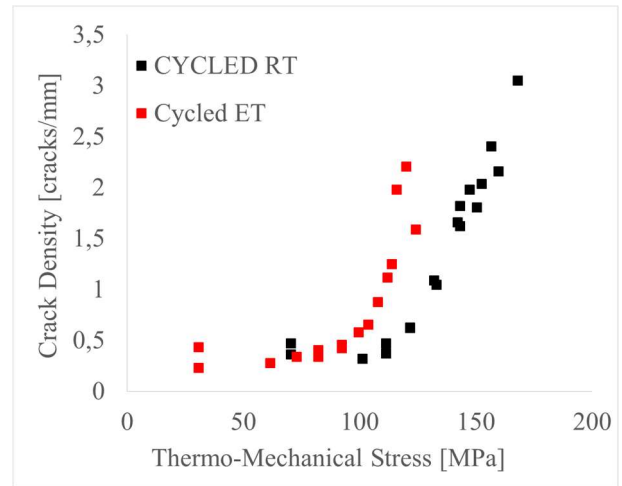
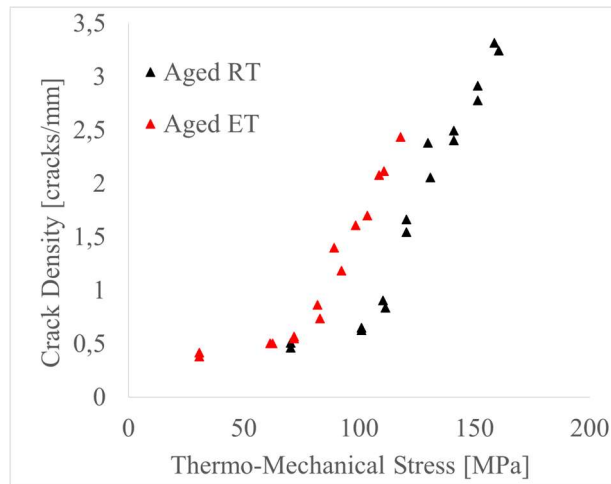
Fig. 20 Crack density vs Thermo-mechanical transverse stress in 90 layers, for (a) as-built, (b) cycling, (c) aging.

Comparison between room (black) and elevated temperature (red)

Moreover, it can be assumed that when the temperature increases the matrix is subjected to a softening process which degrades the interface bonding strength between the fibers and the matrix, resulting in a significant reduction of the load transfer capacity that the fibers provide to the matrix. Consequently, at 150°C the initial structure of the composite lose rigidity, leading to higher crack density for the same applied thermo-mechanical transverse stress respect to the room temperature ^[11].

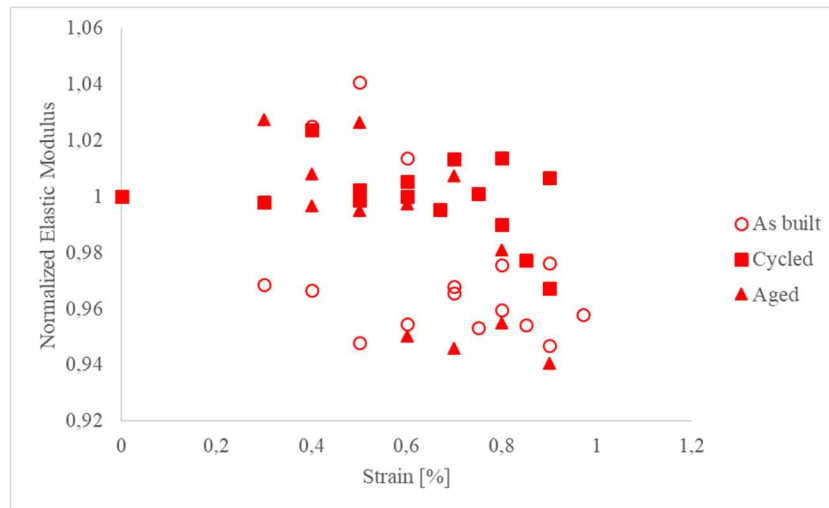
Fig. 21 Normalized elastic modulus evolution versus applied strain during quasi-static tests at elevated temperature

The following graph (Fig.21) shows the elastic modulus evolution during the quasi-static tests. As it was noticed before, there is some fluctuation in the values, probably due to misalignment of the sample position or the extensometer. However, an overall reduction in the elastic modulus from the initial (before the quasi-static tests) to the final value (after 0.9% strain) can be observed.

Unexpectedly, Fig.21 reveals a higher reduction in the elastic modulus for the as-built specimens compared to the treated ones. Specifically, the percentage decrement from before and after the quasi-static tests is 5.7% for the as-built specimens, while it is 4.3% and 4.9% for the cycled and aged specimens, respectively. This discrepancy may be attributed again to the misalignment of the extensometer or the behavior of the extensometer itself after exposure to 150 °C. It is possible that the extensometer is not well calibrated immediately after the tests at elevated temperature, as it may still be cooling down.

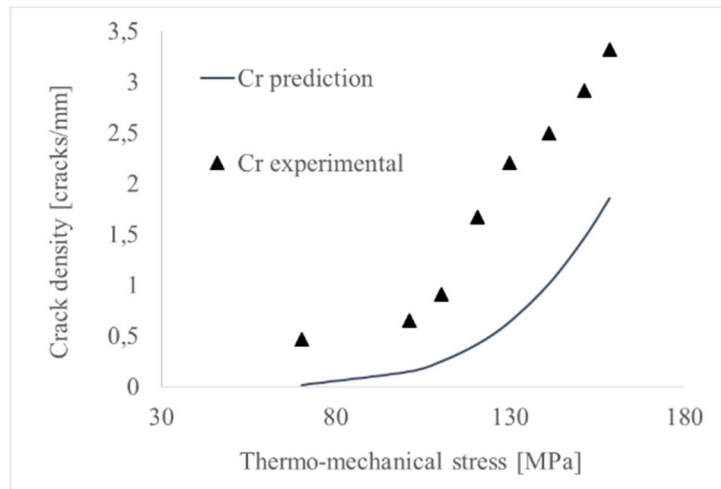
Fig. 23 Comparison between experimental crack density of an aged sample (dots) and predicted crack density (line) using Weibull parameters obtained from as-built room T

aged specimen, the line represents the crack density prediction using the Weibull parameters from as-built material tested at room temperature.

It is immediately evident that using only the Weibull parameters from the as-built room temperature sample without any correction yields inaccurate predictions of the crack density, significantly underestimating the crack density of the aged sample. It is obvious that the model requires adaptation to be applicable to other cases, including as-built specimens tested at elevated temperatures, cycled and aged specimens, both at room and elevated temperatures. Specifically, the correction for the scale parameter σ_0 was made, while keeping the shape parameter m fixed. For each thermo-mechanical transverse stress level, the scale parameter in the probability of failure prediction equation was multiplied by a corrective factor k in order to align the prediction curve with each experimental data-point. The individual corrective factors for each strain level were then averaged to obtain a single factor K that, when multiplied by the scale parameter in the equation, ensures a good fit with the experimental data.

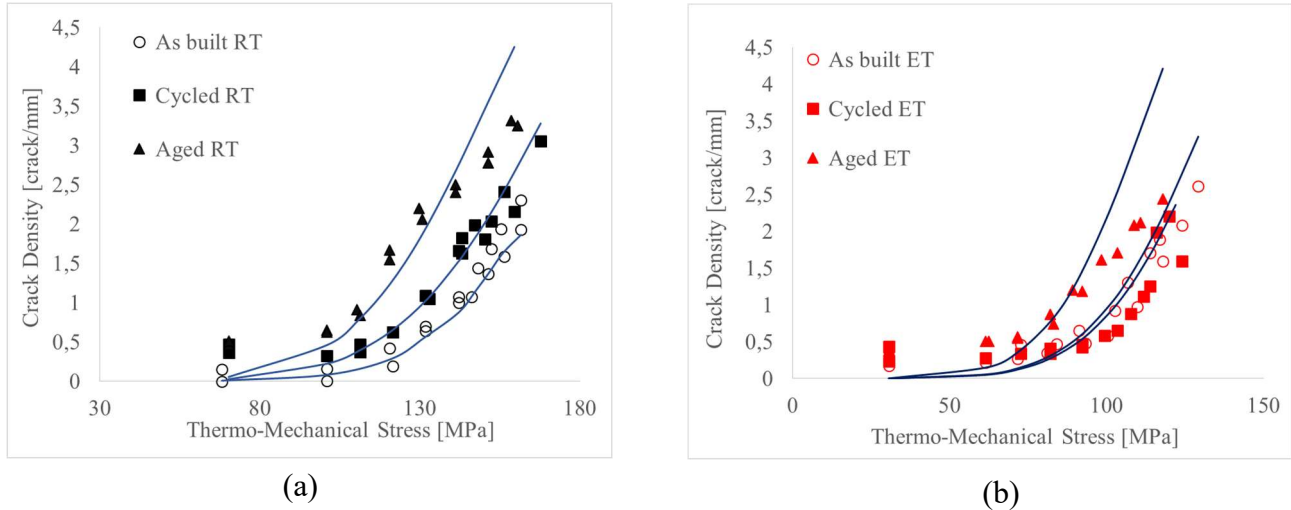
Fig. 24 Fitting of crack density prediction through Weibull model (lines) of experimental crack density (points). For **(a)** room temperature and **(b)** elevated temperature

The following graphs shows a comparison between the experimental crack density data-points and the predicted crack density (line).
