UNIVERSITA' DEGLI STUDI DI PADOVA  
DIPARTIMENTO DI INGEGNERIA INDUSTRIALE  
CORSO DI LAUREA IN INGEGNERIA DEI MATERIALI

*Tesi di laurea*

***LATE FATIGUE DAMAGE DEVELOPMENT IN  
A 3D WOVEN E-GLASS/EPOXY COMPOSITE***

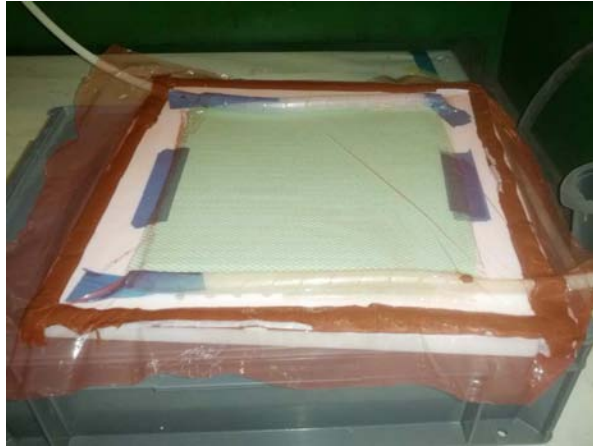
*Fig. 3.1: VARTM laminating process lay-up*

The VARTM process involved several steps. The first step is the preparation of the mold: a fabric perform (cut to dimension 150 mm x 150 mm) is positioned onto a mold, then the fabric was covered with a top release fabric (so called peel ply). A peel sheet ply (cut to dimensions of 150mm x 150 mm) allows for easy removal of the composite laminate after fabrication from the vacuum bag. This is a porous release material which facilitates the resin flow through and leaves an impression on the part suitable for secondary bonding without further surface preparation. The distribution medium is mesh laid on top of the top release fabric. This helps to maintain an even distribution of resin on the top of the fabric and also facilitates the flow of resin through the thickness of the laminate.

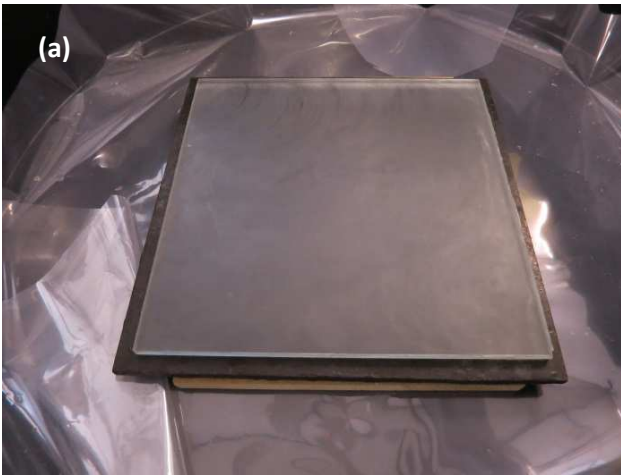
*Fig. 3.6a: Glass plate covered with wax;*

The following step is the preparation of the vacuum chamber and both of the glass plates. Before introducing the frame (with the fabric) inside the vacuum chamber, a pre-heated (140 °C) steel plate has been positioned on the bottom of the chamber in order to create a temperature difference with the purpose of improve the wetting. A glass plate (fig. 3.6a) was positioned on top of the pre-heated steel plate: this glass plate was covered covered with a layer of wax in order to prevent the adhesion of the glass to the silicon coated release film (which is the bottom of the frame). Once the frame was positioned on top of the glass plate, the resin has been poured manually taking care of the homogeneous distribution all over the fabric (fig. 3.6b) . The chamber (fig. 3.7a) was sealed and the cloth with the resin was vacuumed at -1 bar for 2 hours. Such a long time is required because of the particular architecture of the fabric: in 2D composites air has preferential directions to escape from the fabric while in 3D woven cloth there is not a preferential way for the air to exit.

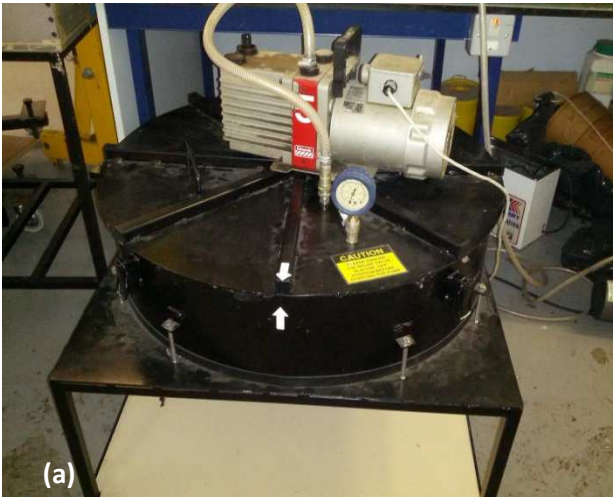
*Fig. 3.7a: Vacuum chamber;*

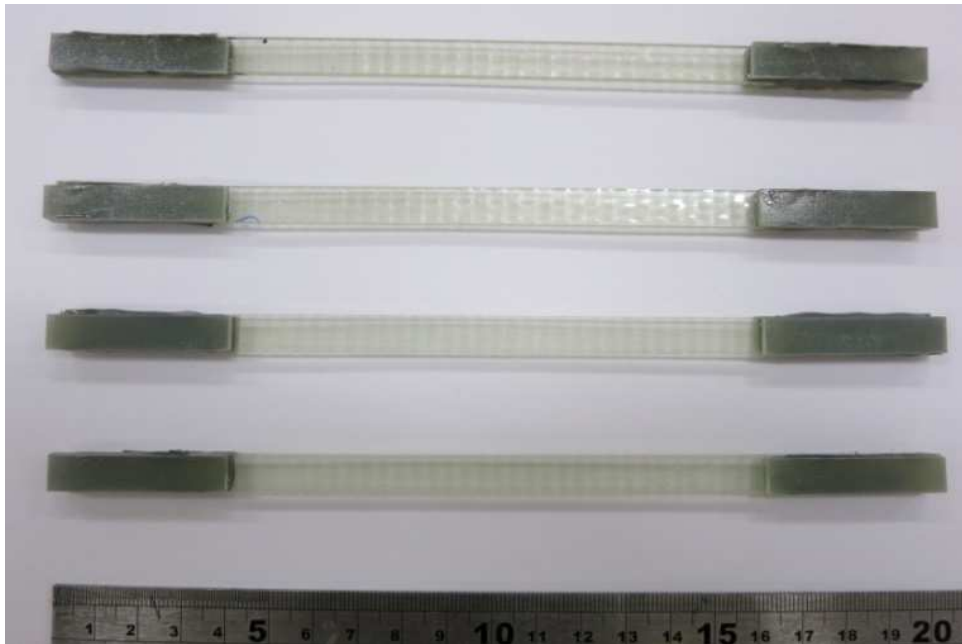
The aim of this project was to investigate the damage development of this composite material during its fatigue life. For this reason X-ray micro computed tomography has been used to observe the internal damage. The micro-CT technique needs specimens with smaller dimensions than 200 mm x 25 mm x 2,2 mm because the optimal image resolution is achievable only if the thickness and the width of the sample are close to each other. An optimal ratio between width and thickness guarantee the same penetration on the X-rays in both directions for a better image quality. For this reason, thinner samples of dimension 200 mm x 8 mm x 2,2 mm were also cut. (fig 3.12)

*Fig. 3.12: Specimens of dimension 200 mm x 8mm end-tabbed*

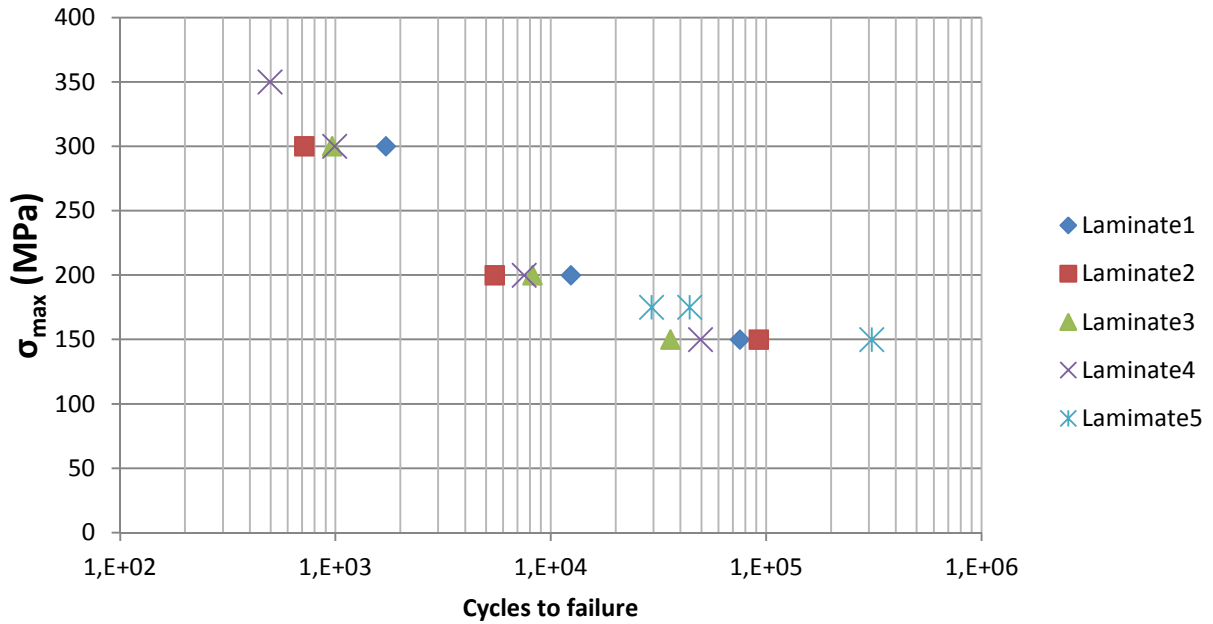
Fig. 4.3: S-N curve for specimens manufactured with VARTM technique

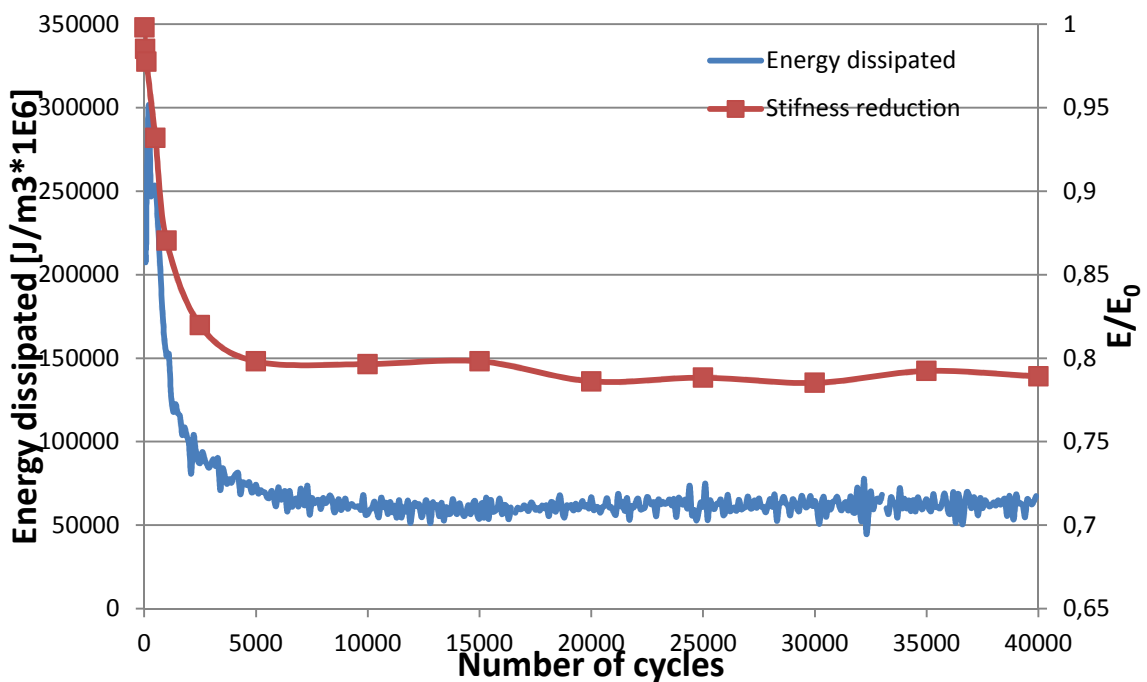
Fig 4.12 Direct comparison between stiffness reduction and hysteresis loops

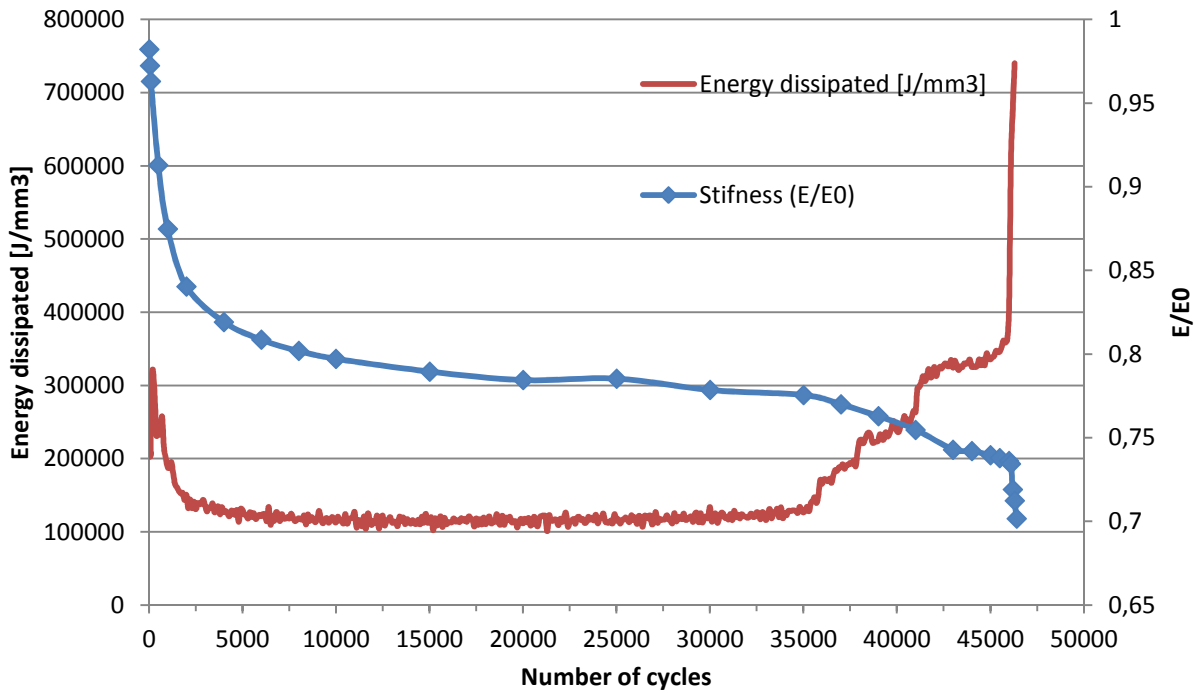
Fig 4.15 Direct comparison of hysteresis loop and stiffness reduction

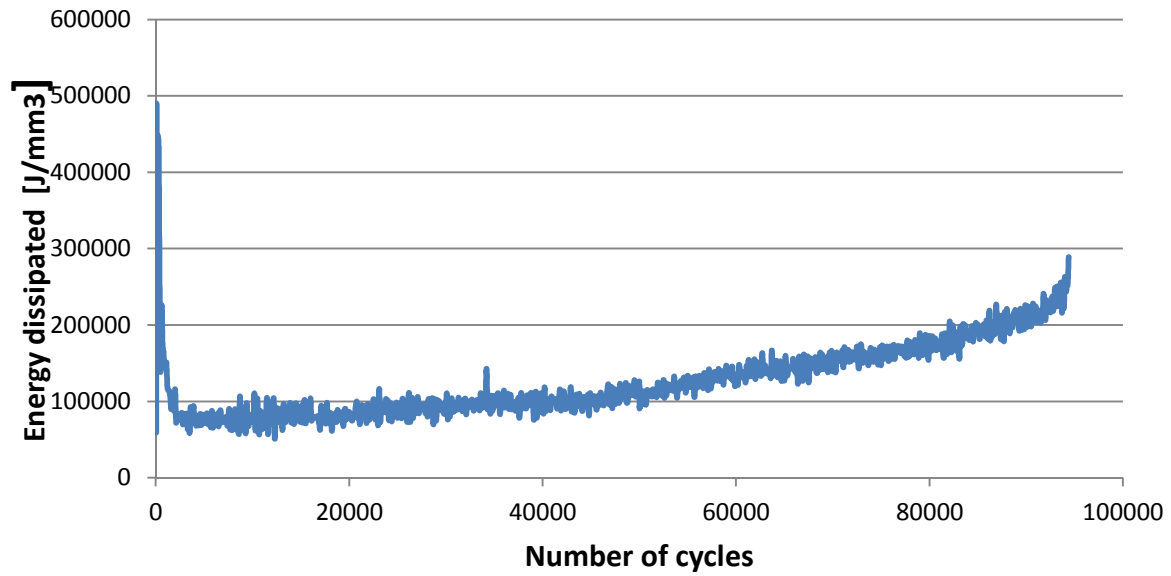
Fig 4.21 shows the trend of the hysteresis loop for specimen B. This was stopped at 94500 cycles using the value of the area included within the hysteresis loop for evaluating the level of damage introduced inside the specimen; it appears from the graph that this is beginning to rise rapidly. Taking sample 3 and 4 as a reference, it was observed that a level of 300000 J/mm<sup>3</sup> of energy dissipated in the hysteresis loop was a reasonable assessment that failure would occur within the next two-three hundred cycles so it was decided to stop the test at that value.

Fig 4.21 Hysteresis loop vs cycles. Frequency 5Hz specimen B

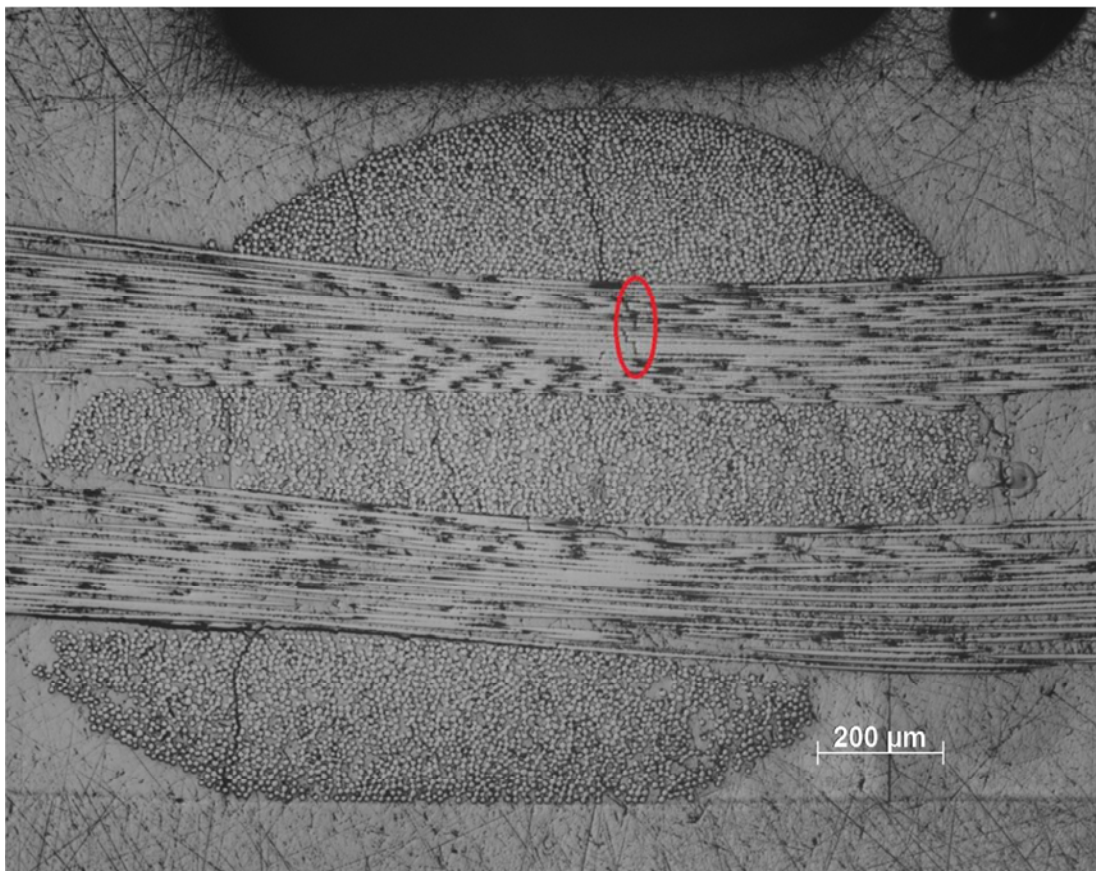
*Figure 5.21 Fiber fracture in the warp tow*
