University of Padua

Master Thesis

PERFORMANCE OF TEXTURED INSULATORS FOR OVERHEAD LINES AND SUBSTATIONS UNDER POLLUTED CONDITIONS

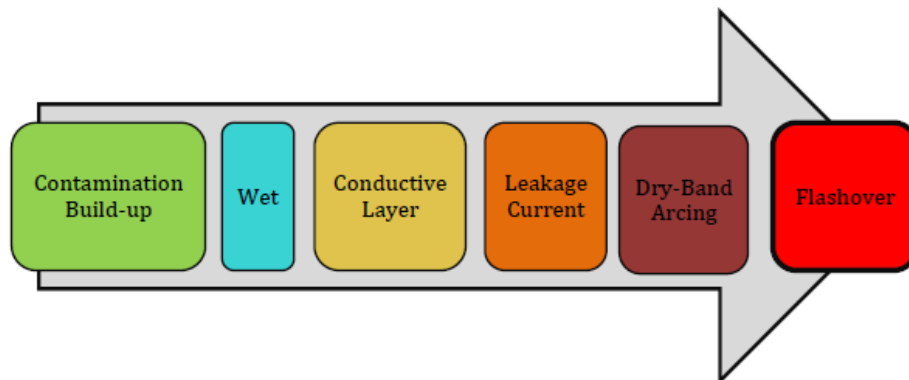
If the conditions for the dry-band are sustained with considerable levels, the ultimate effect of dry-band arcing on the material surface is tracking and erosion, and a decrease of the number of LMW that impart hydrophobicity to the polymer, potentially leading to failure and flashover [213], flashovers occur in wet weather conditions, occurring in step sequences as shown in figure 1.6.

Figure 1.6: flashover mechanism on high voltage insulators

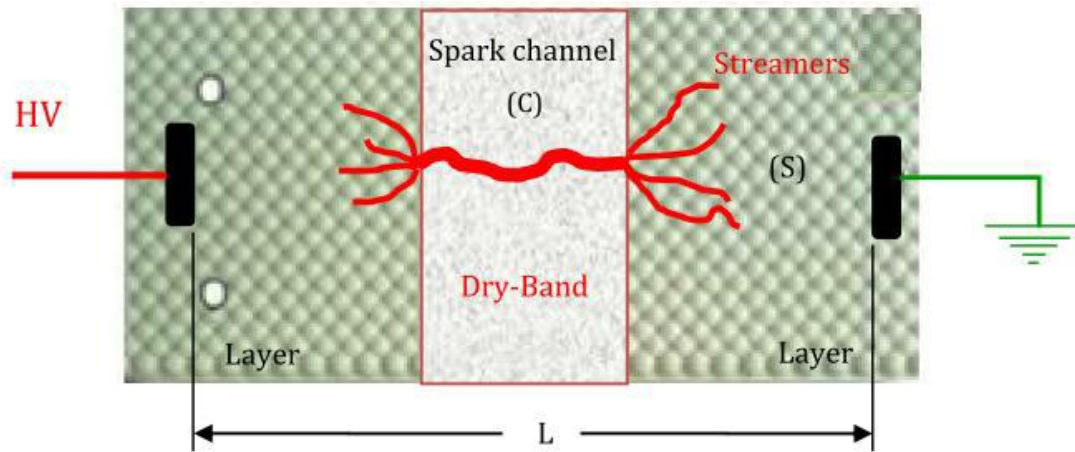
In [19], the authors proposed dry-band discharge modelling called a spark-model as shown in Figure 1.7. This model has been suggested on the premise of that the conductivity of the spark leader is maintained by impact ionisation that occurs at low temperatures, instead of thermal ionisation observed for arc channels at high temperatures. The spark leader channel of length C spans the dry-band. The dry-band might become larger as streamers of combined length S sprouting out the spark leader can penetrate the dry-band [20].

Figure 1.7: the dry-band spark model

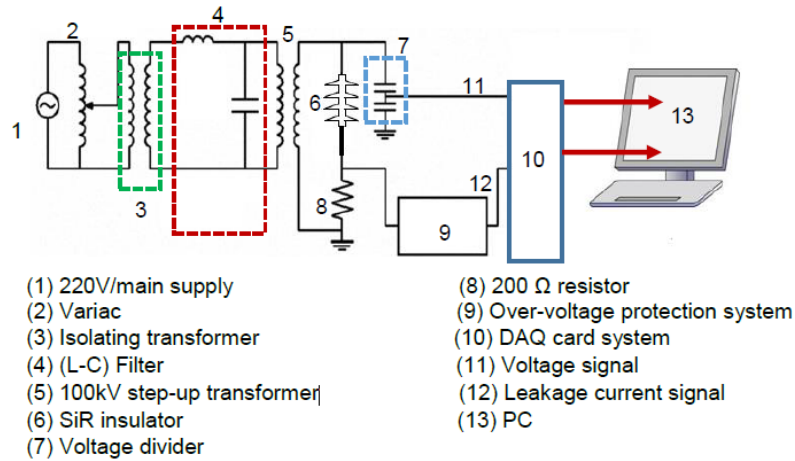
consisted respectively of a voltage divider with a ratio of 3750:1 and a 200 [Ω] shunt resistor for current measurement. The voltage and current signals were acquired using a computerized data acquisition system. For this purpose, a data acquisition (DAQ) card (MIO-16E series) was used, and its input was protected using a three-stage overvoltage protection system.

Figure 1.10: Circuit diagram of RWDT.

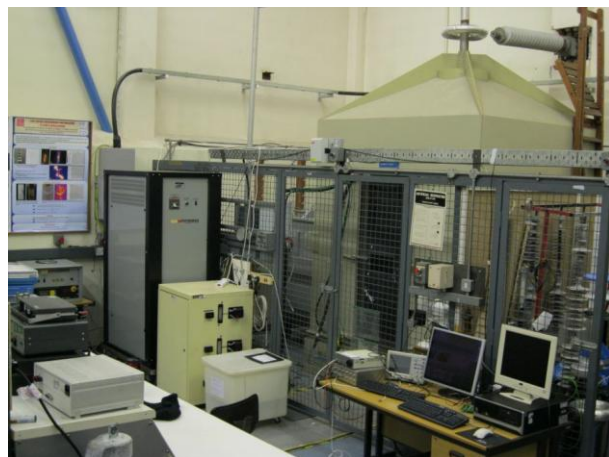
The high voltage supply enters the fog chamber from the chamber ceiling. A vertical aluminium tube with stress rings at both ends, serves as the high voltage conductor. Different types of insulator terminals (cap, pigtail) can be mounted by using the appropriate mounting extension. The test sample is earthed by connecting the lower terminal at the earthed mesh. Measurement coaxial cables also have access through the lower side of the chamber walls.

Figure 1.12: schematic layout of Cardiff University fog chamber (left), test set-up of fog chamber tester (Cardiff University High Voltage Laboratory) (right).

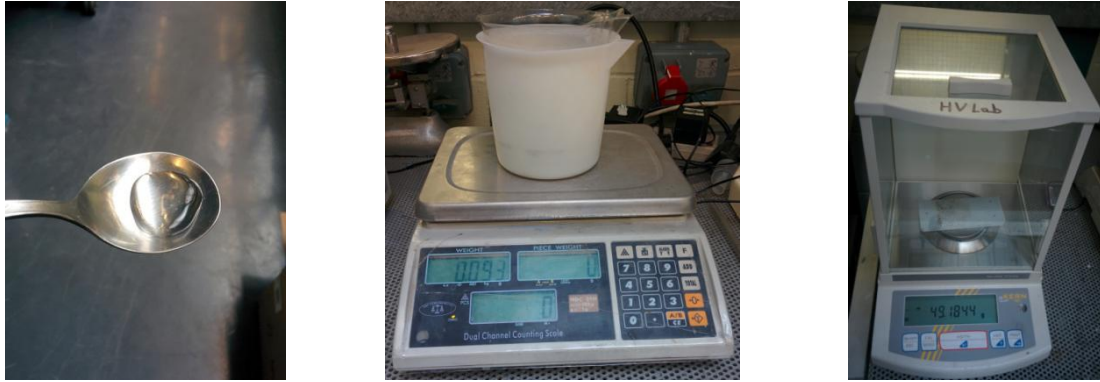
Figure 2.6: a) spoon, b) normal scale, c) precision scale

The sample preparation process for silicone rubber and catalyst was carried out using a precision digital balance scale (KERN ABJ 320-4 that operates to maximum capacity of 320 [g] with readability of 0,1 [mg]), two iron spoons and various laboratory glasses for weighing and mixing the two materials.

The first image is reported just for curiosity: from it the silicone rubber property of hydrophobicity can be noted, in fact the spoon has been used to manipulate the rubber for the weighing and its surface was still impregnated with the material. It can be noticed a contact angle greater than 90° .

To weigh the components a scale with the sensibility of 1 [g] was used (figure 2.6b).

The measurement of the flow rate was possible thanks to the same precision scale used to weigh the silicone rubber (figure 2.6c) which has a sensibility of 0,0001 [g].

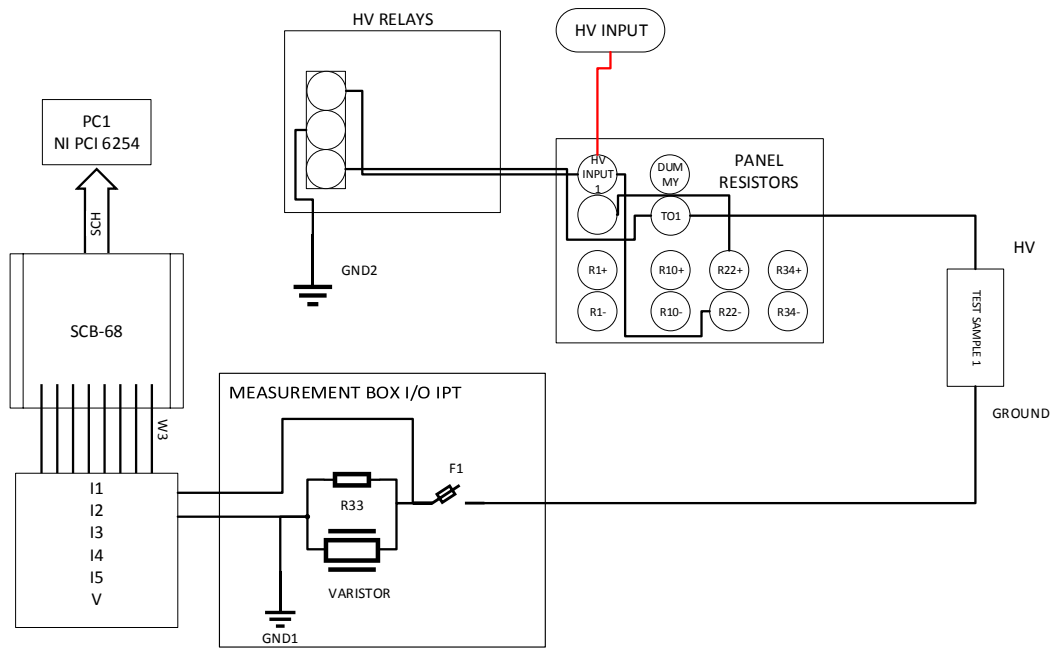
More precisely the internal connections of the accelerated ageing unit can be represented in the following scheme:

Figure 3.8: internal connections of the IPT ageing unit.

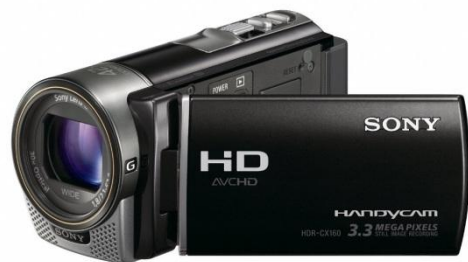
Figura 3.14: Sony handycam

A Sony Handycam has been used to have a visual record during the tests. It was mounted on a tripod and placed outside the machine monitoring the insulators through the rectangular opening of the IPT frontal door.

The data were stored in a memory card inside the camera, avoiding a physical connection with a PC during the test. The quality of the images were good enough to allow a satisfactory view of the physical phenomena of discharge.

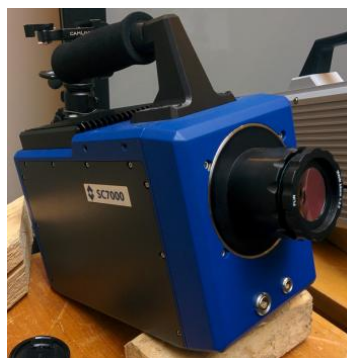
Figure 3.15: FLIR infrared camera

The scope was mapping the thermal stress on the specimen surfaces during the IPT test and detect the formation and development of dry-bands and subsequent spark discharge activities.

The camera detector was a Indium Antimonide (InSb) type with a spectral range 1.5 – 5.1 [μm] with an infrared resolution of 640x512 [pixels]. The maximum imaging frequency was increased if we used the windowing function.

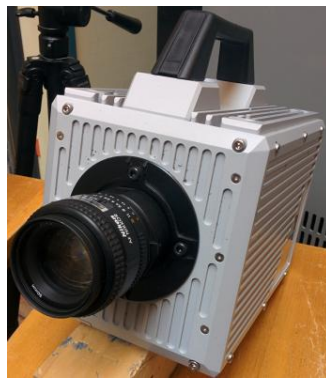
Figure 3.17: ultra high-speed camera

The camera in figure 3.17, as for the infrared SC7000 operated in parallel, was available in the “Morgan-Botti Lightning Laboratory” at Cardiff University, hence it has been borrowed to perform the test when it was not used for lightning tests.

The high performance permits the SA5 model [33] to be applied to areas of research once dismissed as unsuitable for digital high-speed imaging.

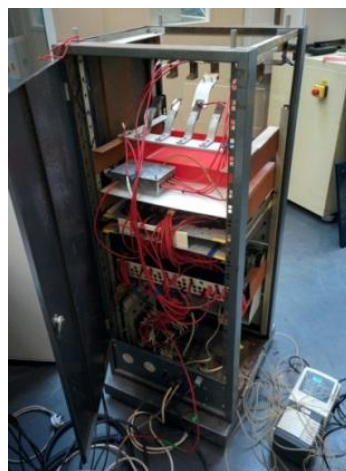
Figure 3.19: the IPT ageing unit.

The inclined plane station has been built with consideration of user safety during testing as well as protection of test equipment and samples. An interlock safety system interrupts power supply in the event of the cage door being opened during the test. A modified test station door has been made of transparent PVC allowing monitoring of the test sample using visual, infrared and fast cameras. The top of the test facility has open holes providing ventilation for smoke resulting from the material erosion. Once a steady flow of the contaminant is established on the test surface, the high voltage is supplied to the sample. All the components have been checked and substituted where necessary considering the long inactivity time of the ageing unit. Some of the power resistors were completely replaced, as well as several high voltage cables, the insulation between the shield and the active parts has been restored. A black epoxy potting compound was put on the power resistors. It protected against moisture and corrosion and improved insulation resistance and mechanical strength. Furthermore the peristaltic pump has been extracted from the shell and kept outside to enhance the operations security avoiding dangerous contacts between electricity and liquid (figure 3.19). The internal control constituted by the variovac autotransformer has been bypassed modifying the original circuit, becoming controllable by the LabVIEW software. The protection box and the scb-68 block were in good conditions, so they have been just checked and recalibrated.

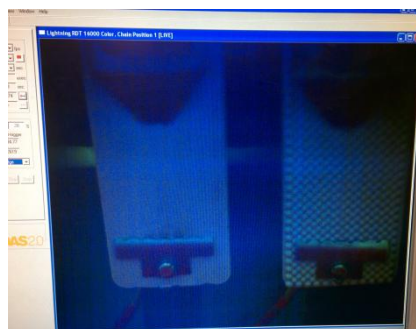
Figure 4.2: Nikon high-speed camera software imaging

The figure 4.2 shows the visualization through the software interface, used to capture the leakage current in the material.

The poor quality pointed out before could be addressed to the fact that increasing the frame rate the portion visualized in the window is smaller and the resolution becomes lower. In consideration of this the new Photron SA5 camera has been adopted for

The old camera image showed in figure 4.2 was unsuitable for the scope of this work because the resolution was too low for looking at the arc movements around the protuberances of the SiR material because it was affected from the sunlight which in the laboratory couldn't be avoided.

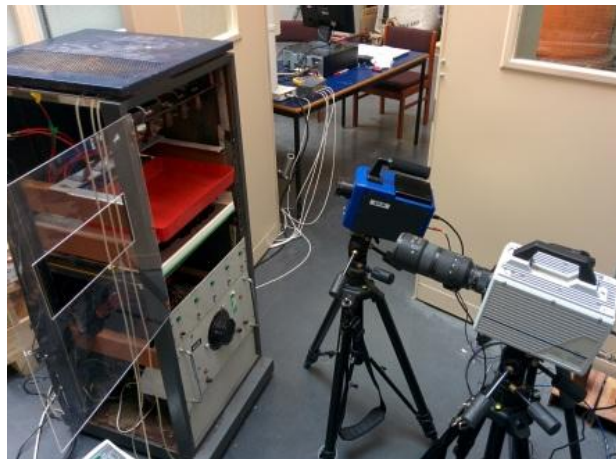
Figure 4.3: cameras installation for the test setup

For test A, the first of the two performed during the day, a conventional specimen with a flat surface and a 4[mm] square arrangements one in parallel have been used. Two bays and the relative channels for the acquisition have been used. The cameras were positioned in front of the IPT ageing unit inside the cage (figure 4.3). Since it was the first time three cameras at the same time have been used to carry out this experiment and the opening in the PVC front barrier of the unit didn't allow a good arrangement of them, it has been kept opened during the test. The cables for the image acquisitions were conducted under the door with the interlock system activated.

All the metal parts of the devices used during the experiment have been grounded.

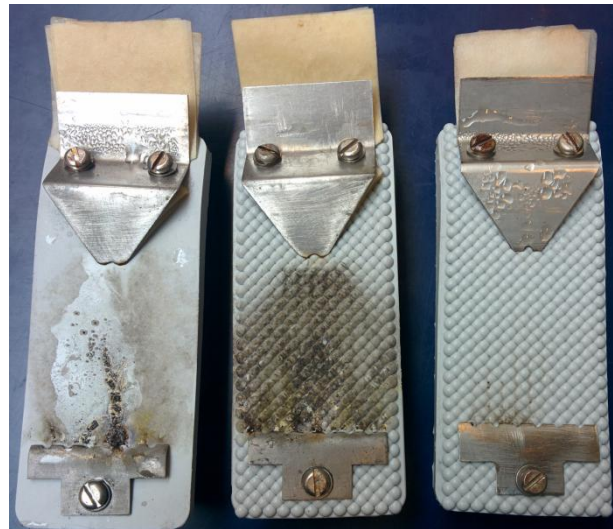
Figure 4.9: tested samples

The picture of the three test sample soon after the experiment is reported in figure 4.9. The photo has been taken before washing and cleaning the surfaces. The left one is the conventional and it can be seen that the central part is eroded by the AC current, in particular a deep cavity is scraped from the surface close to the central part of the lower electrode.

The last specimen (textured 4[mm], test B) has been used only to allow other camera recordings, so the limited time range of voltage application can't permit a blackish formation, but from this observation can be extracted something as well. In fact it has been verified that the first tracking on a rectangular specimen is developed close to the lower electrode, where the contaminant is concentrating.

In general a different involvement of the surfaces is verified. While for the flat sample the current tends to follow the contaminant flow directly from one electrode to the other in central position, the textured ensured a more homogeneous exploitation of the total surface. This brought to a smaller concentrated erosion, scraping less material from the outer surface.

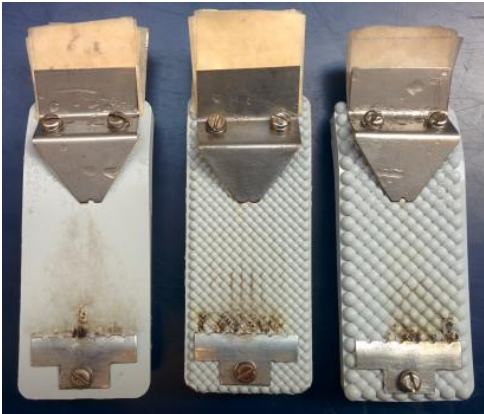
Figure 4.23: specimens conditions after test, 6th June

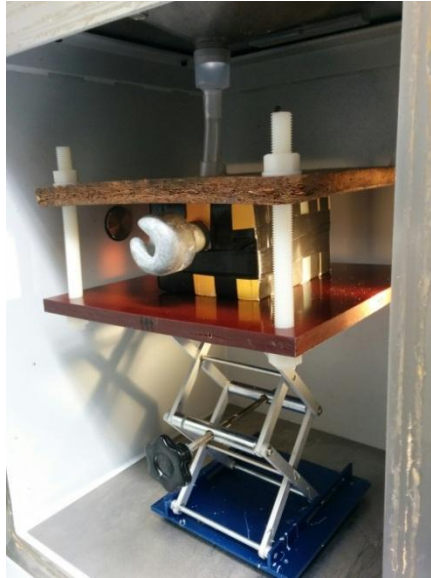
Figure 6.6: fixing of the silicone mould

Another attempt with the same mould has been done. 150 [g] of 600A and 16,67 [g] of 600B materials have been adopted. This time the mould was closed and strongly pressed to guarantee a good fixing and prevent a material flow from the splits which would be eliminated (figure 6.6).

The material flow from the bigger hole where the core was inserted was not totally eliminated, but the amount of silicone rubber flowed out was limited. The silicone mould was put in the oven at 50^o Celsius for 8 hours and which was left another day to rest. After this time it was opened and the cylinder was gently removed from the housing with the help of the scalpel. The result was a good textured cylinder insulator (figure 6.7) ready to be tested in the fog chamber and analysed with the infrared and the high speed cameras.
