UNIVERSITÀ DEGLI STUDI DI PADOVA

SEISMIC VULNERABILITY ASSESSMENT OF CLUSTERED BUILDINGS IN THE HISTORICAL CENTER OF TIMISOARA: FRAGILITY CURVES FOR IN-PLANE LOCAL MECHANISMS OF COLLAPSE

LAUREANDA: CLAUDIA VALOTTO

ANNO ACCADEMICO 2014 / 2015

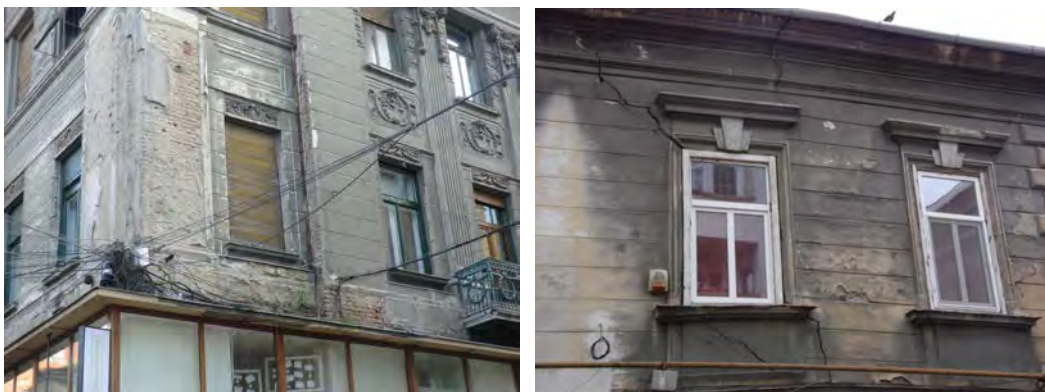
The majority of buildings is in good condition or with widespread damage on non-structural elements, but there are anyway many buildings in bad condition or with very serious damage. In these constructions the damage of plasters, coverings, tiles and chimneys is quite spread, but also in few cases very deep cracks and evident structural subsidence interest the construction. Even if the building from the outside seems in good conditions, it is not sure that has the same characteristics inside. It is very common indeed to restore just the outer part of the façade and leave the inner parts as they were.

Fig. 1.8.8: Non-structural and structural damage (US 133 and US 71)
