Université de Liège – Università degli Studi di Padova

**Room temperature wear behavior of laser clad
316L+WC composite coating**

Final Year Project

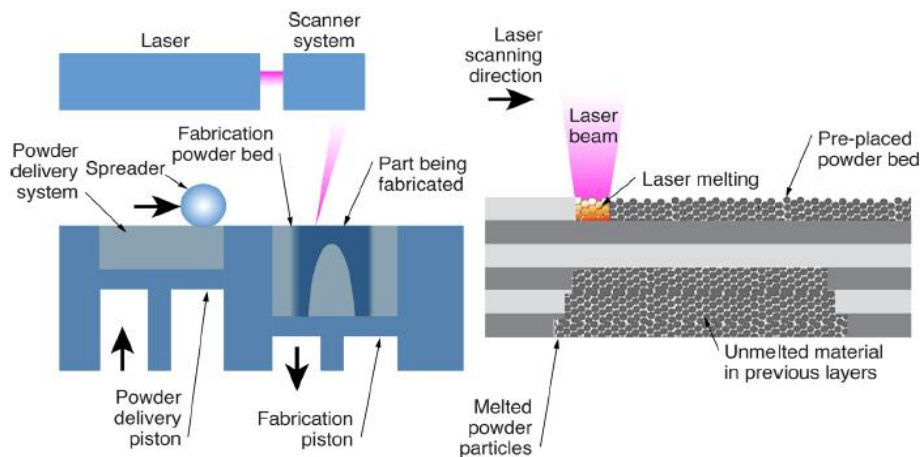
- **Powder bed system:** a thin layer of powder is spread by a coater. Then it is scanned by the energy source (laser or electron beam) that melts or sinters the powder in the desired shape controlled by the CAD file (STL). During the second step, the working plate is lowered, another powder layer is spread by the coater and the energy source scans the new deposited powder. The process is repeated until the object, designed with the CAD software, is created. The advantages of this technique are the high resolution, the capability to produce complex lattices and the large range of material.

Figure 2-2: Schematic illustration of a powder bed AM system [9]

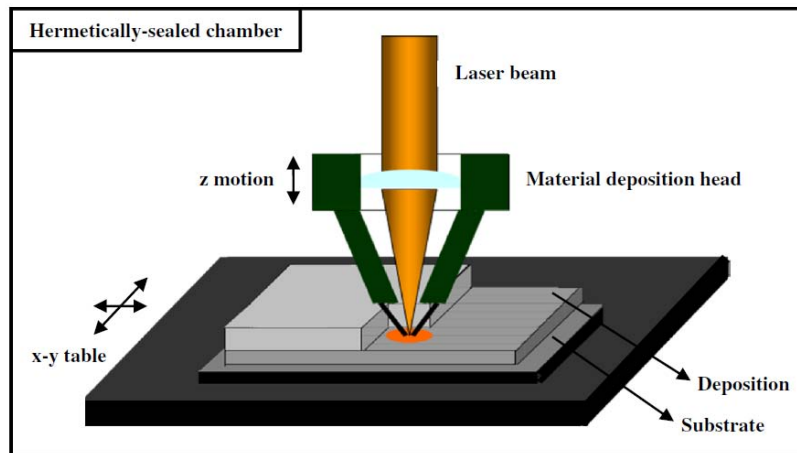
- *Powder feed system:* in this technique the powder is fed in a nozzle and deposited on the build surface. At the same time, a laser provides heat to melt the powder. These systems are especially used to repair worn or damaged parts. The main advantage of this manufacturing process is the use of many materials. This can be obtained through the additional feeding of a different types of powder. Other two advantages are the possibility to build a large volume and a gain a good control of the quantity of the material that is deposited.

Figure 2-3: Schematic illustration of a powder feed AM system [2]

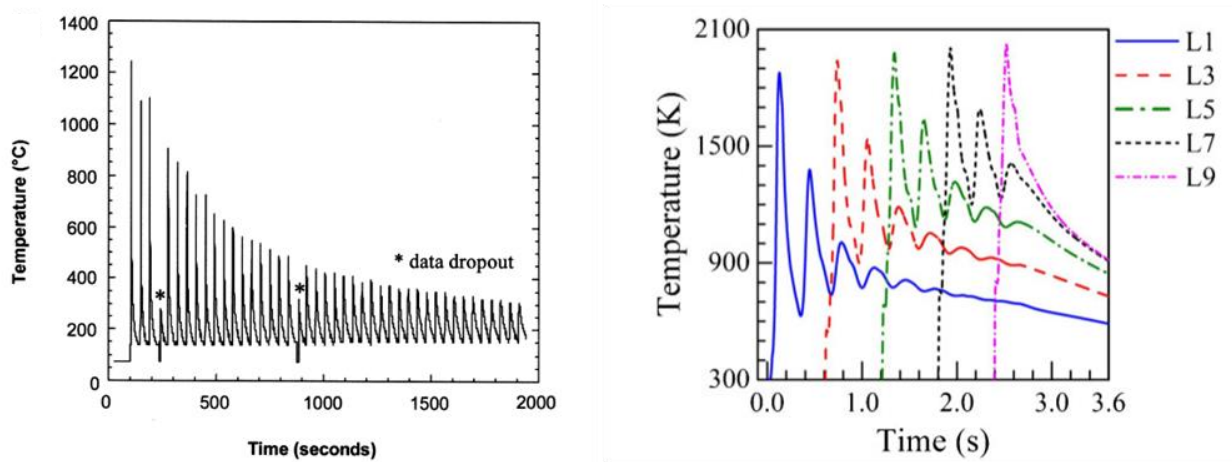
The laser processes are characterized by high temperatures and high cooling rates. These two features lead to a refined microstructure in comparison to the traditional fabrication methods. As a consequence, the mechanical properties are usually enhanced as well as said in section 2.1[5–7]. The complex thermal history of the material subjected to the Laser Cladding process was analysed by M.L. Griffith et al., showing the relative thermal cycle [39].

Figure 2-9: Thermal history of additive manufacturing processes [39,40]

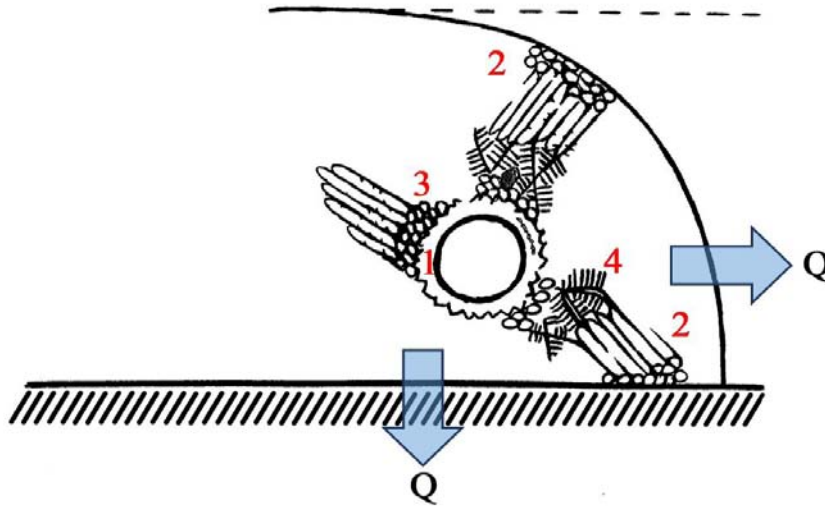
The addition of the tungsten carbides during the fabrication by LC changes the chemical composition of the 316L stainless steel. Indeed, a percentage of every carbide is dissolved by the contact between the original WC powders and the liquid metal, enriching the composition of the original 316L. This phenomenon leads to the solidification of a new metal matrix composite (MMC), around partially dissolved WC. In addition to the classical solidification from the melt pool sides, during the track solidification the remaining and partially dissolved WC act as nuclei for the solidification [16].

Figure 2-13: Schematic representation of the 316L+WC solidification [16].

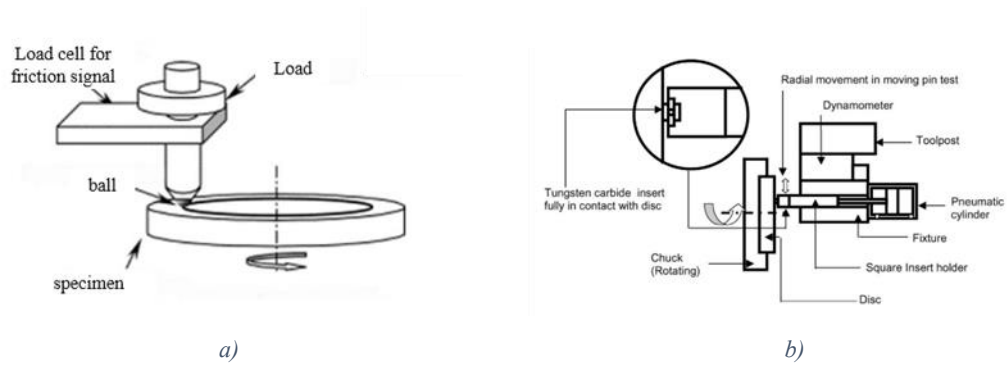
L.J. Yang et al. [69] utilized a different configuration of the Pin-on-disk machine. They used as a pin the material that they wanted to test, and three different disks of different materials are utilized.

Figure 2-19: a) Schematic illustration of classic Pin-on-disk tester [62]. b) Schematic illustration of the “reverse” Pin-on-disk tester [69].

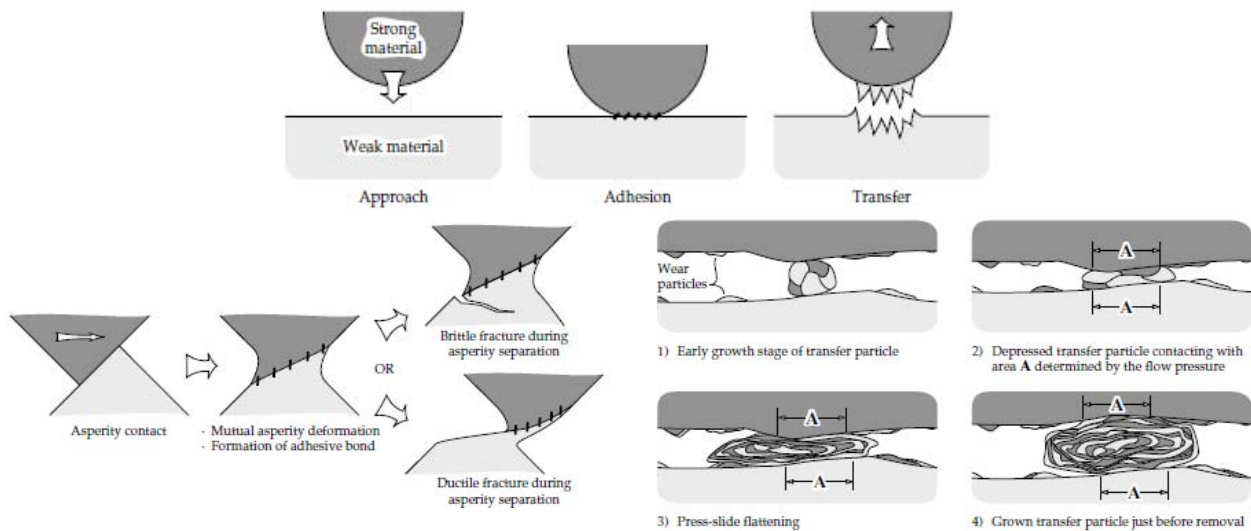
Adhesion occurs when two solids are in contact and the relative surfaces are completely free of contaminations. Passive films, oxidation, lubricants and adsorbed gases reduce the adhesion between the two surfaces. This decreasing is due to the creation of a shield provided by these contaminations that decreases the real contact area. The adhesive mechanism is the electron transfer between the two materials and consequentially formation of adhesive bonds [81].

Figure 2-26 Schematic illustration of the adhesive wear process. Bond formation, alternative model for the adhesive contact, possible mechanism of wear debris formation due to adhesive wear [81].

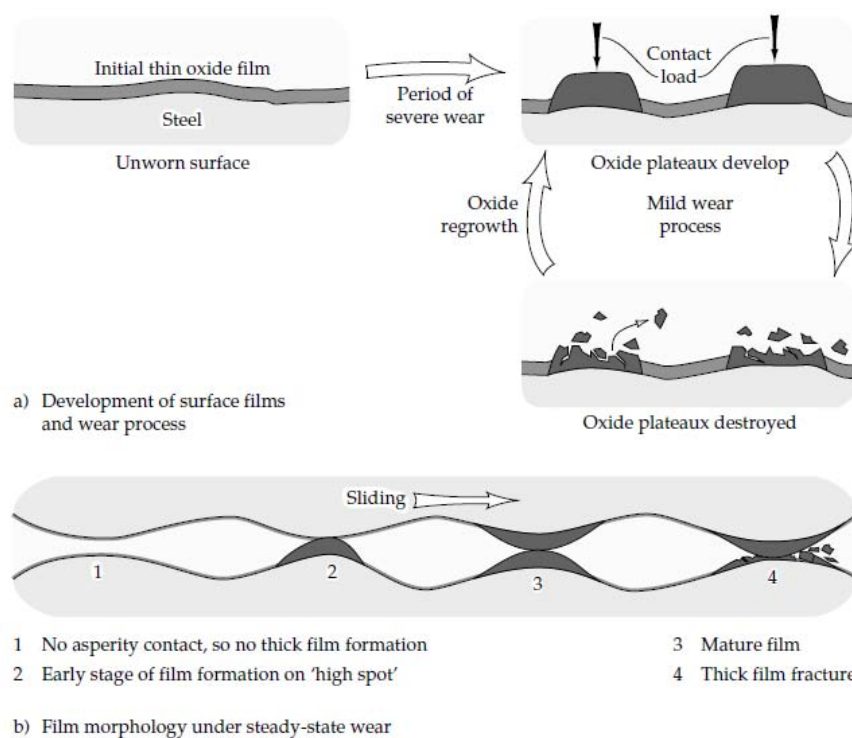
At high sliding speeds, a severe wear occurs, and it eliminates the native oxide film. Afterwards, there is a period of mild wear and re-growth of the oxide layer. Frictional heating could be so high that thick oxide films are rapidly generated. Since only sliding surface asperities experience this frictional heating, oxide grows preferentially at contacting asperities. The oxide runs out when it reaches a critical thickness. Indeed, it cannot stand anymore the frictional shear stresses or the applied load. At sufficiently high sliding speeds, oxidative wear can become detrimental if significant material loss occurs through the repetitive growth and removal of oxide layers.

Figure 2-28: Schematic illustration of the oxidative wear process at high sliding speed [81].

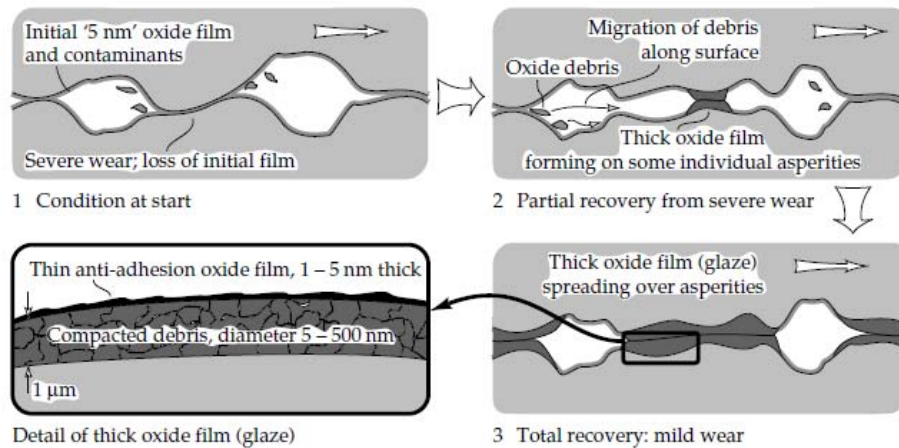
The oxidative wear takes place by a different mechanism if under low sliding speed. In this case the heating is not sufficiently high, thus a thin oxide layer forms on the surface, but its growth is limited by slow diffusion. With the proceeding of the sliding, the thin layer fractures and the metallic wear debris oxidize while rolling between the sliding contacts. This leads to the formation of a compact layer of mixed wear debris. The mixed layer often reduces the friction and the wear.

Figure 2-29: Schematic illustration of the oxidative wear process at slow sliding speed [81].

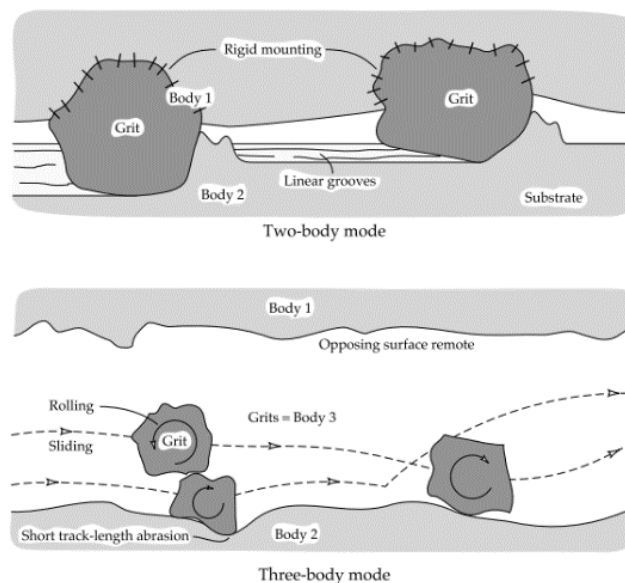
Abrasive wear may occur by two-body or three-body abrasion. During wear, the grains could be fixed in a rigid setting and they are sliding against a softer material. This is the two-body abrasion. Unlike, the three-body abrasive wear refers to hard particles that are freely moving between the two sliding surfaces. The particles of wear debris may be generated by the sliding of hard materials, causing the three-body abrasive wear.

Figure 2-33: Schematic of mechanisms of abrasive wear in the two-body and three-body configuration [81].

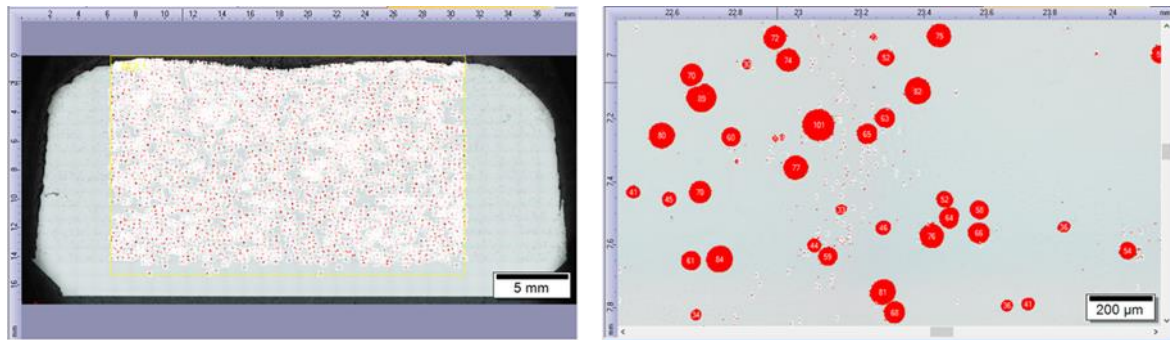
An estimation of the carbides position and dimension was obtained using the Stream Motion Software by Olympus.

Figure 4-4: Stream motion analysis of the section XZ. The sides were not considered because they are quite different respect the bulk, moreover this sample had a crack on the left side.

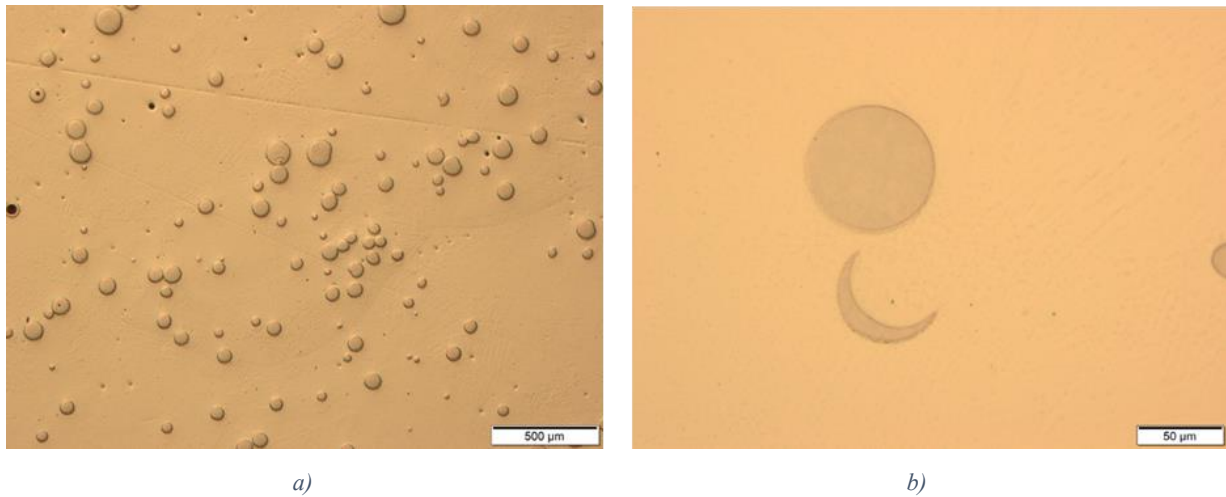
Figure 4-10: a) Different tracks detected in the XZ section. b) Spherical big tungsten carbide and a very particular “moon”-shaped tungsten carbide in the XZ section. Here it is also possible to notice the presence of the cellular dendrite microstructure.

Figure 4-12 is the equivalent SEM image of Figure 4-10a, captured with the optical microscope. In the SEM micrograph the observation of same track shapes is easier.

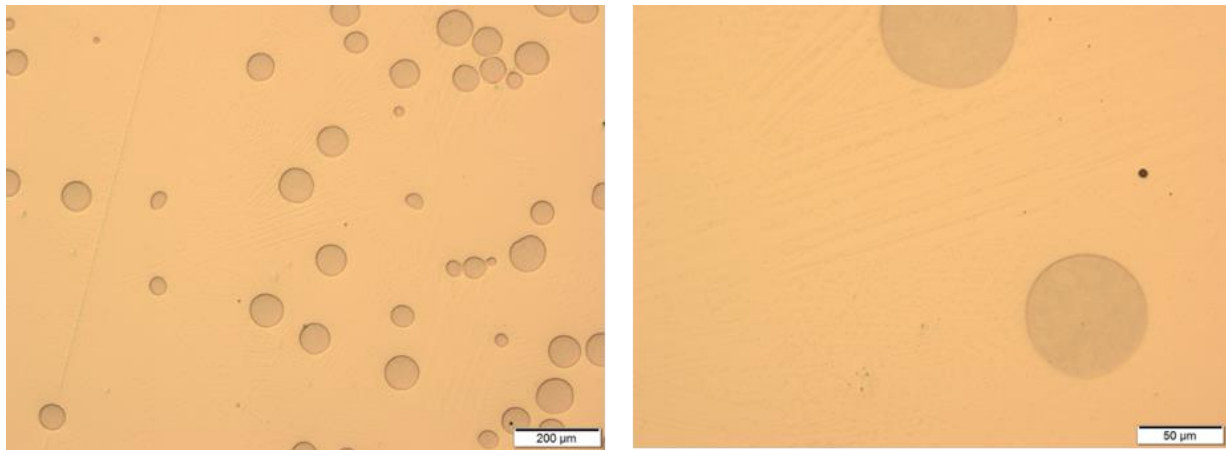
Figure 4-11: Dendrite across the track and the Heat Affected Zone detected in the XY section.

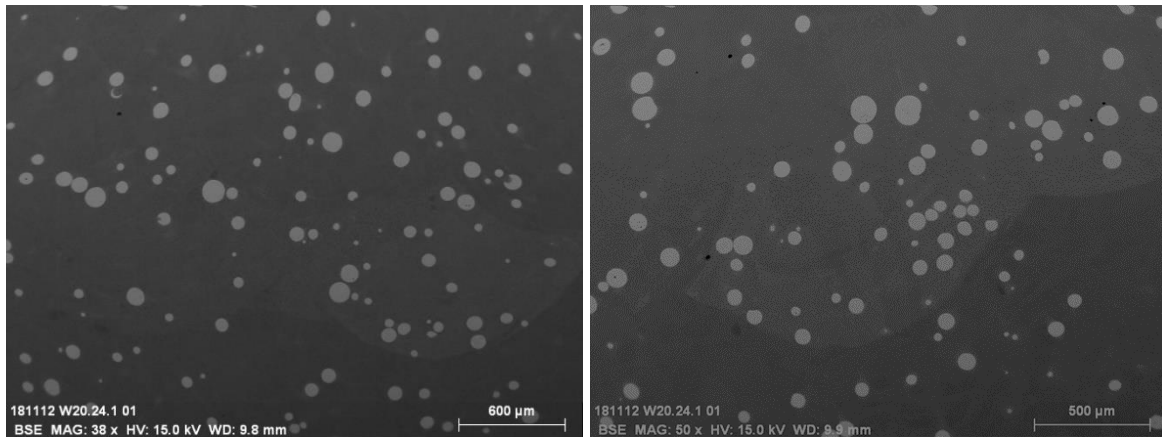
Figure 4-12: Large SEM images detected on the XZ section. It is possible to distinguish the different tracks

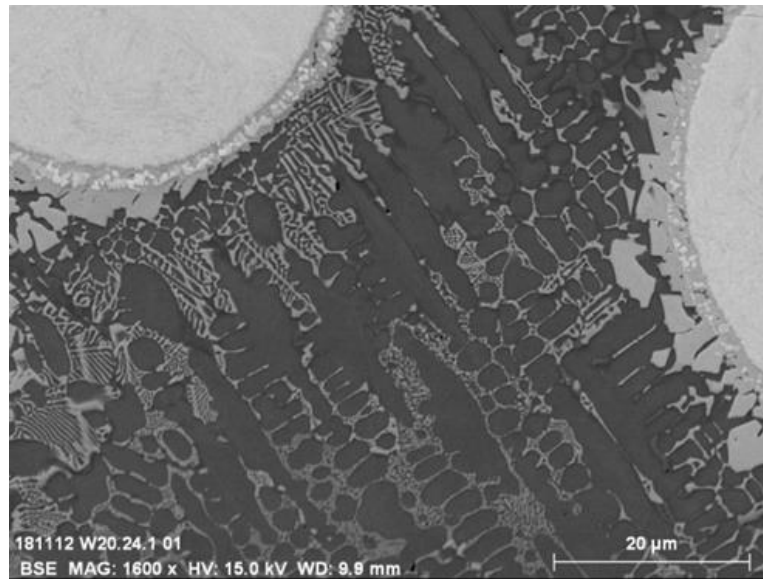
Figure 4-14: SEM images of a zone near the WC.

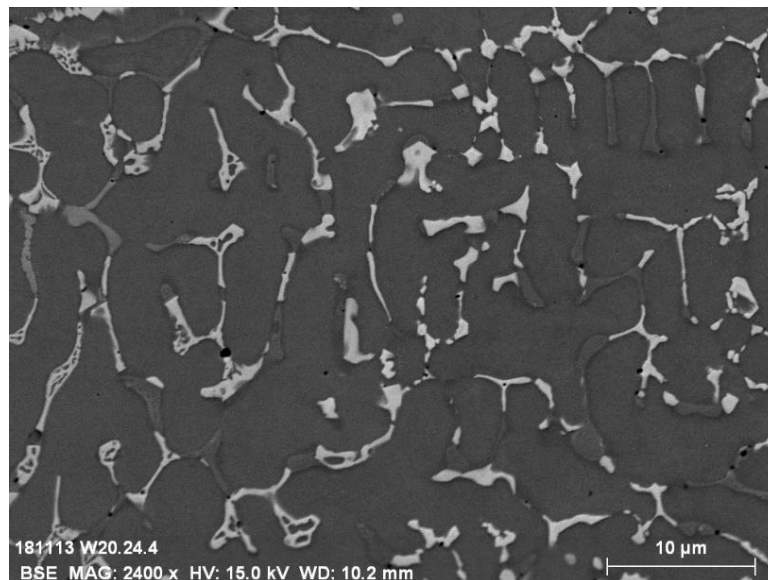
Observing the previous micrographs (Figure 4-13 and Figure 4-15), the carbides appear with a completely different morphology. Indeed, in the HAZ two different carbides are observed, meanwhile in the track only the complex regular carbide is observed. The brighter carbide in Figure 4-15 has a brighter color than the complex regular carbide in Figure 4-13 because it is richer in “heavy” atoms. Consequently, the darker carbide has lighter atoms.

Figure 4-15: High magnification SEM image in the Heat Affected Zone.

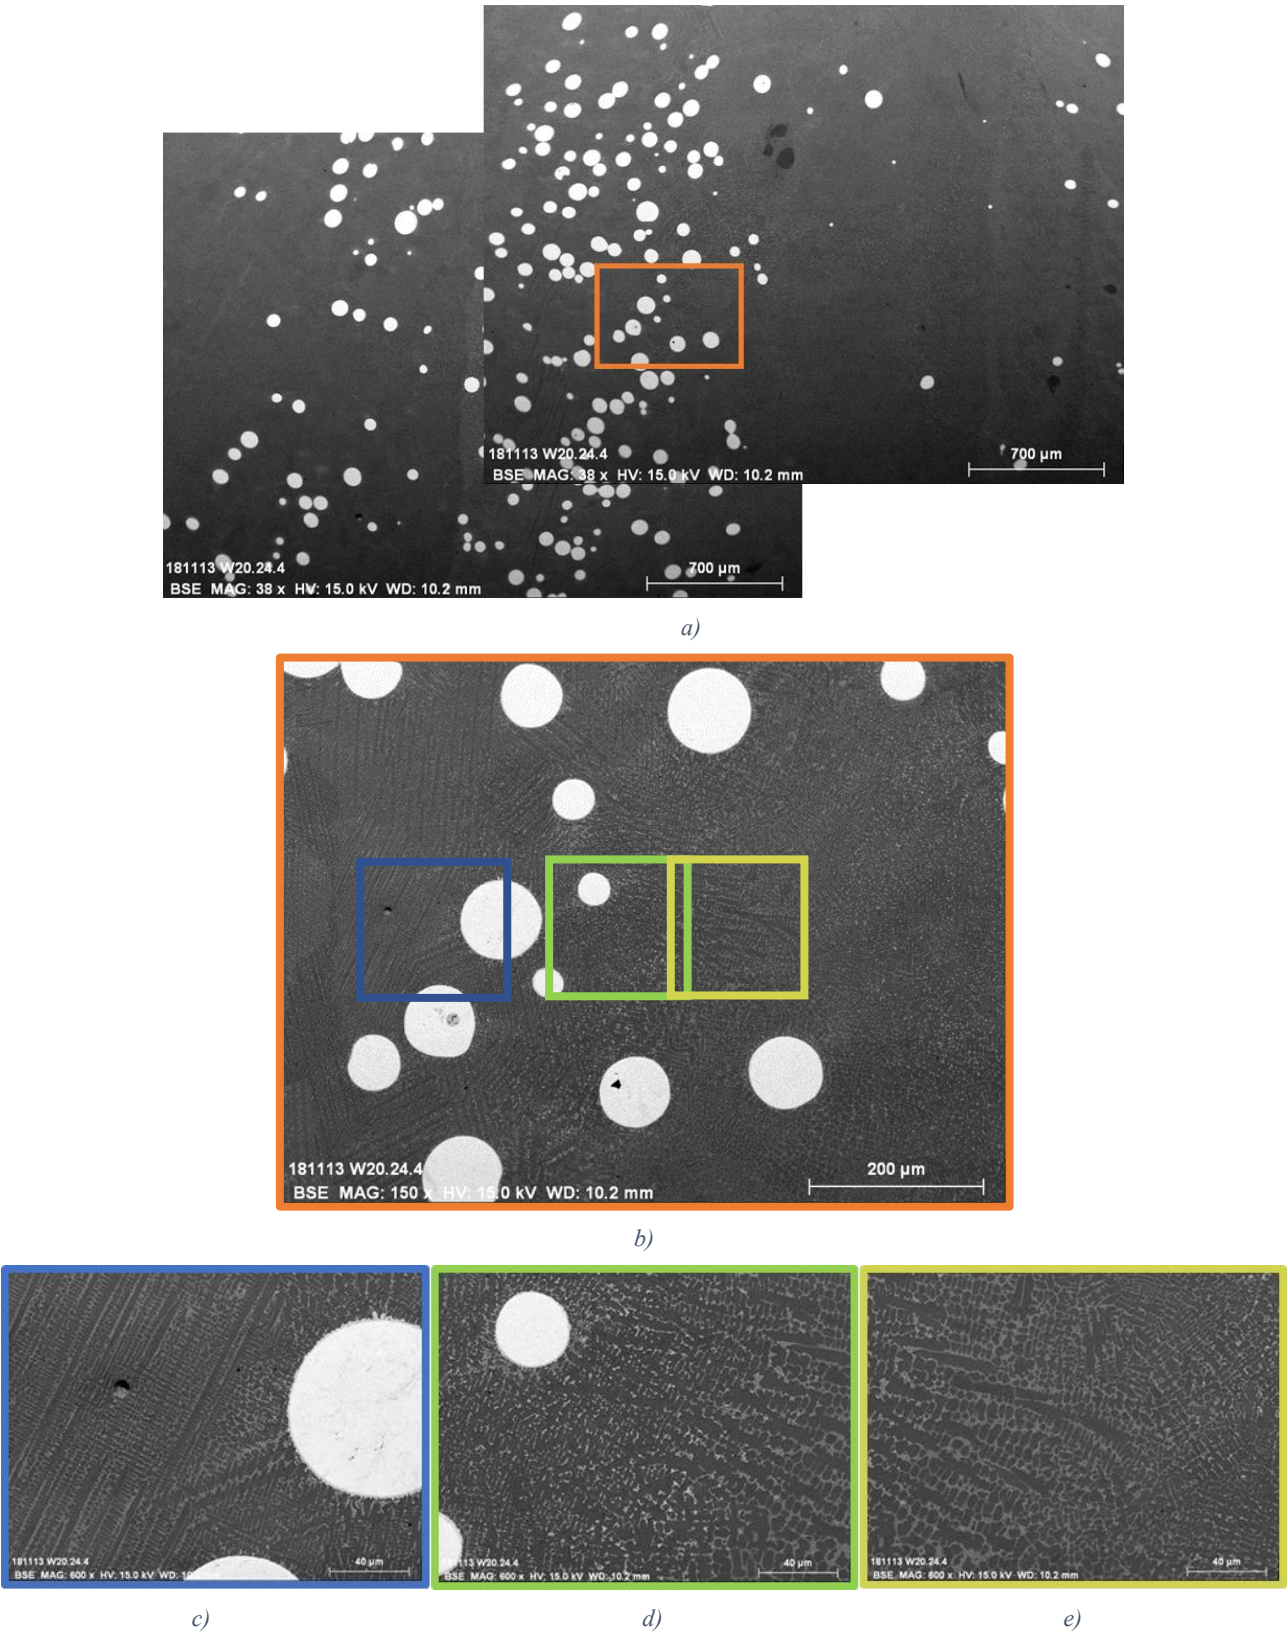
Figure 4-16: SEM images from XY section. a) General overview close to the side; b) zoom from the zone in a); c), d), e) zoom of different zones in b).

A different microstructure can be noticed in the Figure 4-16d. The heat affected zone (HAZ) is characterized by the presence of two carbides in the intercellular spaces.

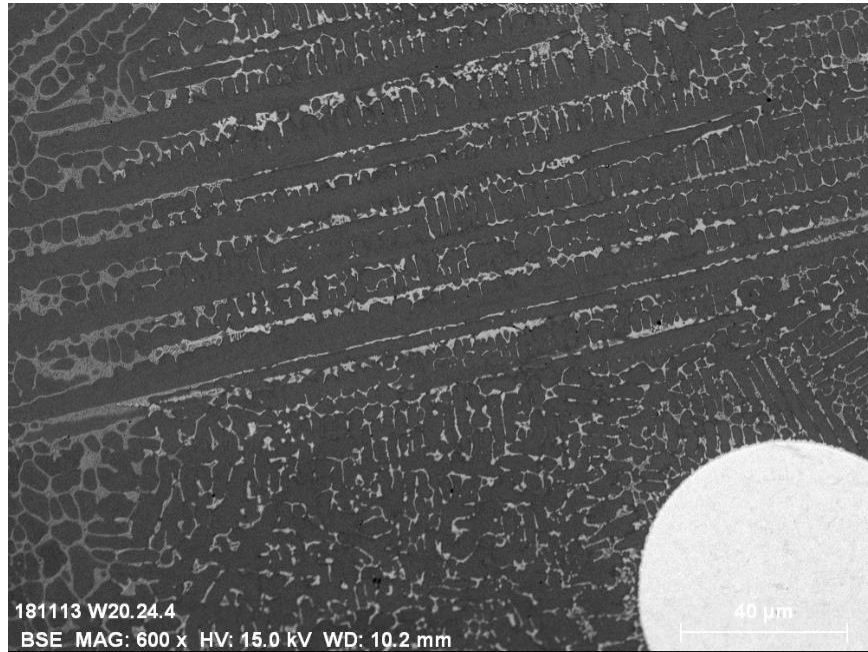
Figure 4-17: SEM image of the HAZ zone. The dendrite continues his growth in the HAZ.

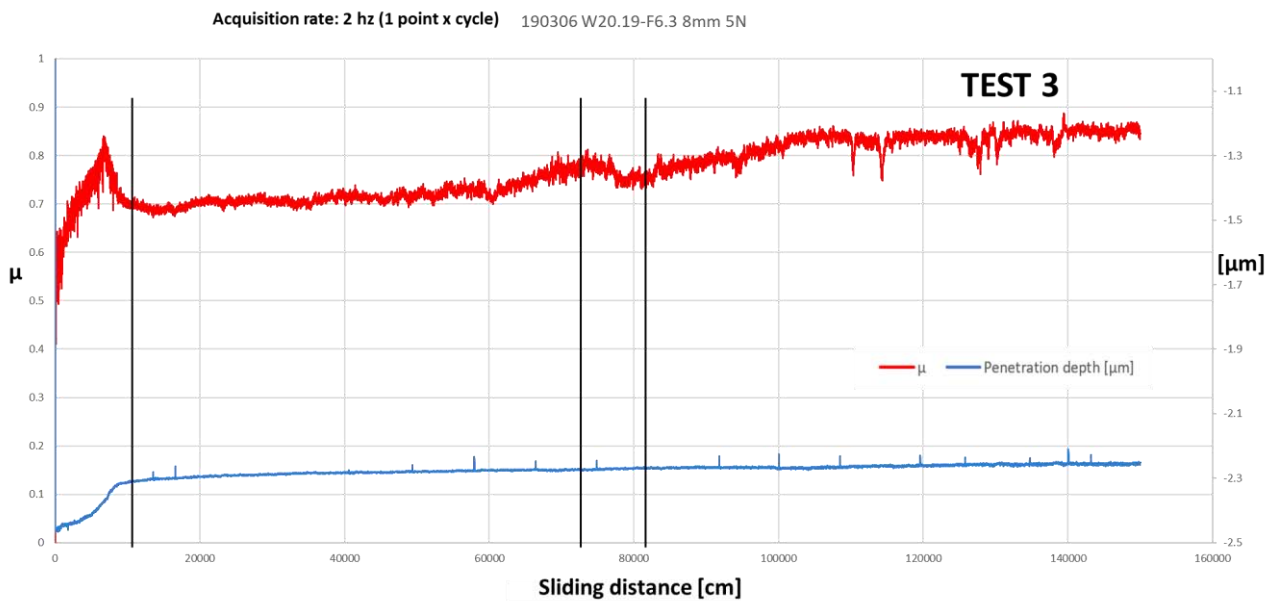
Figure 4-35: Friction coefficient and penetration depth evolution for the W20.19-F6.3 at 8mm..

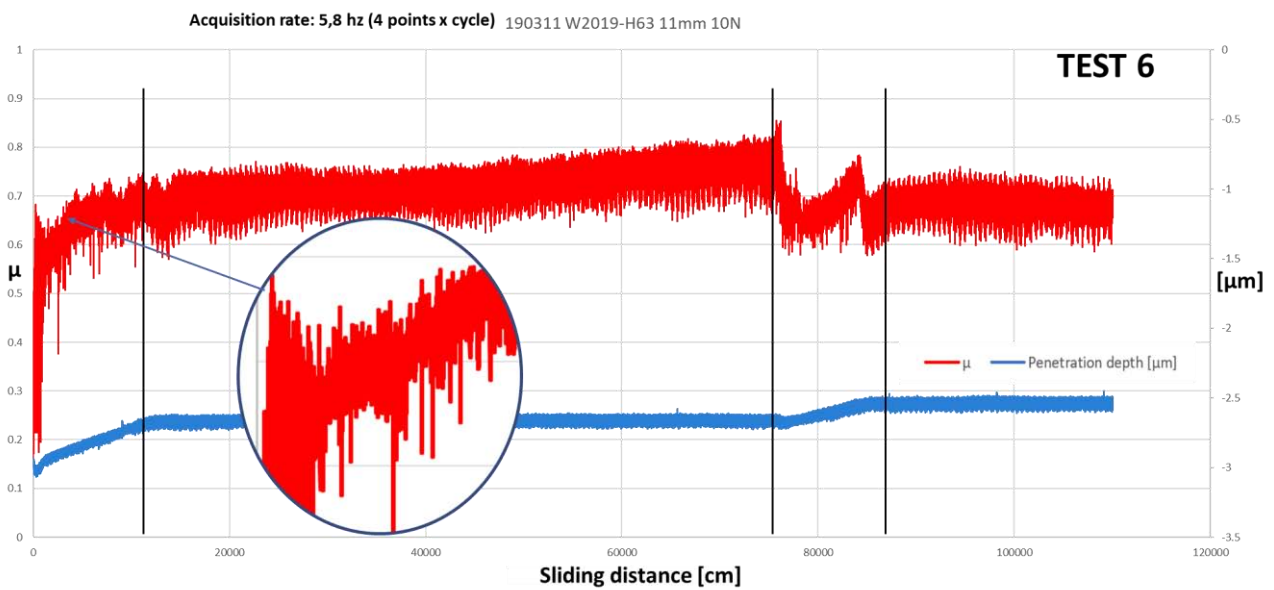
Figure 4-38: Friction coefficient and penetration depth evolution for the W20.19-H6.3 at 11mm.

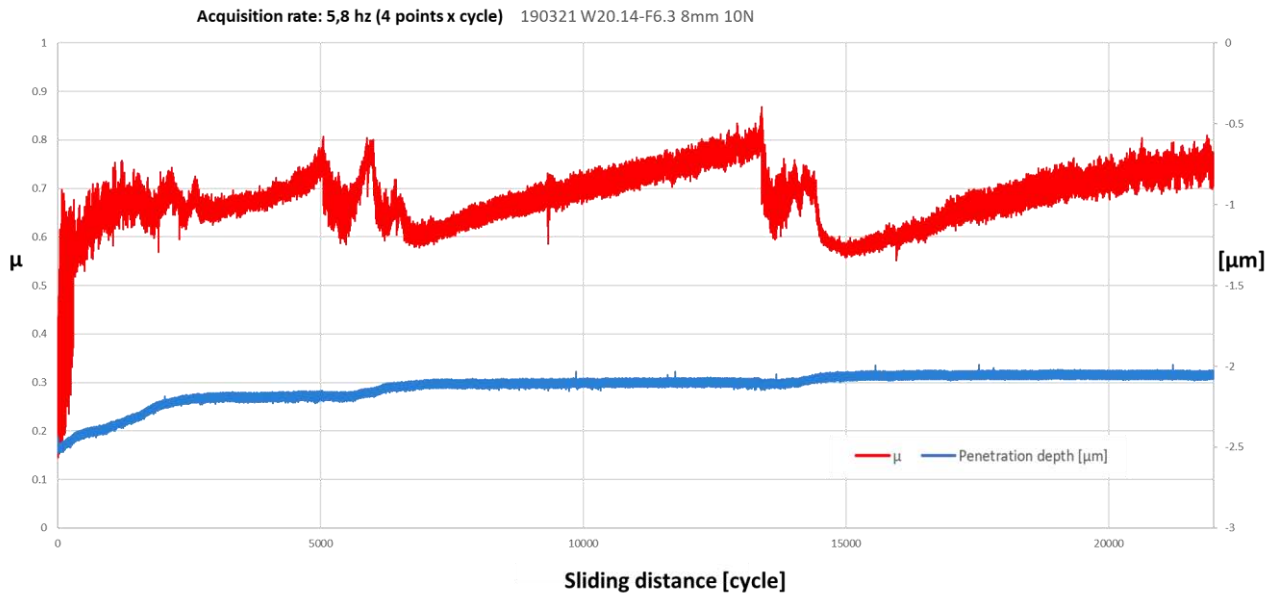
Figure 4-39: Friction coefficient and penetration depth evolution for the W20.14-F6.3 at 8mm.

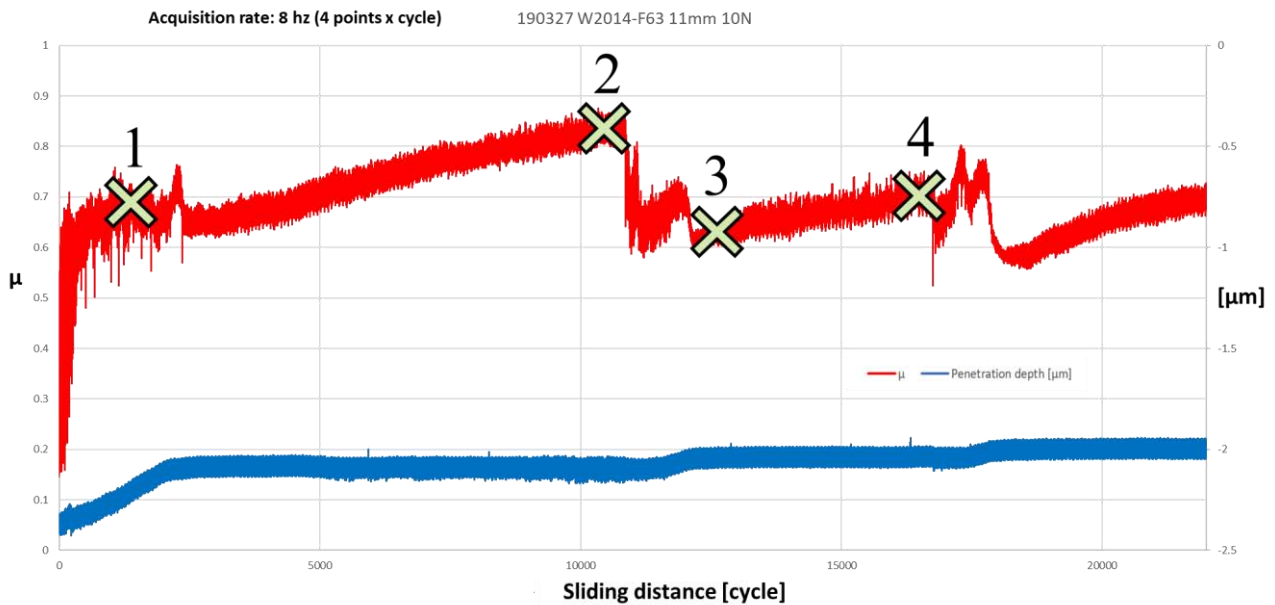
Figure 4-41: Position of the fourth interrupted tests.

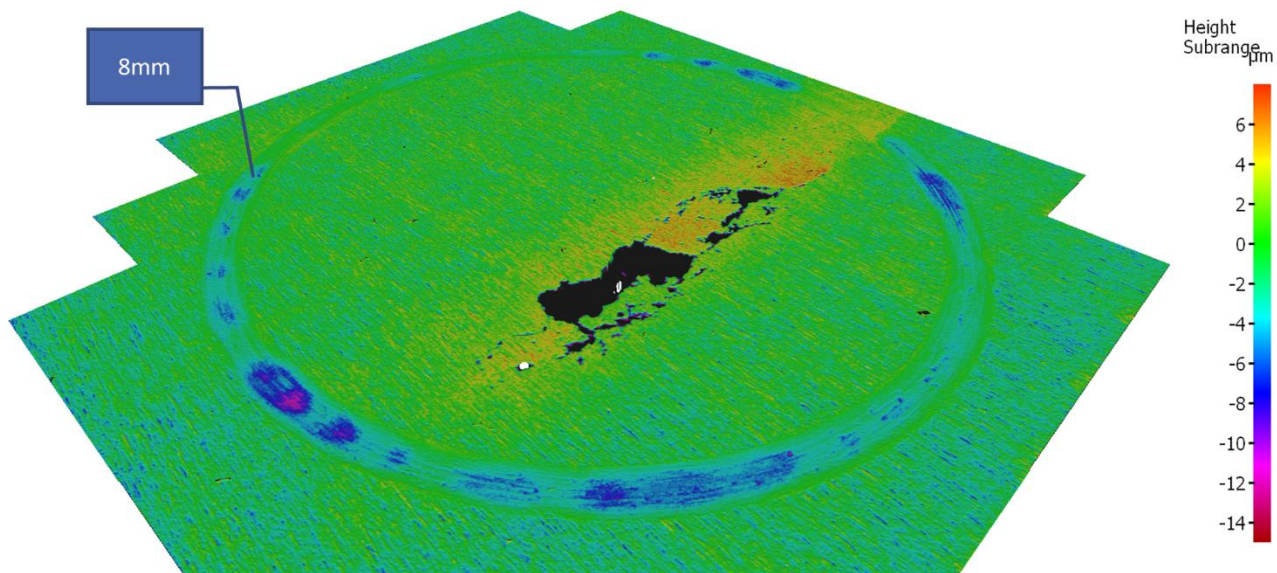
Figure 4-46: W20.19-F6.3 8mm radius 5N force worn track profilometer overview.

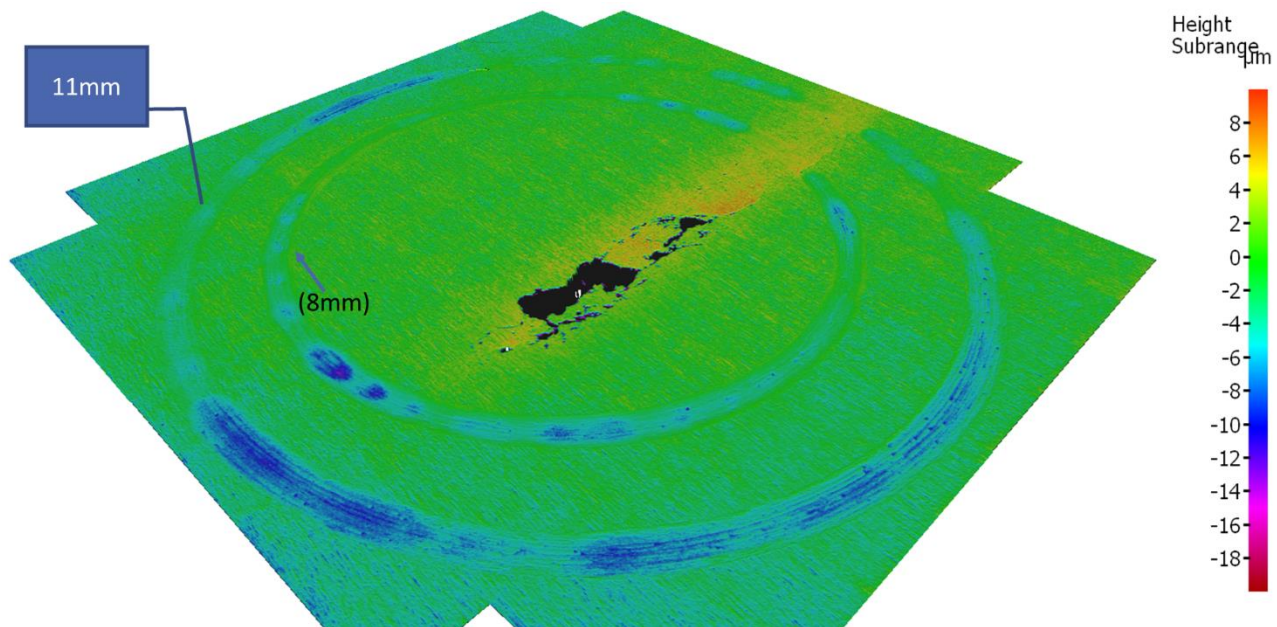
Figure 4-47: W20.19-F6.3 11mm radius 5N force worn track profilometer overview.

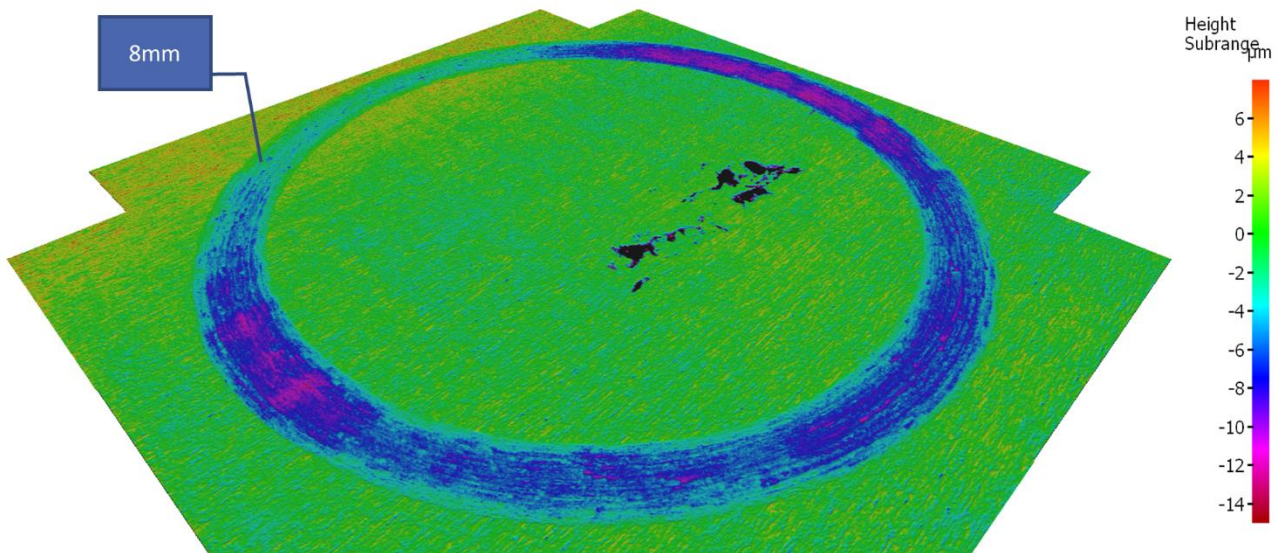
Figure 4-48: W20.19-H6.3 8mm radius 10N force worn track profilometer overview.

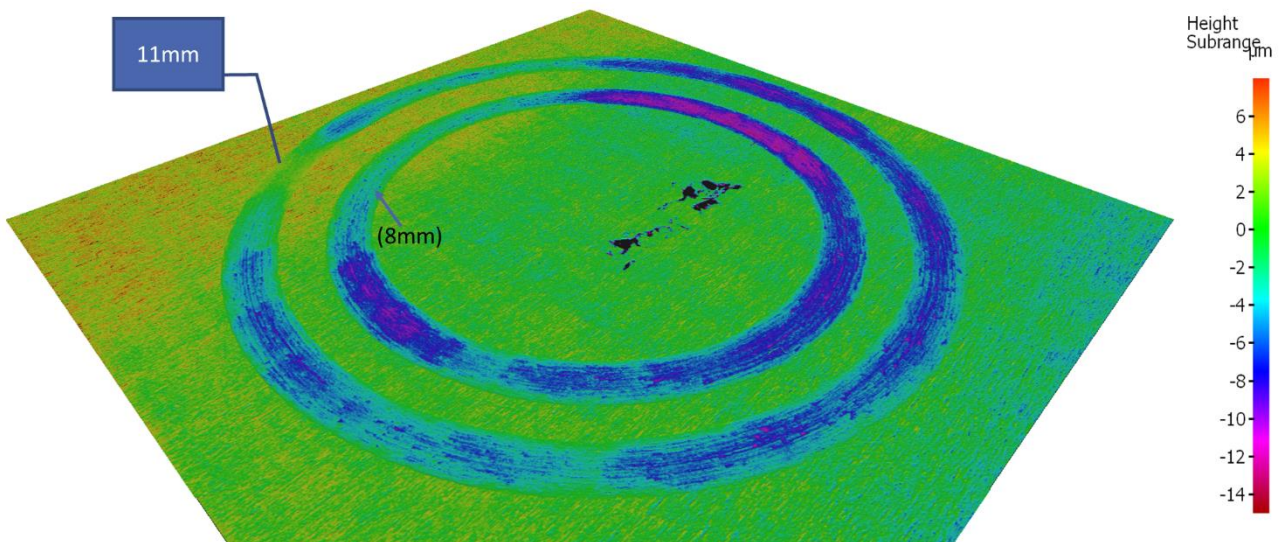
Figure 4-49: W20.19-H6.3 11mm radius 10N force worn track profilometer overview.

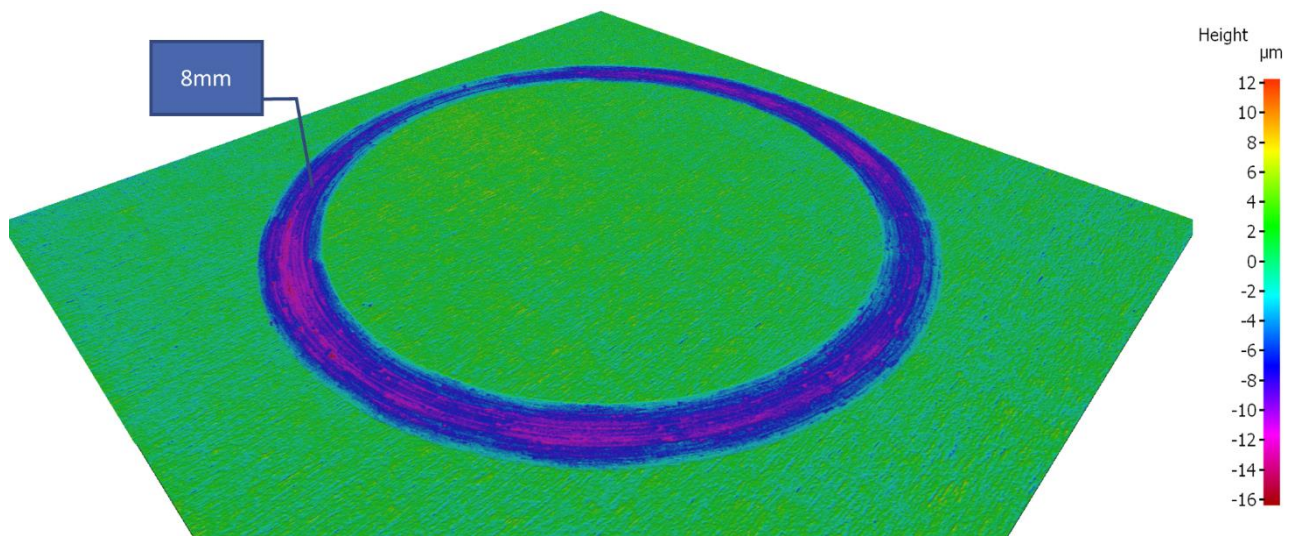
Figure 4-50: W20.14-F6.3 8mm radius 10N force worn track profilometer overview.

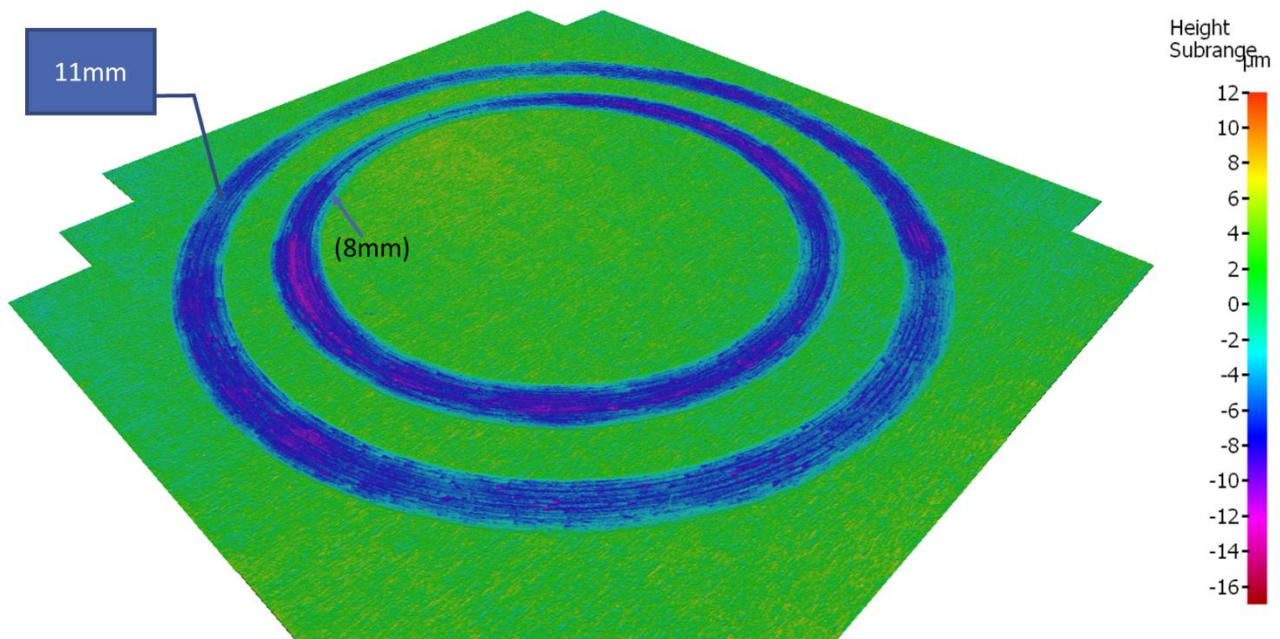
Figure 4-51: W20.14-F6.3 11mm radius 10N force worn track profilometer overview.

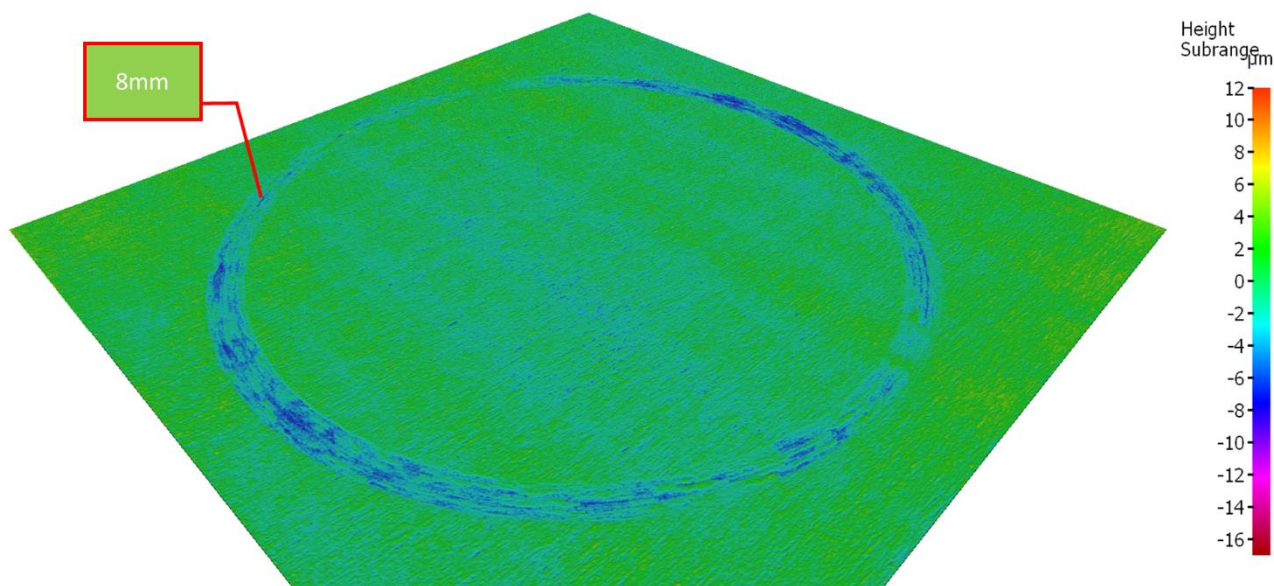
Figure 4-52: W20.18-F6.3 8mm radius 10N force worn track profilometer overview.

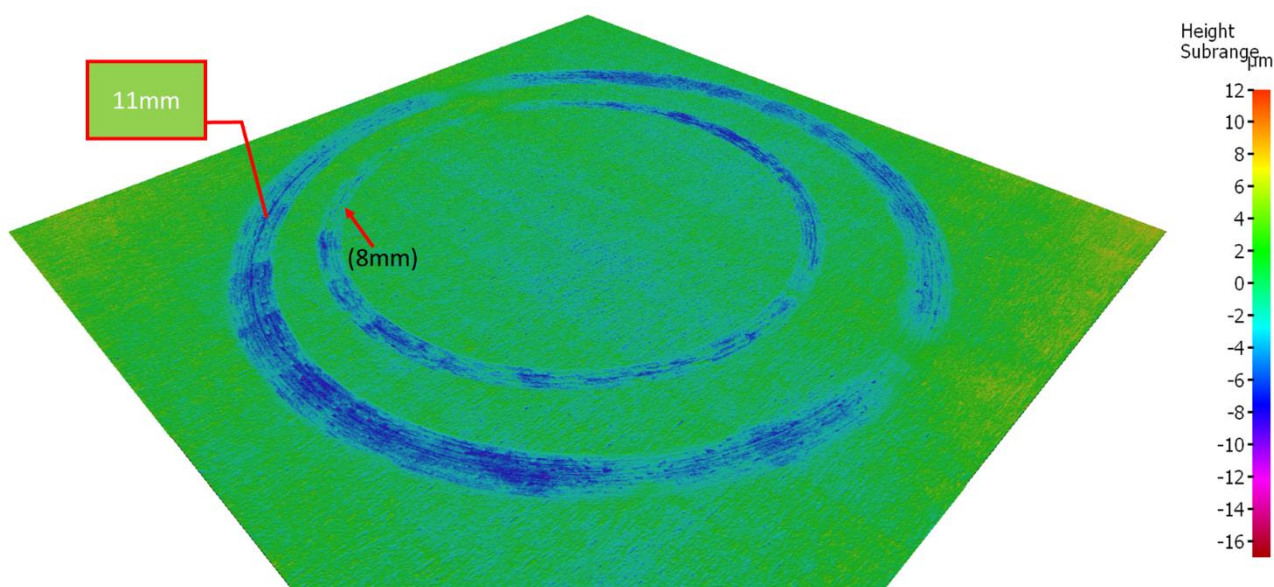
Figure 4-53: W20.18-F6.3 11mm radius 10N force worn track profilometer overview.

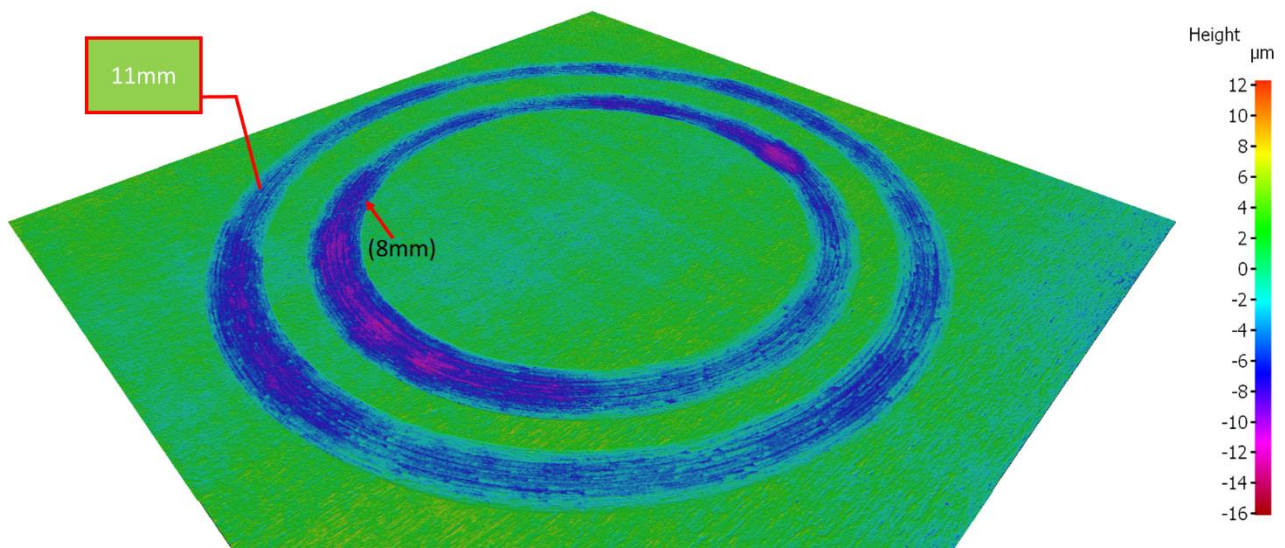
Figure 4-54: W20.14-H6.3 11mm radius 10N force worn track profilometer overview.

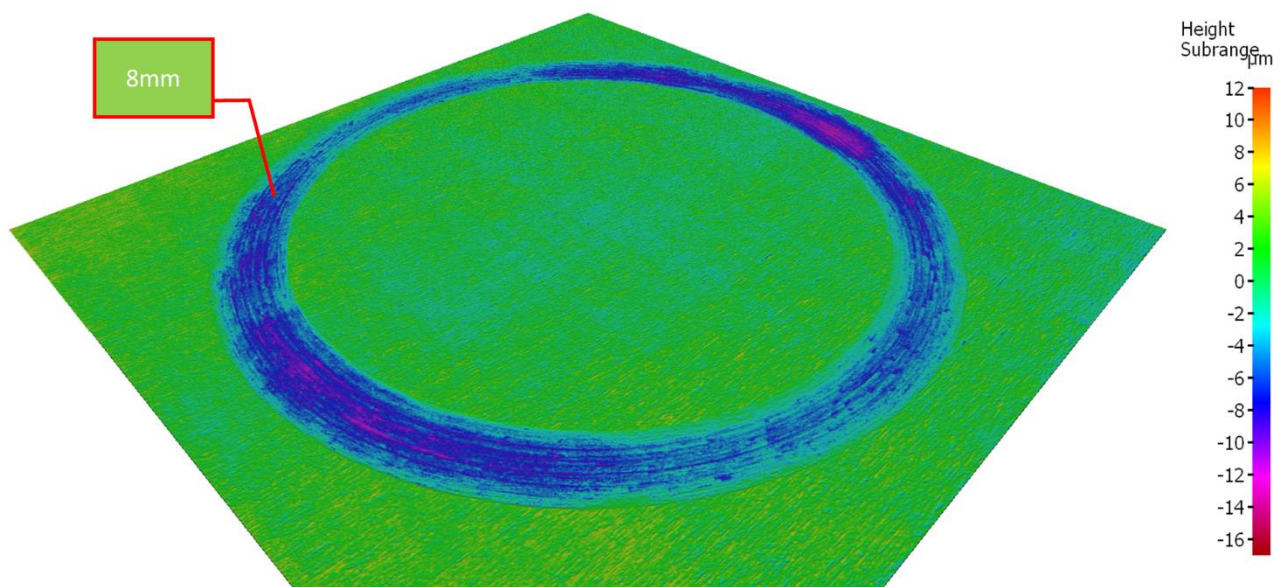
Figure 4-55: W20.14-H6.3 8mm radius 10N force worn track profilometer overview.
