Université de Liège – Università degli Studi di Padova

**Room temperature wear behavior of laser clad
316L+WC composite coating**

Final Year Project

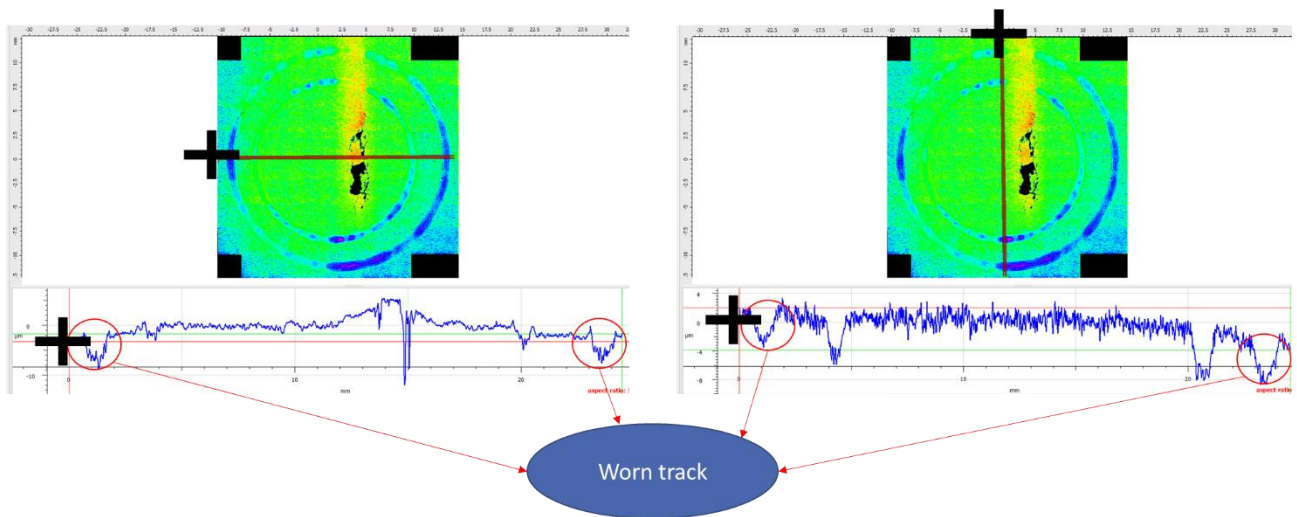
Figure 4-58: Horizontal (left) and vertical (right) profile on W20.19-F6.3 11mm radius 5N force worn track.

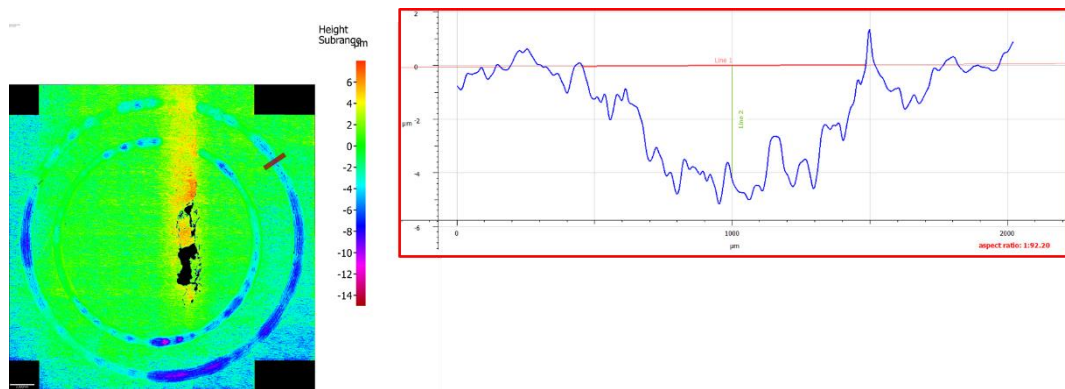
Figure 4-59: Short linear profile on W20.19-F6.3 11mm radius 5N force worn track.

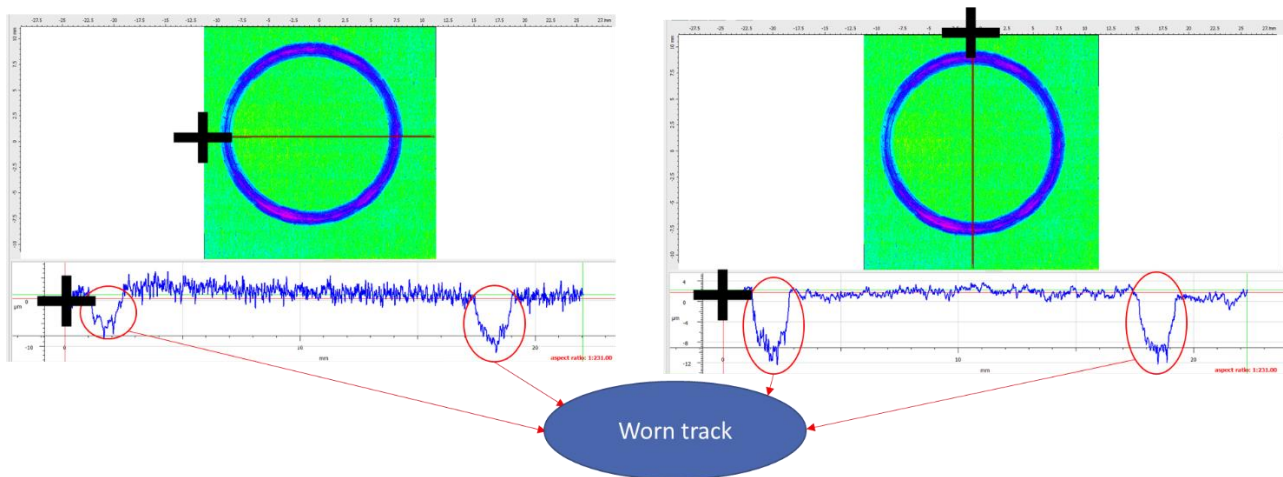
Figure 4-61: Horizontal (left) and vertical (right) profile on W20.14-F6.3 8mm radius 10N force worn track.

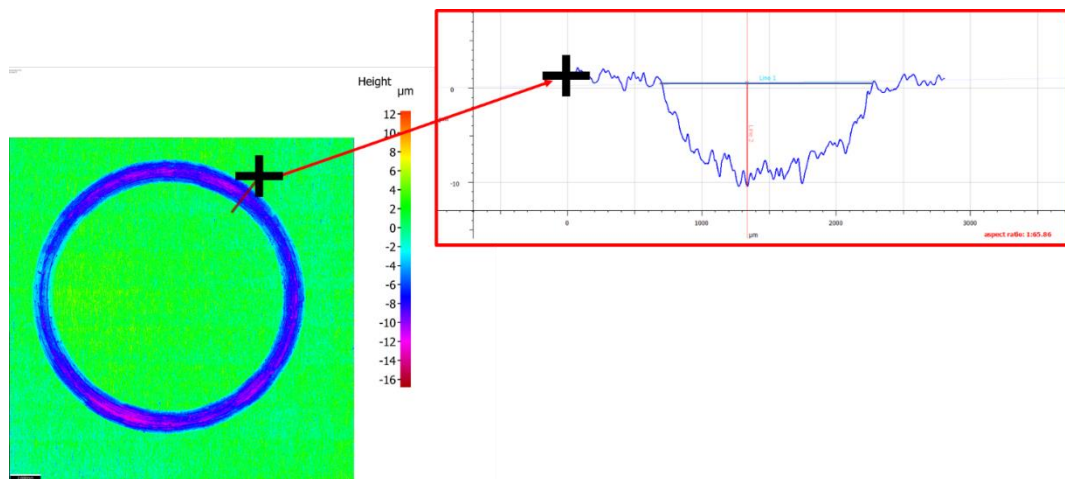
Figure 4-62: Short linear profile on W20.14-F6.3 8mm radius 10N force worn track.

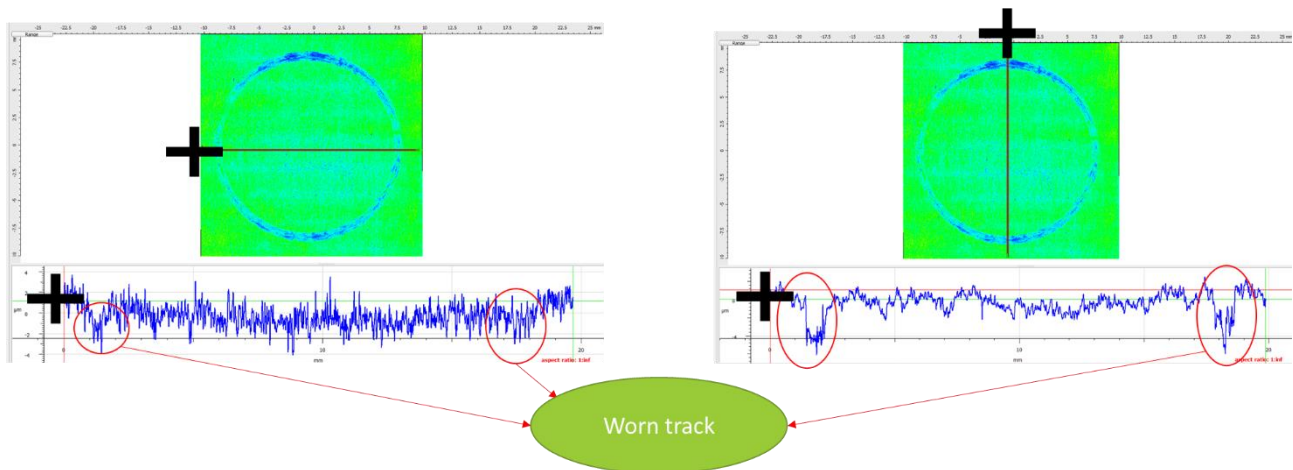
Figure 4-64: Horizontal (left) and vertical (right) profile on W20.18-F6.3 8mm radius 10N force worn track.

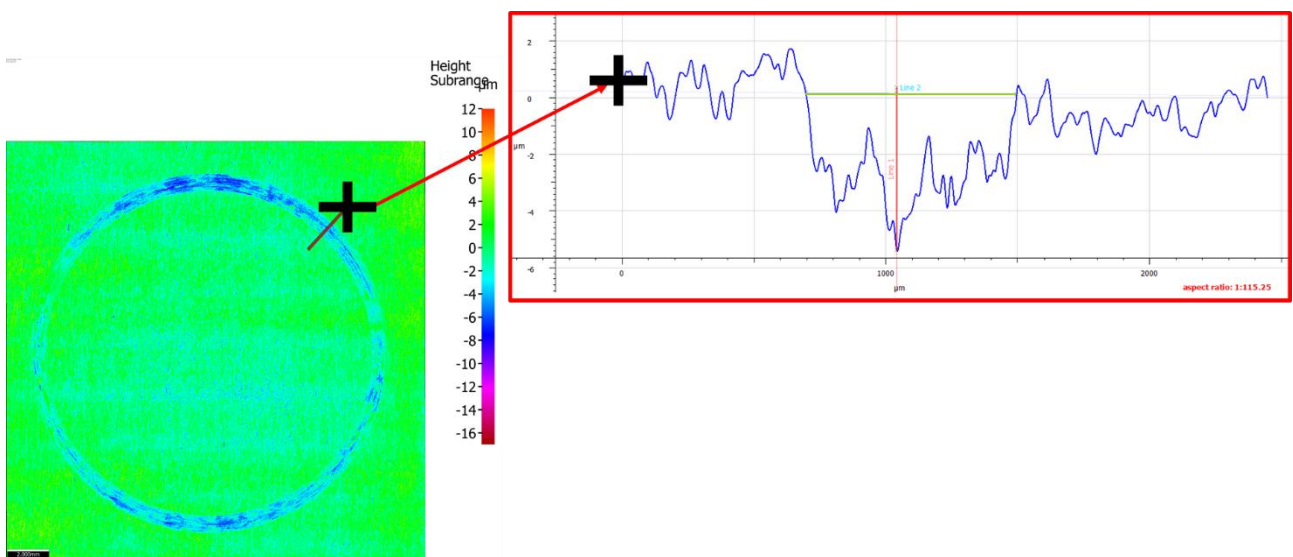
Figure 4-65: Short linear profile on W20.18-F6.3 8mm radius 10N force worn track.

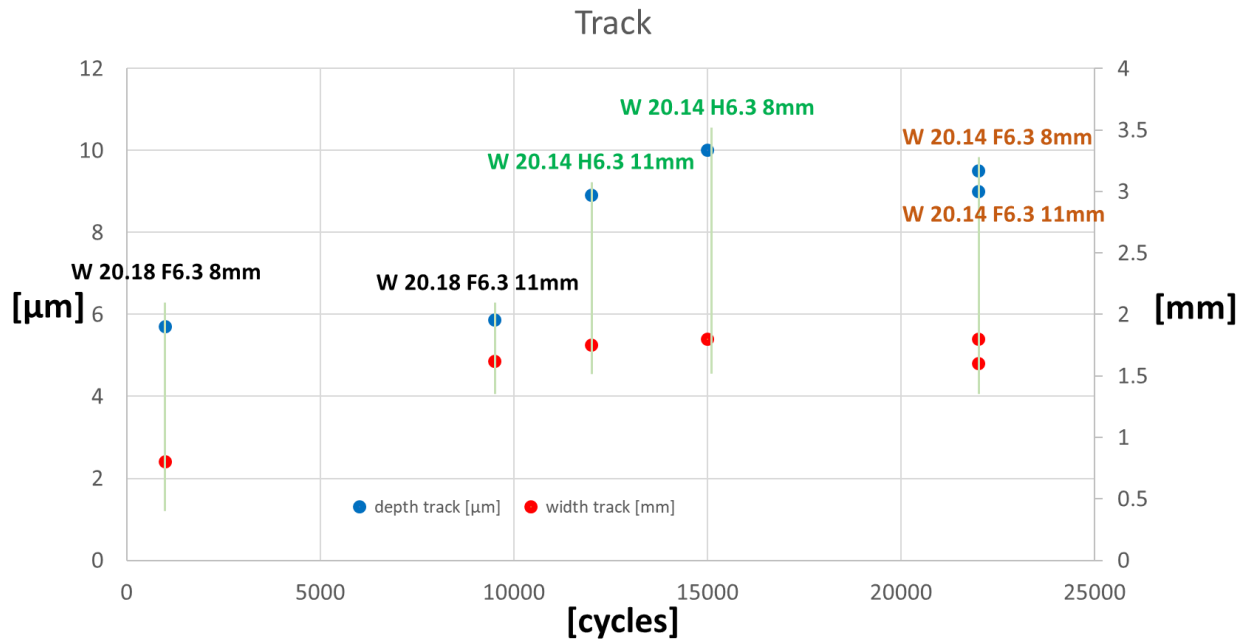
Figure 4-66: Resuming chart. Track depth (left axis) and track width (right axis) in function of the number of cycles.

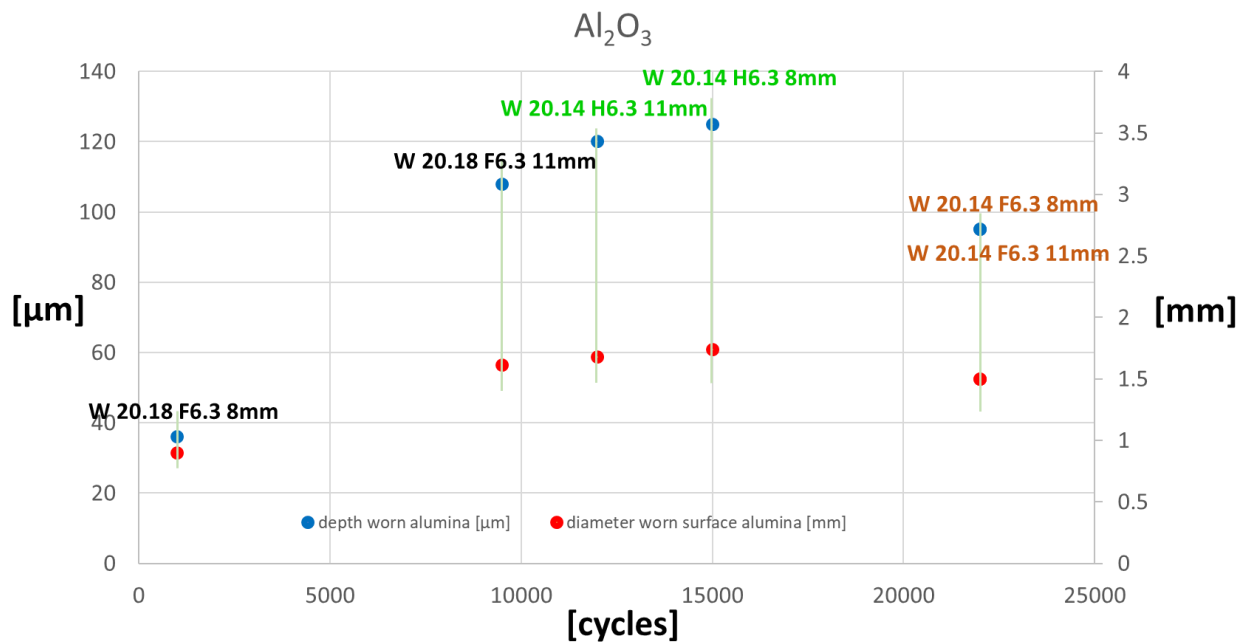
Figure 4-70: Resuming chart. Worn Alumina depth (left axis) and worn surface diameter (right axis) in function of the number of cycles.

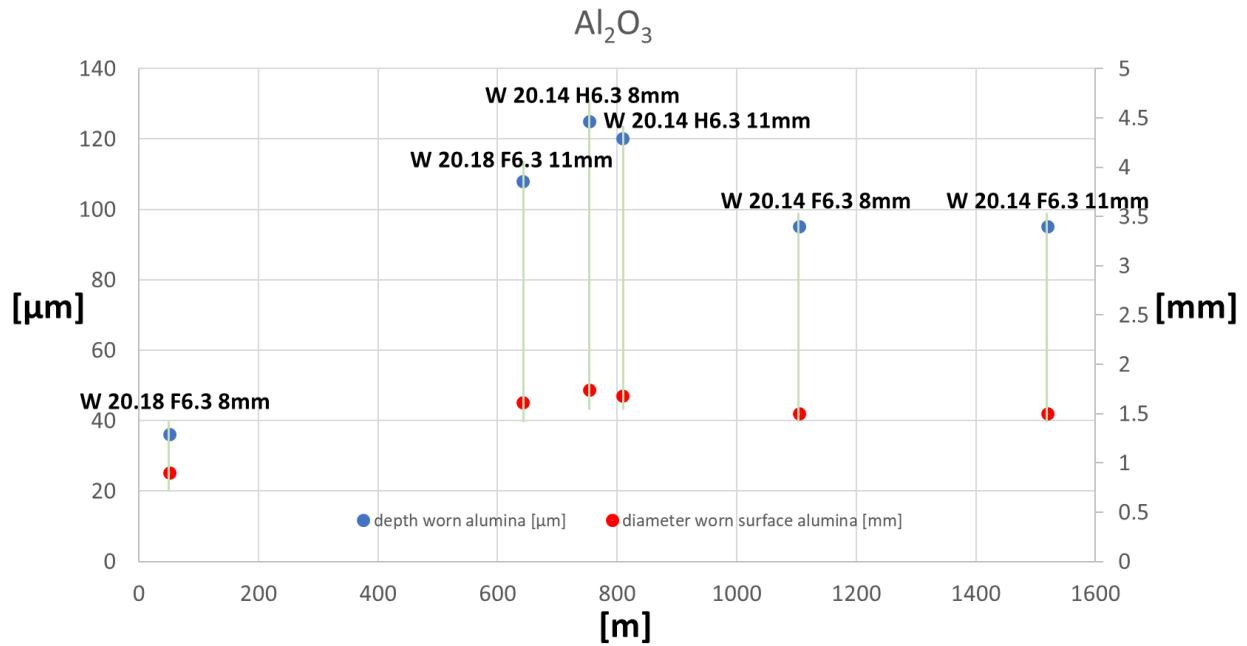
Figure 4-71: Resuming chart. Worn Alumina depth (left axis) and worn surface diameter (right axis) in function of the distance.

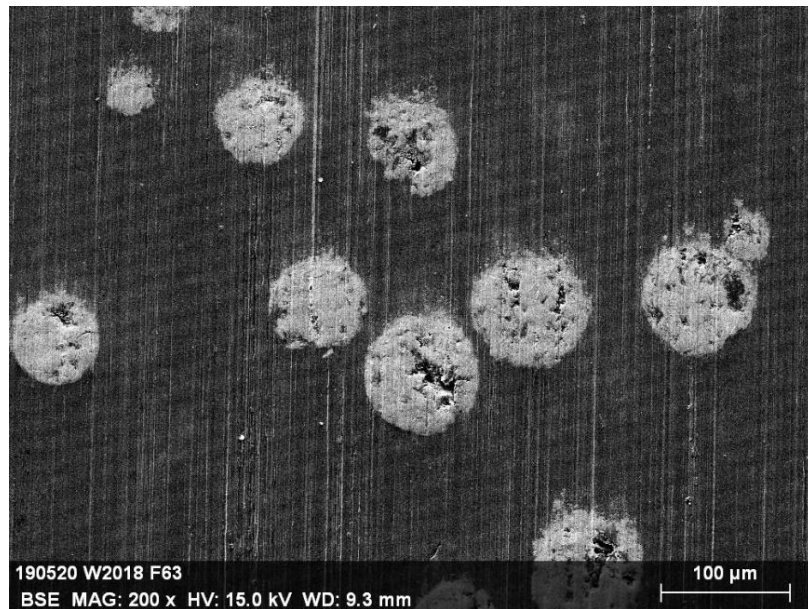
Figure 4-72: Tungsten carbides outside the worn track.

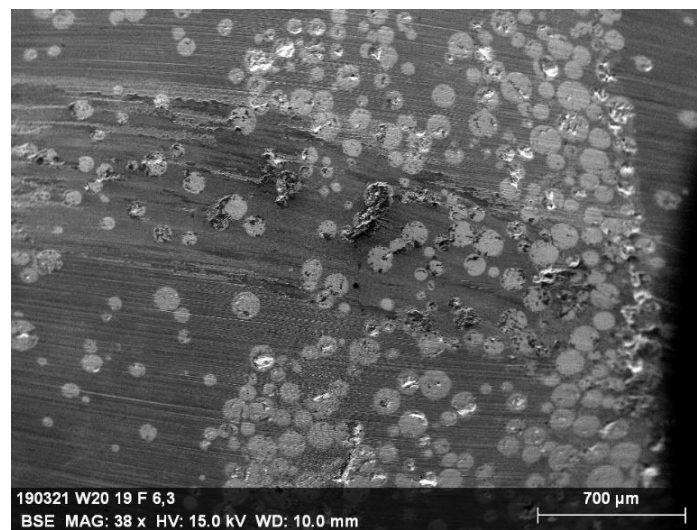
Figure 4-73: Detail of W20.19-F6.3 radius worn track (5N applied force).

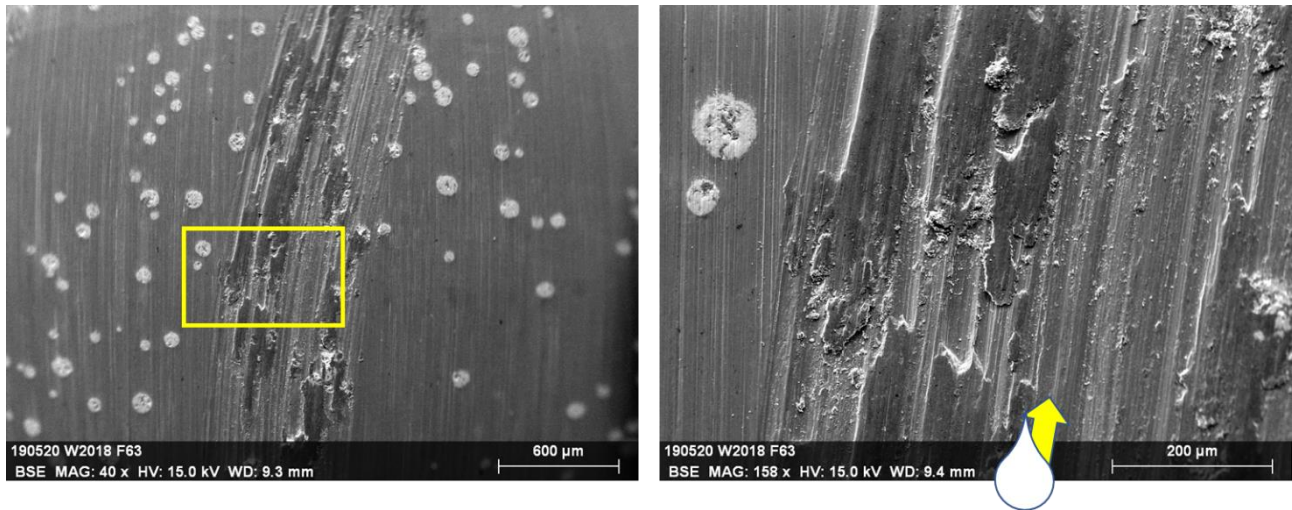
Figure 4-74: Detail of the worn tracks after the first interrupted test. On the right there is a zoom of the zone highlighted on the left.

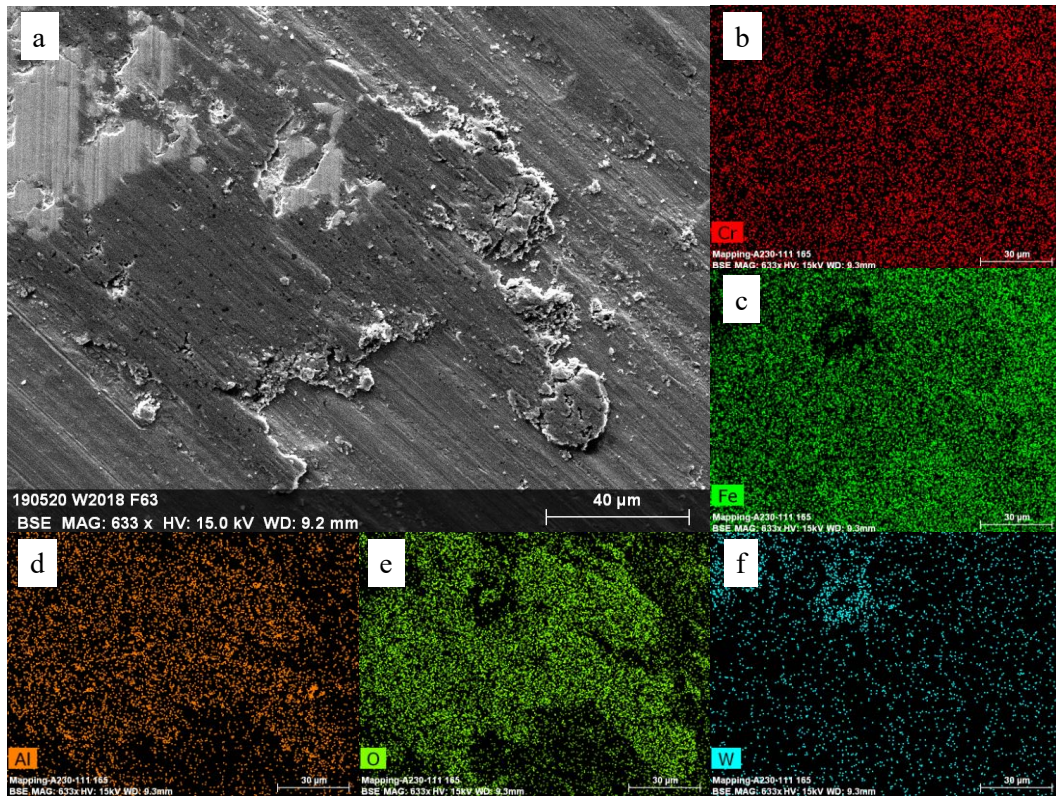
Figure 4-75: (a) BSE mode of a zone on the layer inside the track W20.18 F6.3 8mm (shortest interrupted test: about 1000 cycles) ; from (b) to (f) EDS Composition maps of the zone.

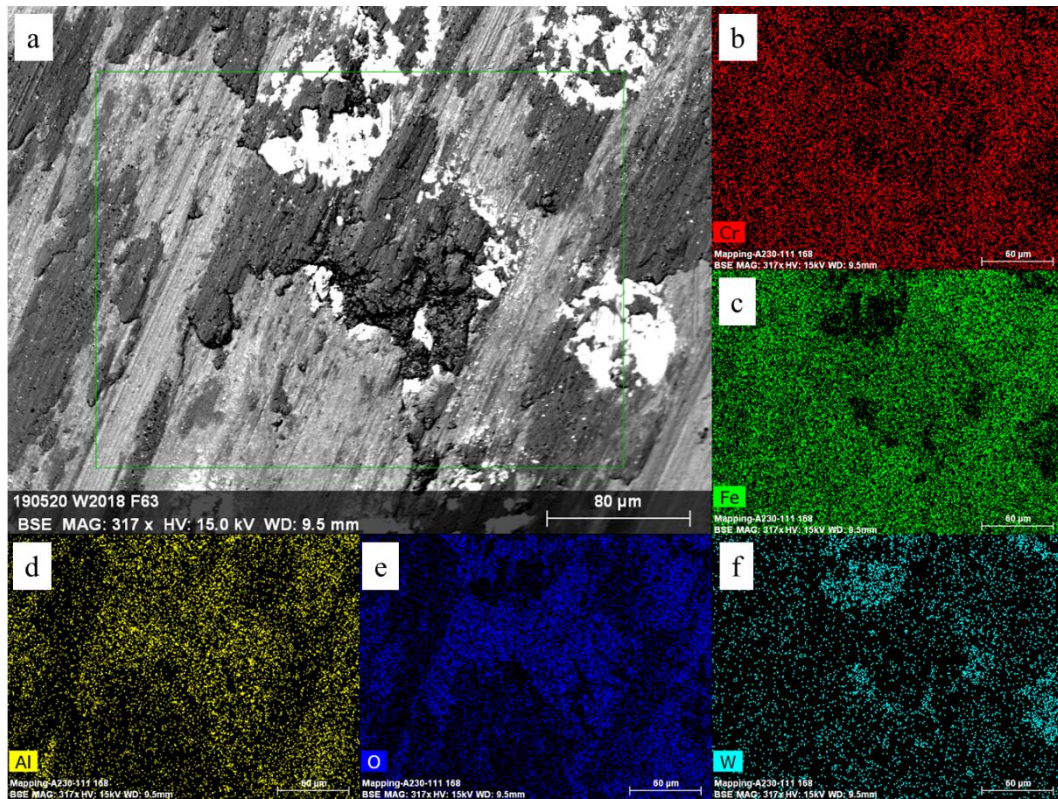
Figure 4-76: (a) BSE mode of a zone stacked material over the WC inside the track W20.18 F6.3 8mm (shortest interrupted test: about 1000 cycles) ; from (b) to (f) EDS Composition maps of the zone.

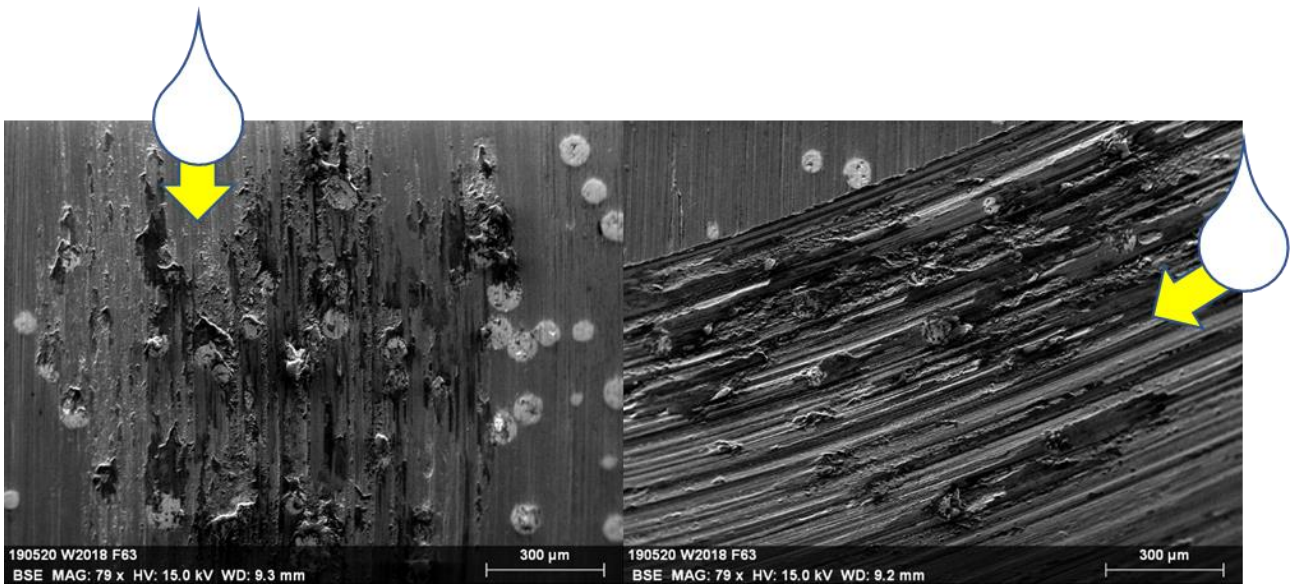
Figure 4-77: Details of the worn tracks after the second interrupted test.

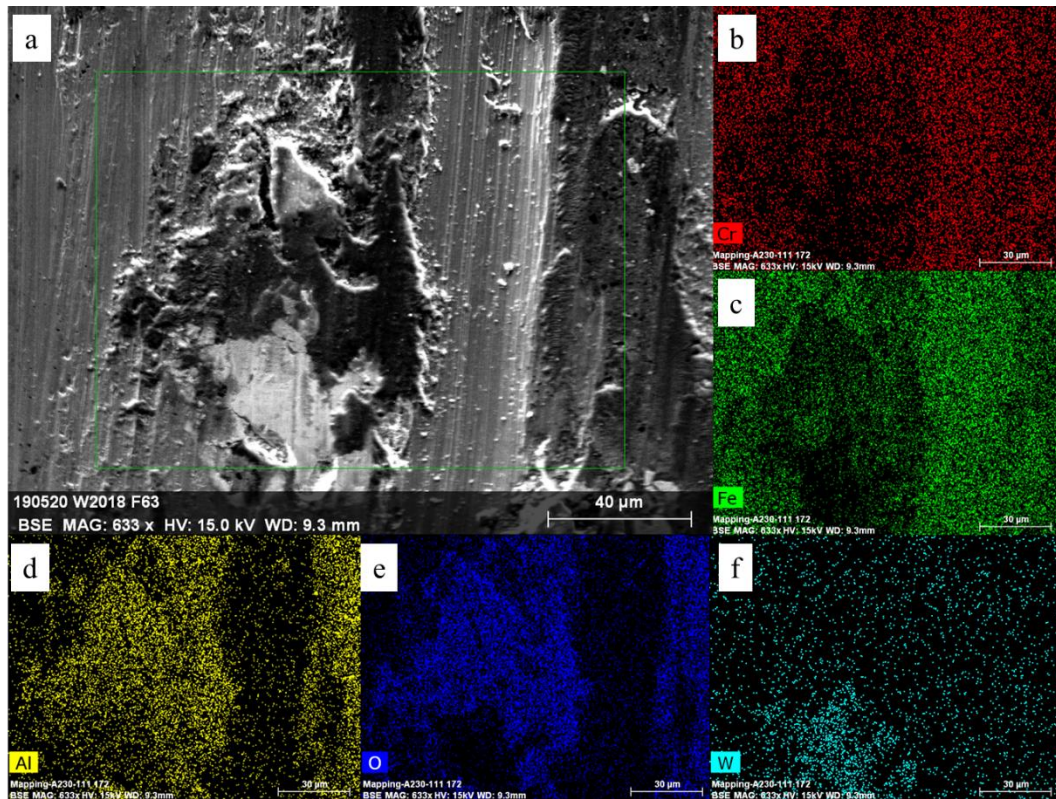
Figure 4-78: (a) SE mode of a detail close to a WC on the worn track of W20.18 F6.3 11mm (stopped at about 9500 cycles, after the stable friction coefficient region); from (b) to (f) EDS Composition maps of the zone.

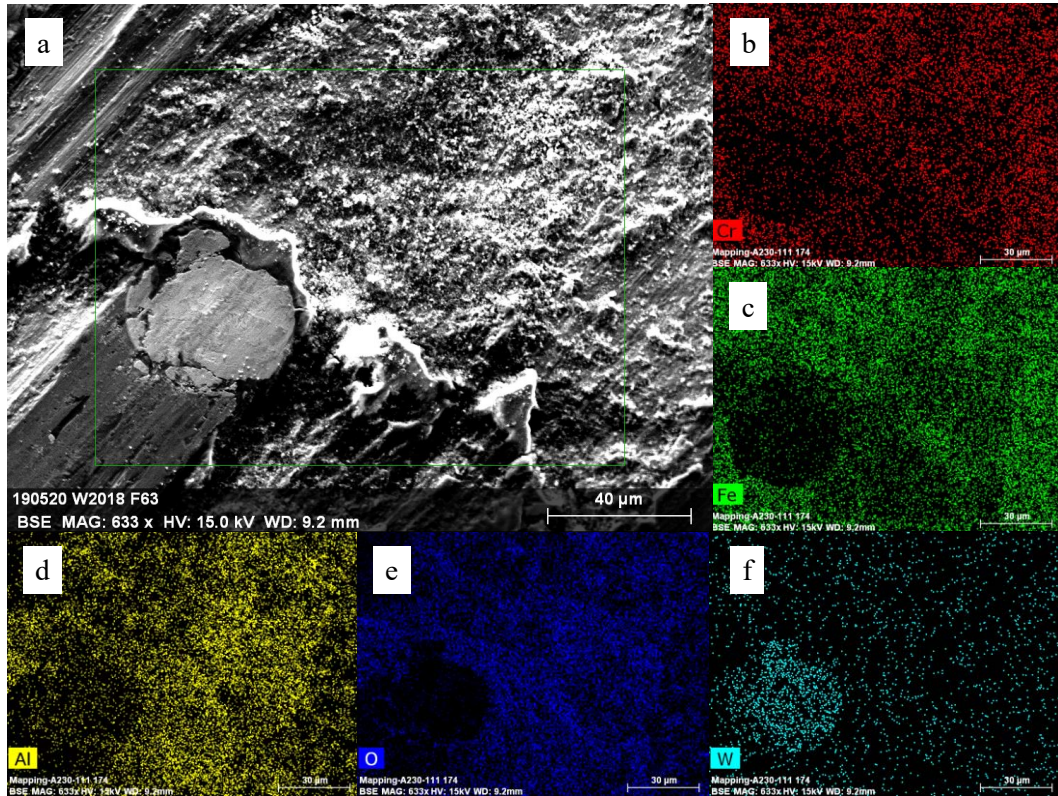
Figure 4-79: (a) SE mode of a detail close to a WC on the worn track W20.18 F6.3 11mm (stopped at about 9500 cycles, after the stable friction coefficient region); from (b) to (f) EDS Composition maps of the zone.

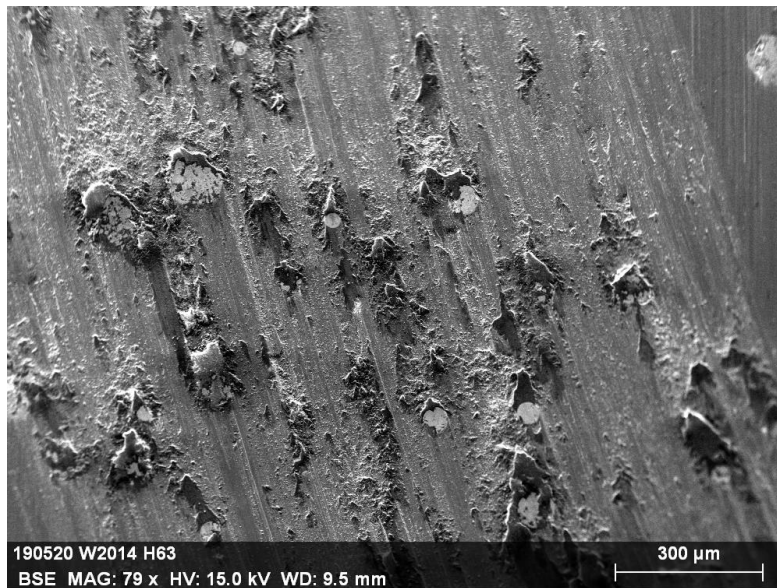
Figure 4-80: Detail of the worn tracks after the third interrupted test.

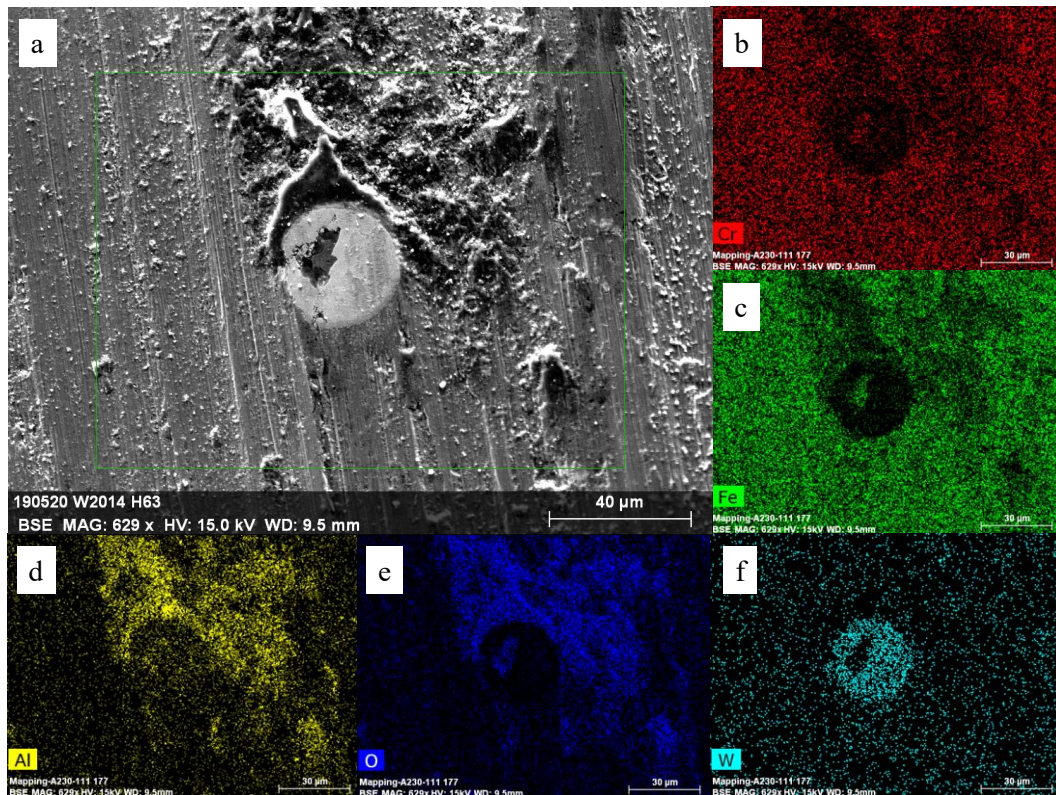
Figure 4-81: (a) BSE mode of a zone on the layer inside the track W20.14 H6.3 11mm (stopped at less than 12000cycles, interrupted just after the drop of the friction coefficient); from (b) to (f) EDS Composition maps of the zone.

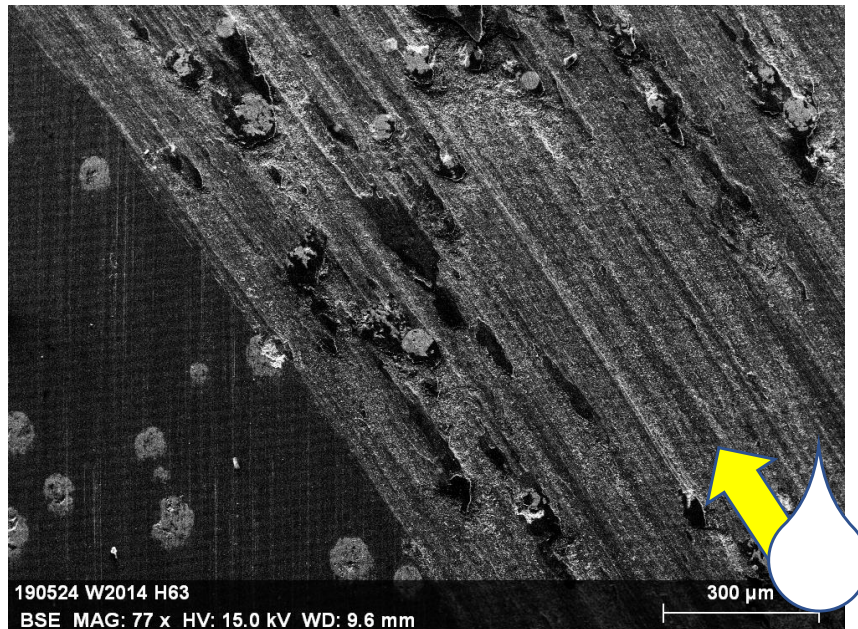
Figure 4-82: Detail of the worn tracks after the third interrupted test.

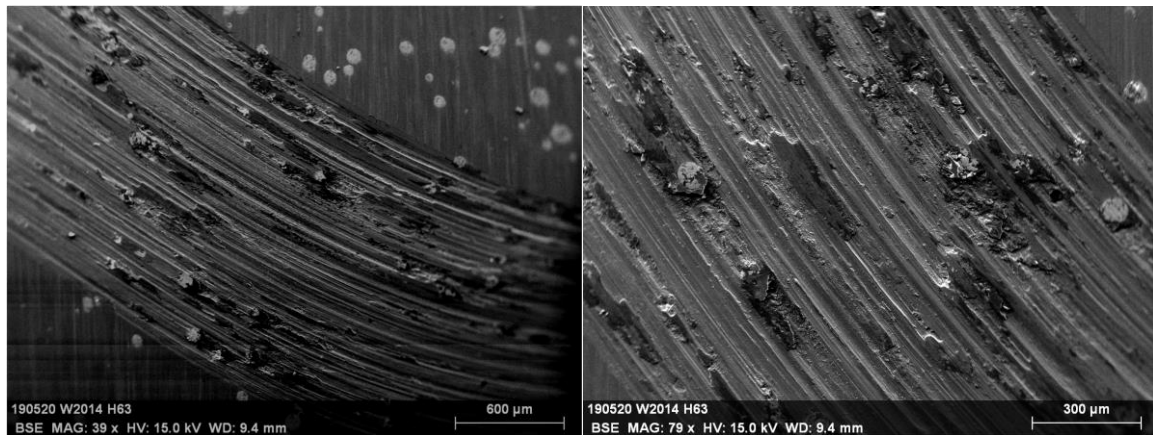
Figure 4-83: Details of the worn tracks after the fourth interrupted test.

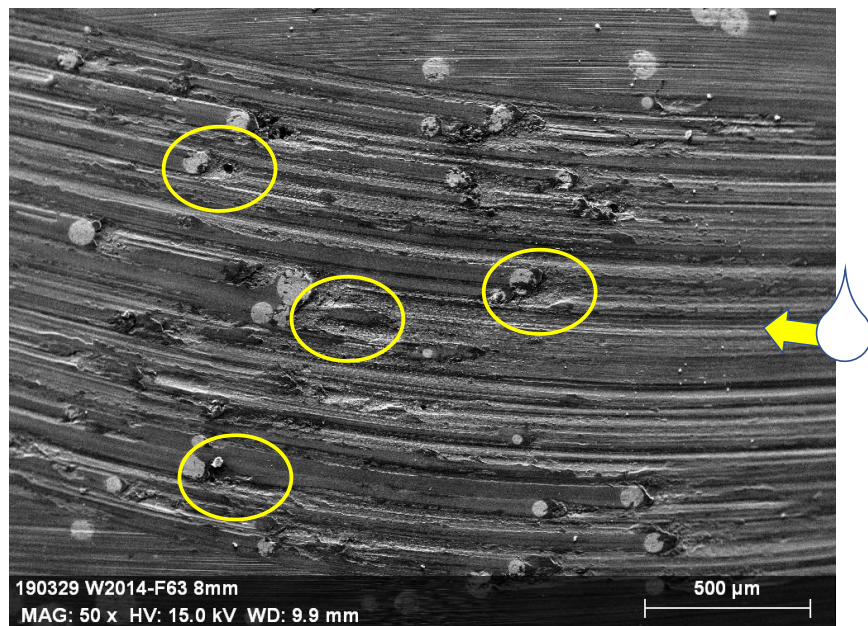
Figure 4-84: Detail of the W20.14-F6.3 10N worn track. The grooves correspond to the highlighted zones.

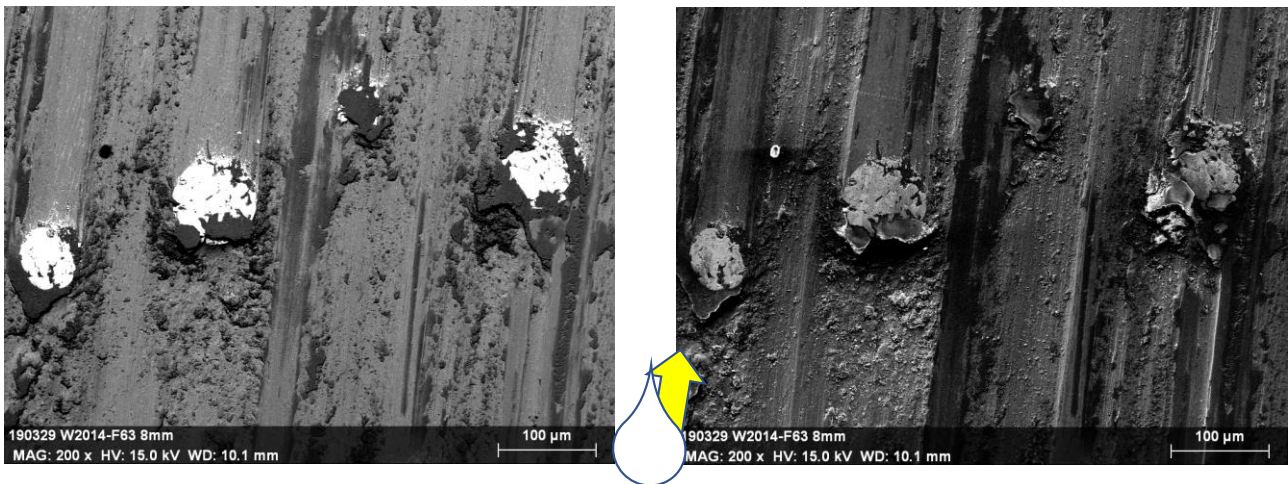
Figure 4-85: Material stacked in front of the carbides

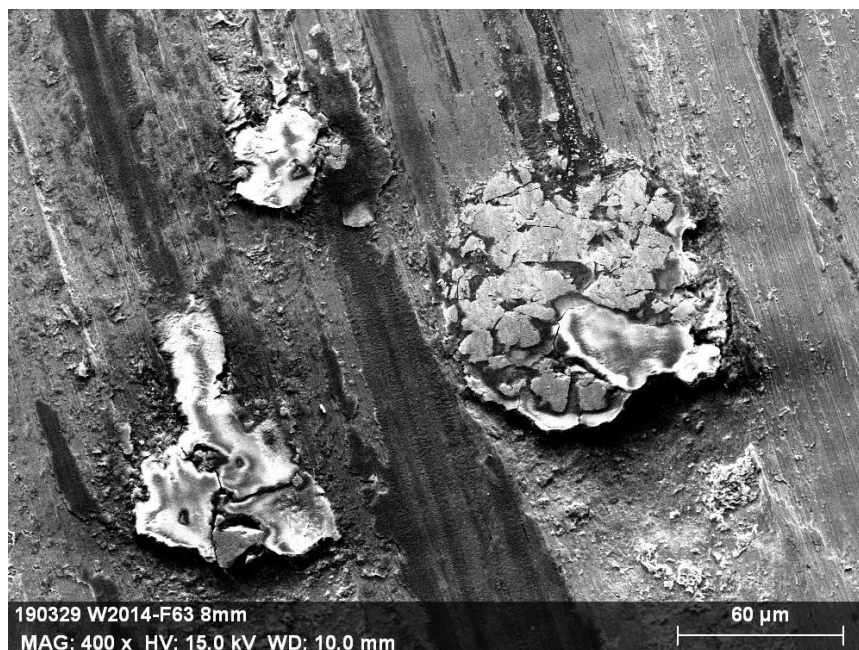
Figure 4-86: Fractured carbide.

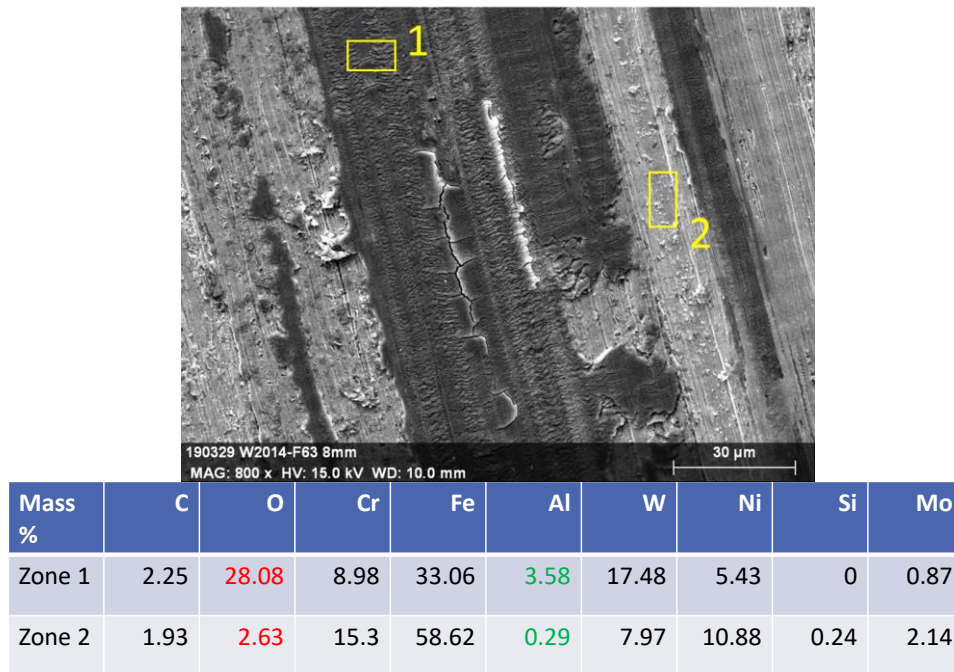
Figure 4-87: Layer cracked from W20.14-6.3.

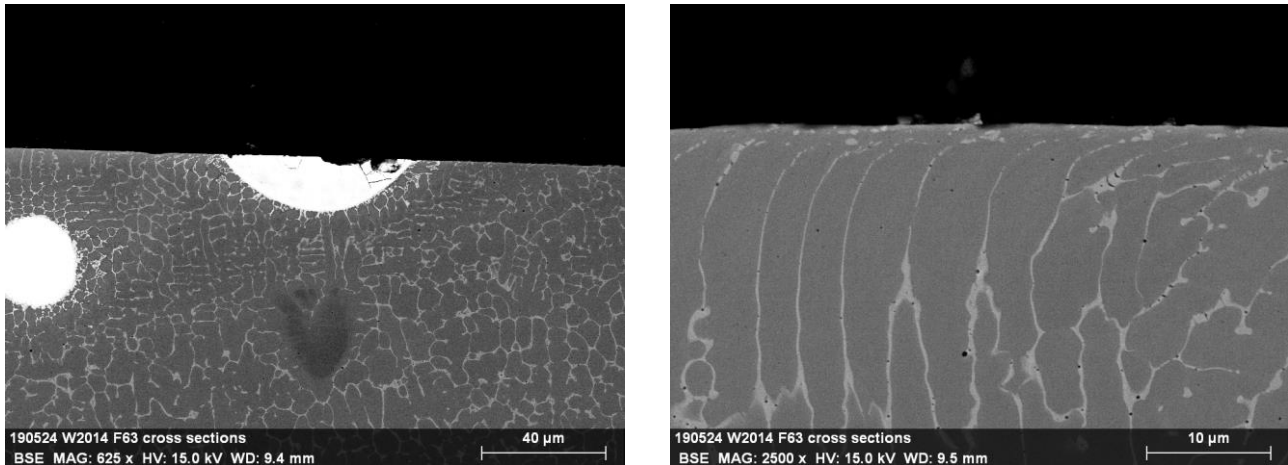
Figure 4-88: Fractured carbide (on the left) deformation of the carbides dispersed in the matrix (on the right).

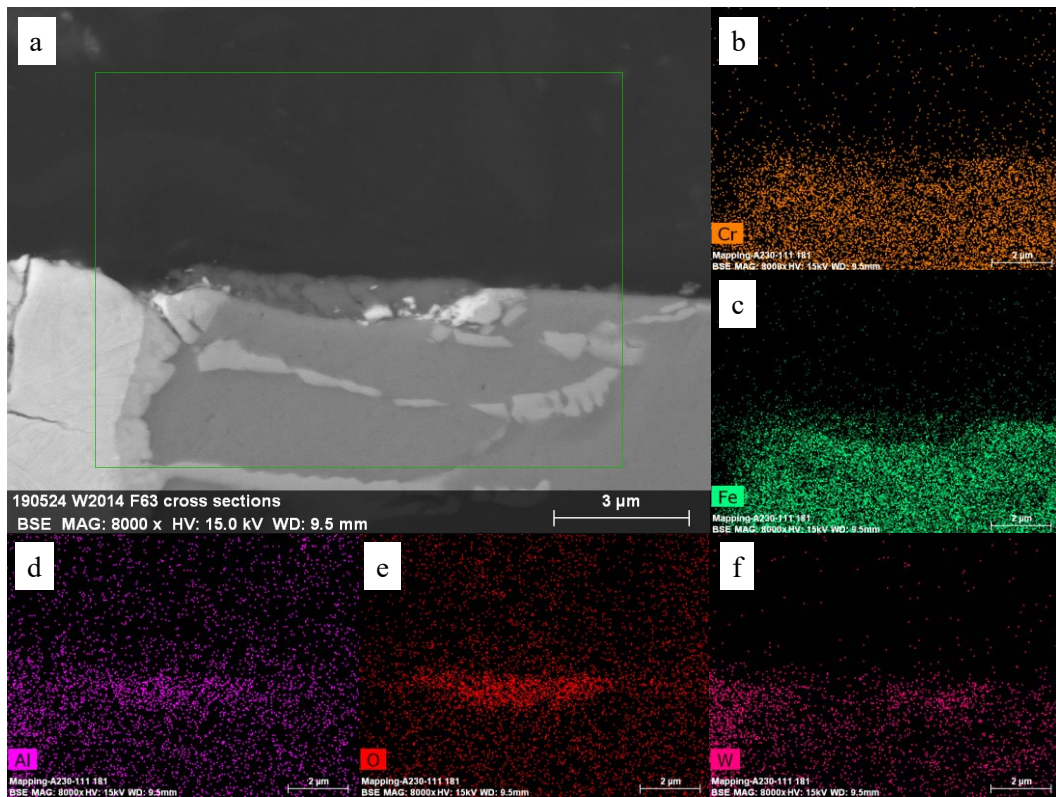
Figure 4-89: (a) BSE mode of a detail found on the cross section of the W20.14 F6.3 (22000cycles); from (b) to (f) EDS Composition maps of the zone.

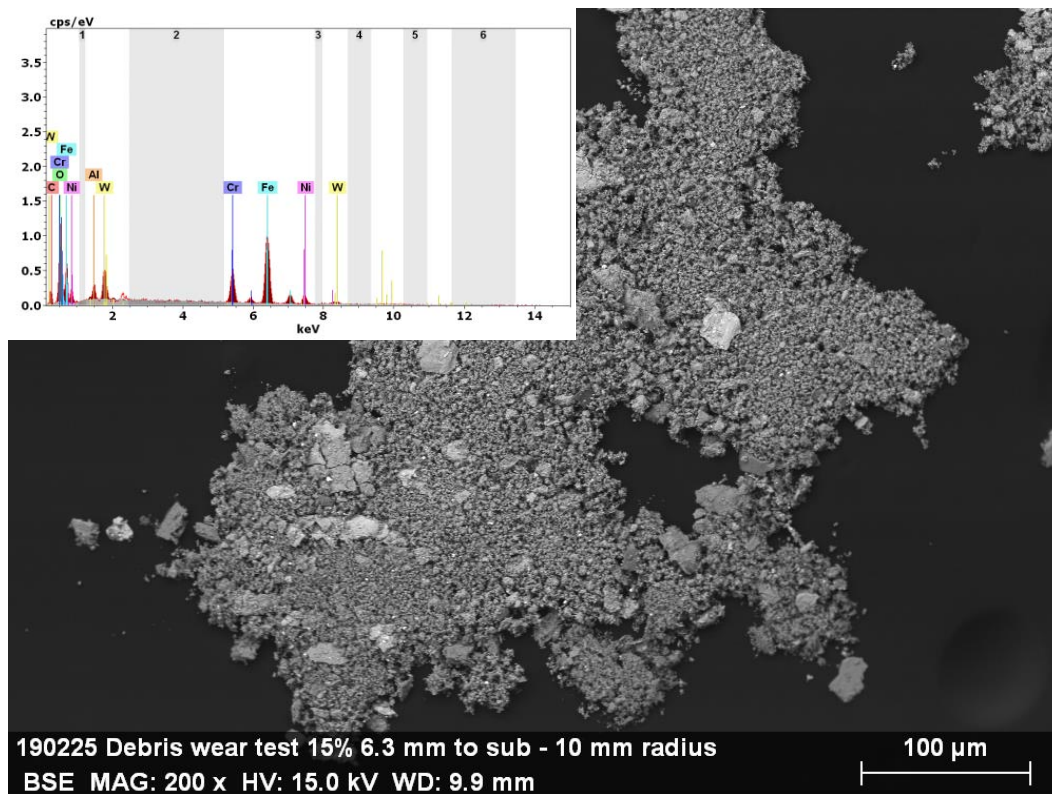
Figure 4-90: SEM image and chemical spectra of small debris from the preliminary tests.

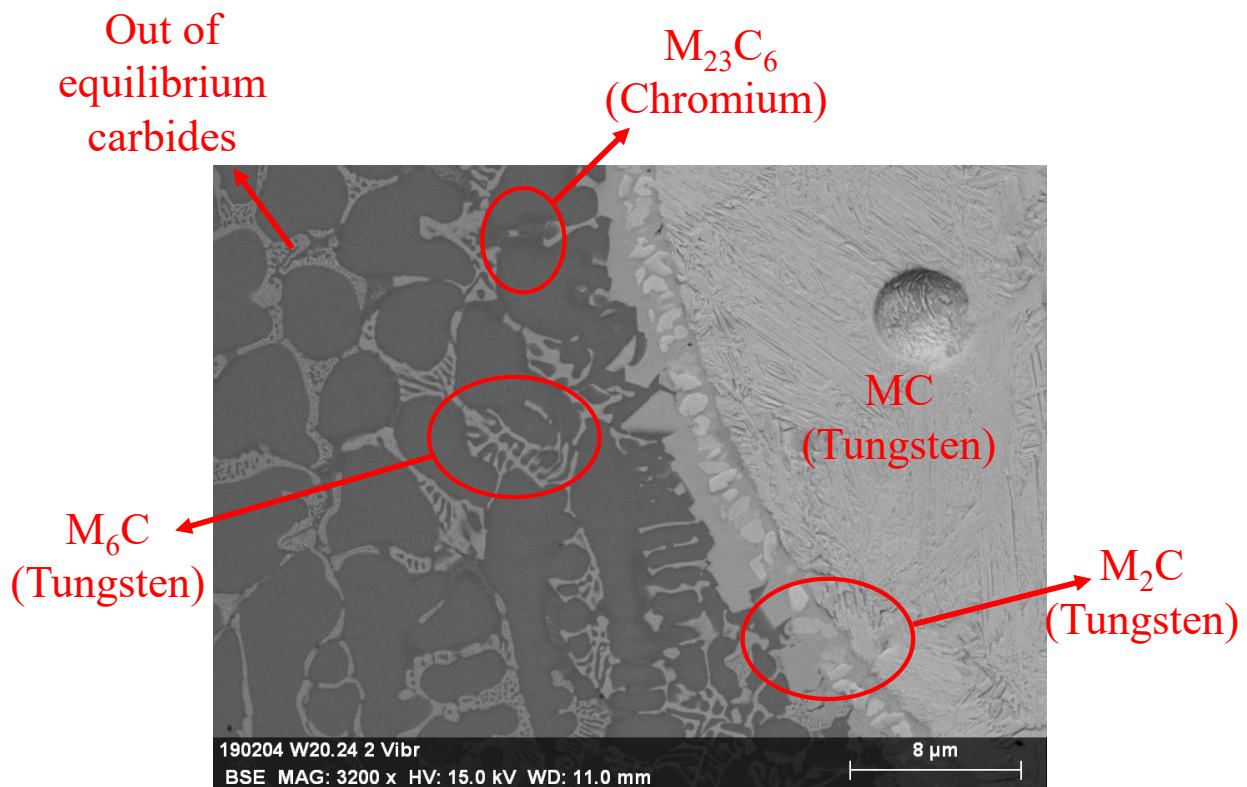
Figure 5-2: Different morphologies of the phases detected.

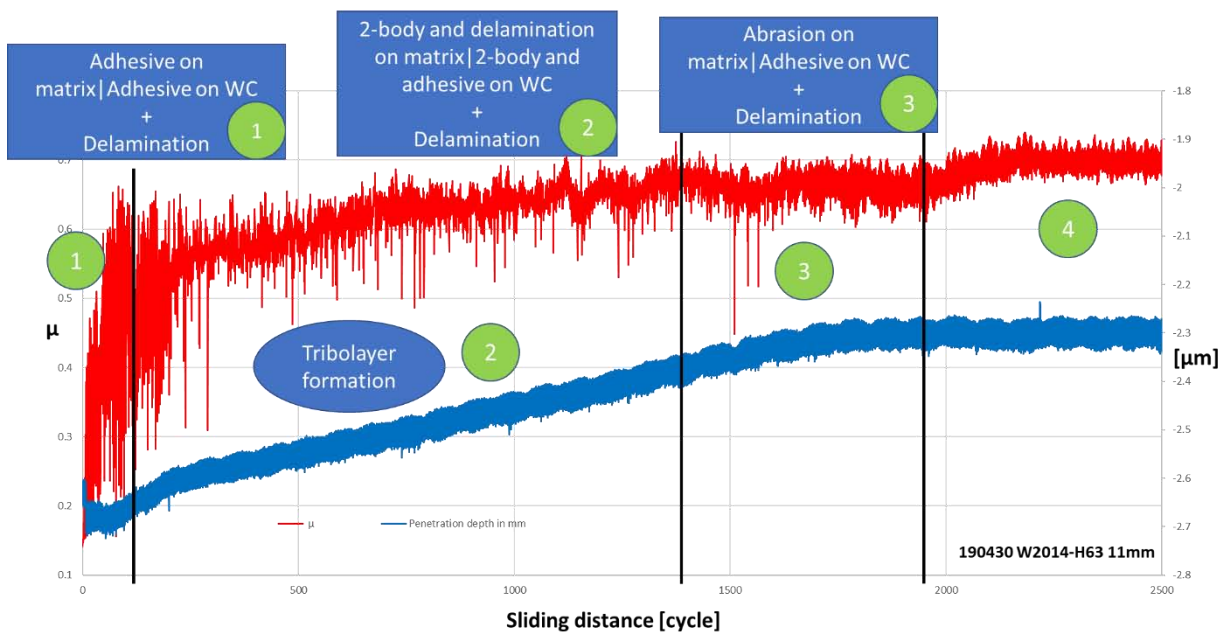
Figure 5-3: Association of the different wear types to the COF evolution.

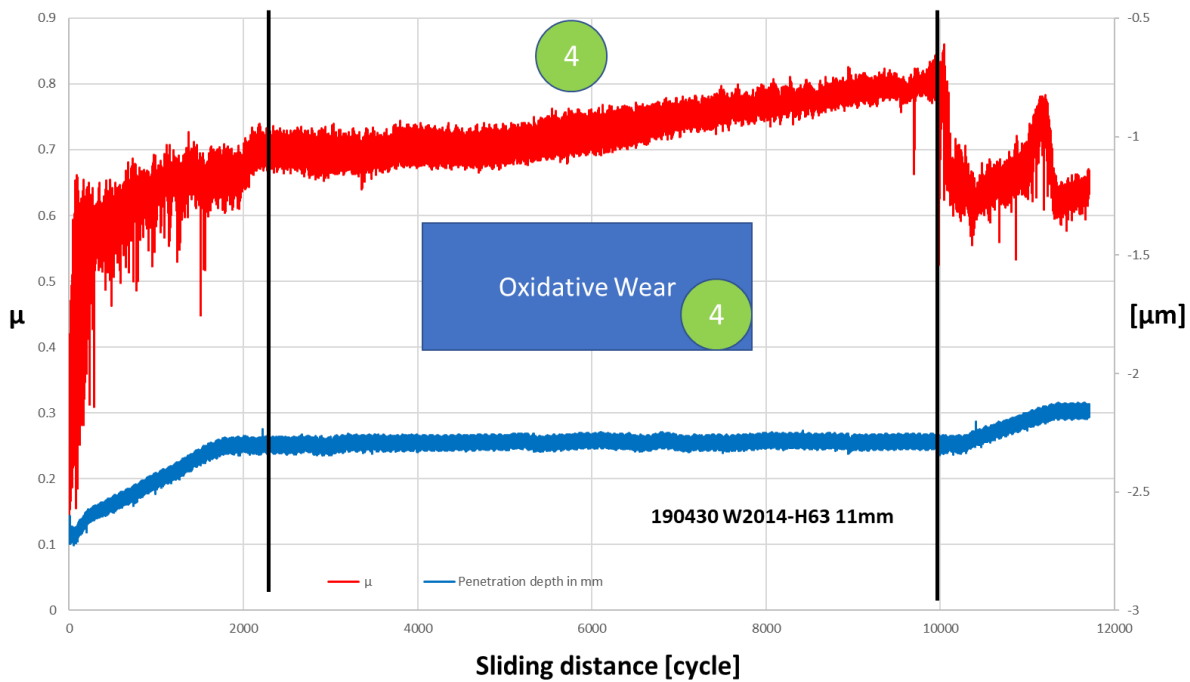
Figure 5-4: Association of the different wear types to the COF evolution.

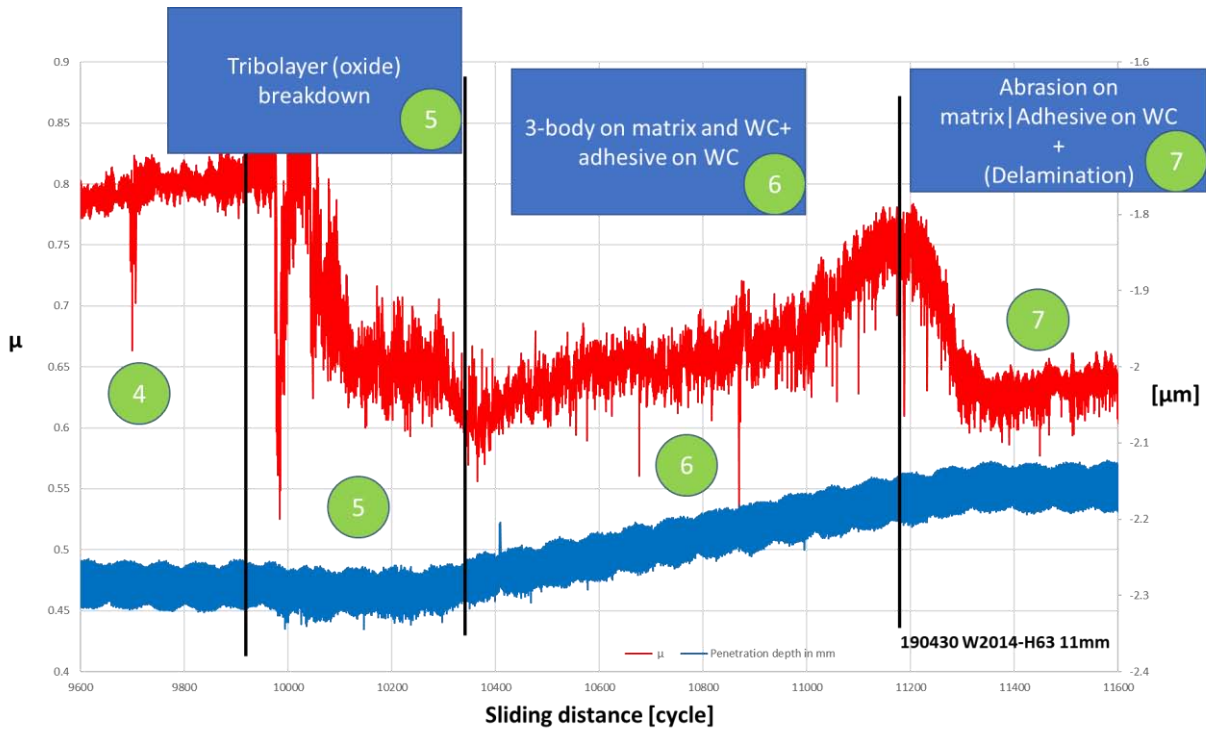
Figure 5-5: Association of the different wear types to the COF evolution.
